FIVE-YEAR REVIEW REPORT

**St. Louis River Superfund Site
Duluth
St. Louis County, Minnesota**

**U.S. Steel Site - EPA OU 02
St. Louis River/Interlake/Duluth Tar Site, Tar Seep OU – EPA OU.01
St. Louis River/Interlake/Duluth Tar Site, Soil OU – EPA OU 03**

**U.S. Army Corps of Engineers
Omaha District**

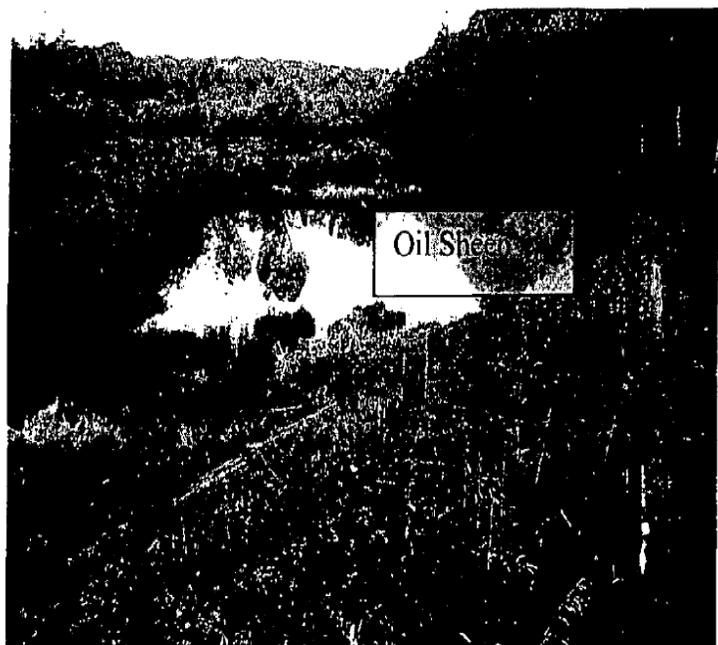
An oil sheen was observed in the pond pictured on the left. The sheen was located adjacent to the toe of the cover. Floating tar balls were also noted during the inspection and continued intermittently eight weeks later. ATV tracks were observed on the northern slope of the cover. The vantage point of this photo is viewed looking in a northerly direction along the Unnamed Creek.

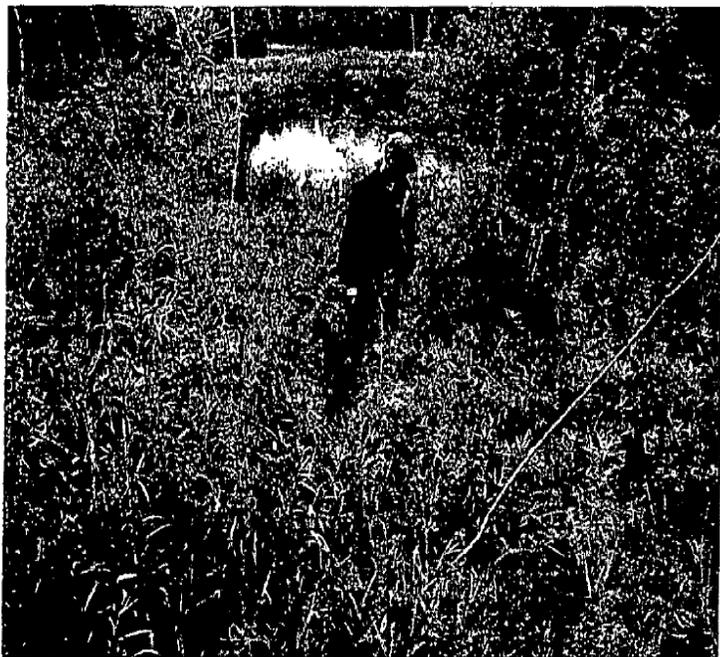
The photo on the left is viewed looking north at the berm separating Cell A and the up-gradient pond. Note the erosion runnel in the center of the photo. These erosion runnels were nearly a foot deep.

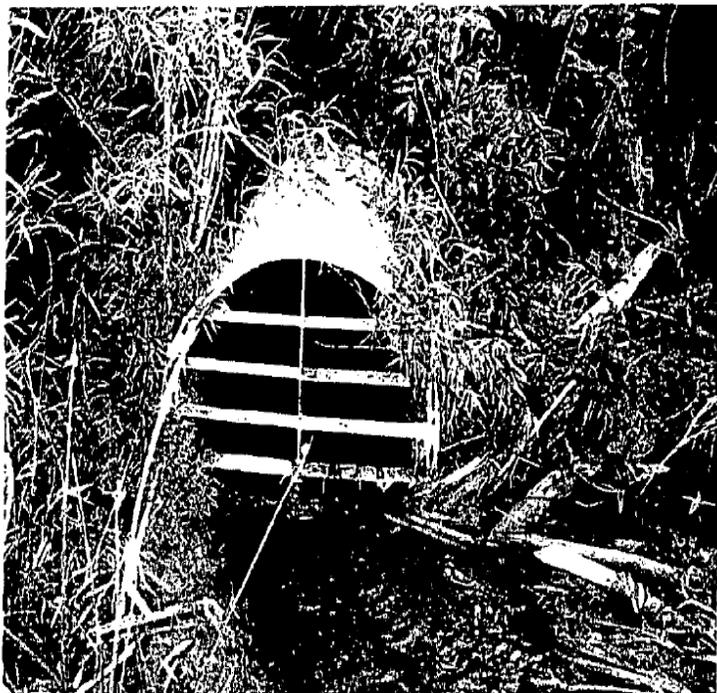
The photo is viewed looking south at the inlet of the conduit.

The inlet as shown in the photo on the left was found to be in good condition and free flowing. There were no oil sheens observed in the pond or water entering the culvert.

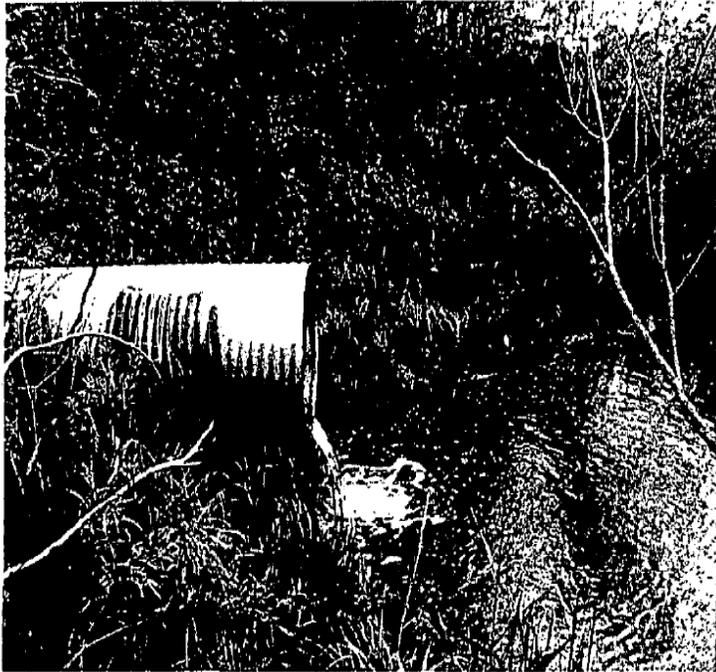
The outlet as shown in the photo on the left was also found to be in good condition and free flowing. There were no oil sheens observed in the discharge water or in the plunge pool.

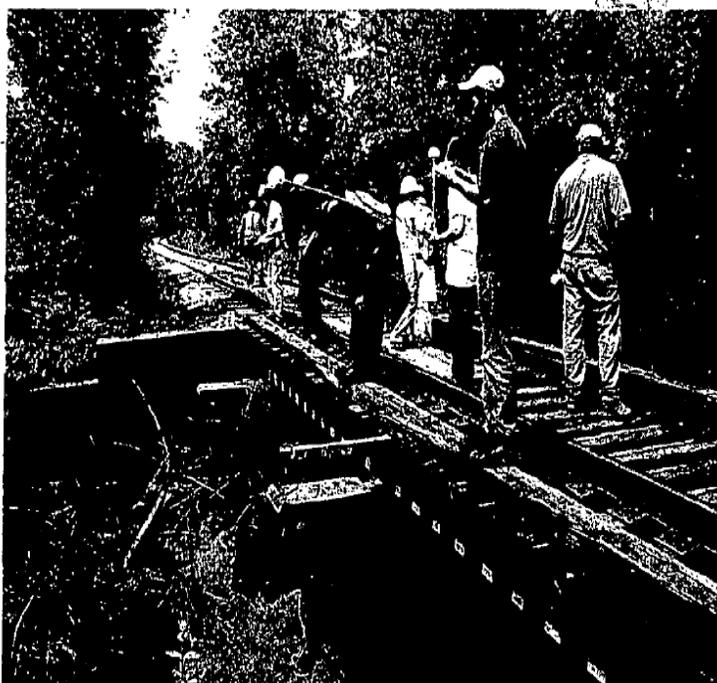
Pictured on the left is the downstream terminus of OU-L. The Water Monitoring Point CP-3 is located at this location. Members of the inspection team observed a small sheen near the bridge abutment. The photo on the left is viewed looking northerly or downstream relative to the parallel St. Louis River.

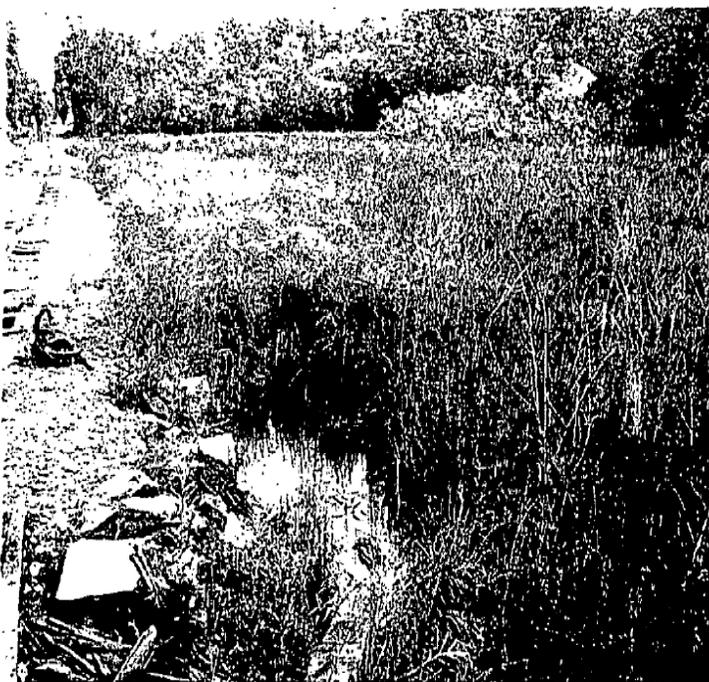
An oil sheen was observed in the delta of the Unnamed Creek. The oil sheen was located adjacent to a culvert that was recently installed under the railroad tracks. New replacement ties were found in the immediate area of the oil sheens. The source of the sheens is unknown. The photo on the left is viewed looking south or upstream relative to the parallel St. Louis River. The railroad bridge shown in the previous photo can be seen in the upper left hand corner of this photo.

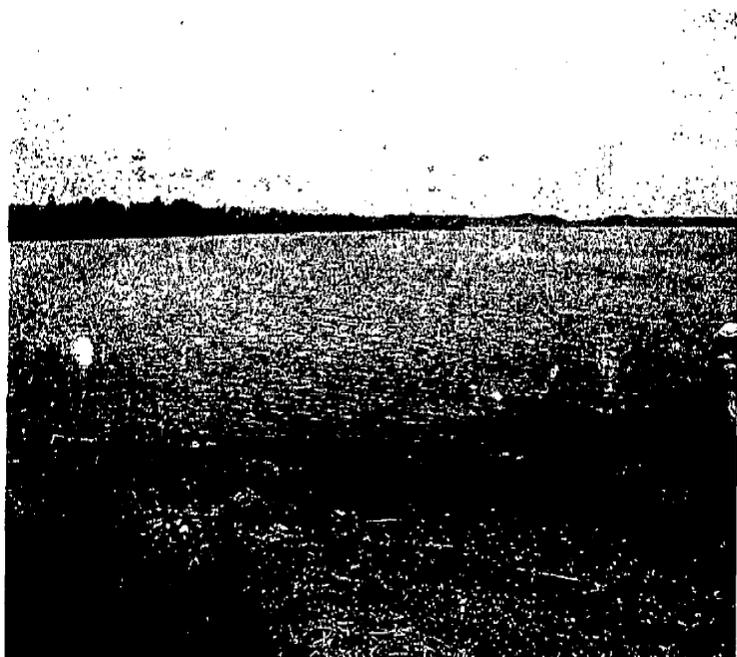
The Spit of Land was found to be in good condition. There was no shoreline erosion, oil sheens or visual evidence of PAHs. The south face (as viewed in this photo) was open to the St. Louis River. It appeared that trespassing (fishing, camping, hiking etc.) appears frequently on the Spit of Land. The path that extends from the railroad tracks to the tip of the peninsula was surveyed with GPS.

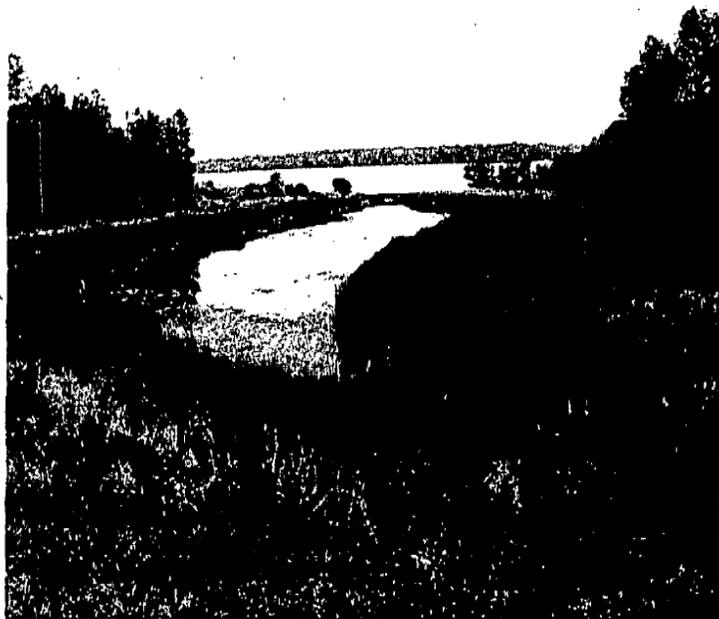
The photo on the left is view of the Wire Mill Pond looking easterly towards the St. Louis River. The wetland vegetation was well established. There was an oil sheen observed on the pond surface near the hydraulic control structure on June 27, 2003. There was no shoreline erosion or sloughing noted. The perimeter of the pond was surveyed with GPS.

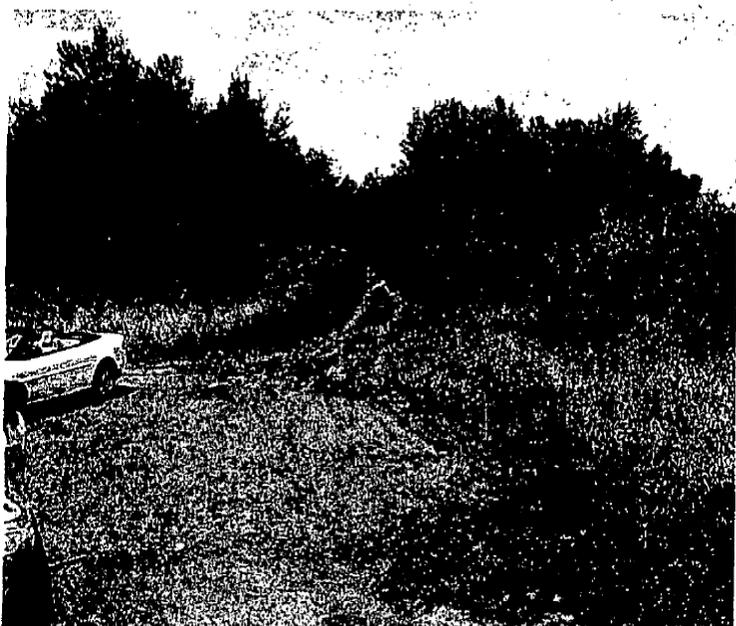
Trespassers access the site at the Wire Mill Pond area by using the city owned railroad tracks. During the short duration of the inspection, several ATVs and hikers passed by on the railroad tracks.

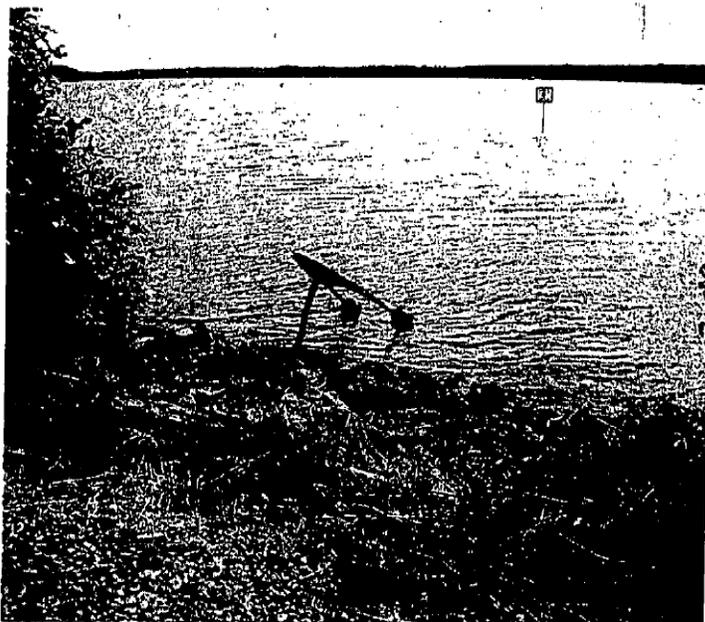
The shoreline of the St. Louis River was inspected adjacent to the Wire Mill Pond. The photo on the right is viewed looking towards the St. Louis River from the Wire Mill Pond. The original contaminant warning sign was damaged. The replacement sign can be seen in the background of the photo.

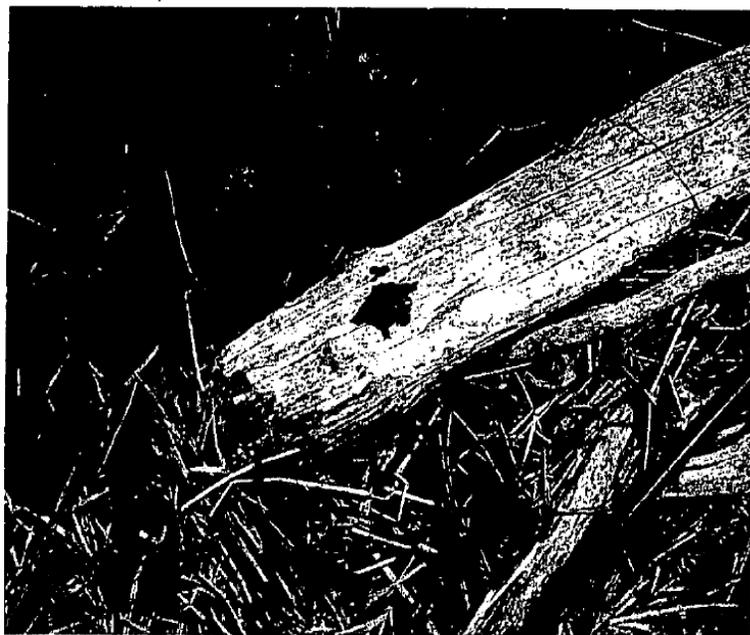
Non-native materials were observed along the shoreline of the St. Louis River near the Wire Mill Pond. The photo on the left is a close-up view of the non-native material.

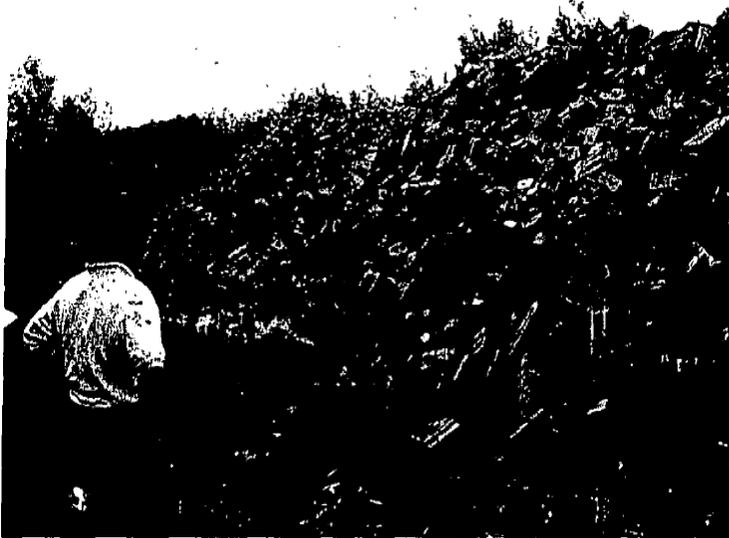
A demolition stockpile of bricks was located near the northeast corner of the former Materials Storage Area. The area was not surveyed. This demolition stockpile is not Demolition Landfill Nos. 1, 2 or 3 that were previously discussed in this report. No information could be found in the literature search that indicates this demolition stockpile was ever permitted.

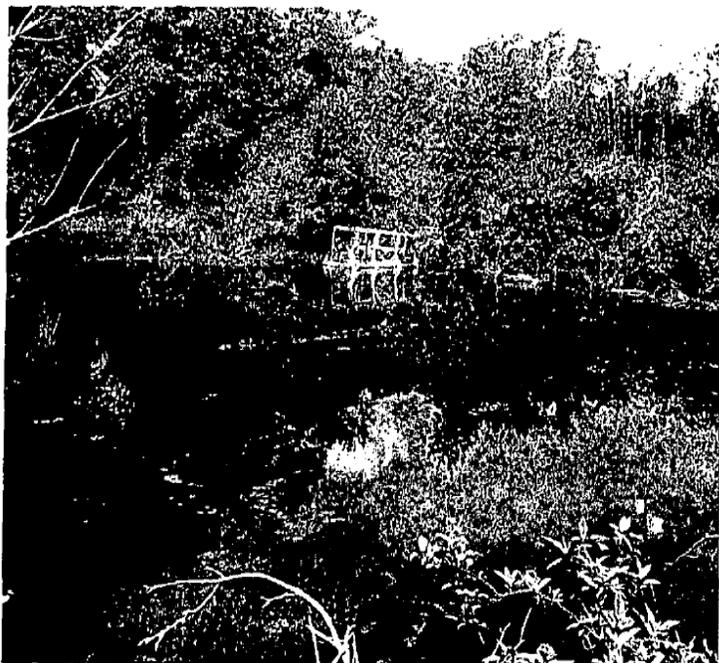
This pond was inspected on June 27, 2003. The pond is located south of Seep 1. A citizen stated his dog fell through the ice at this pond and was coated with an oily material.

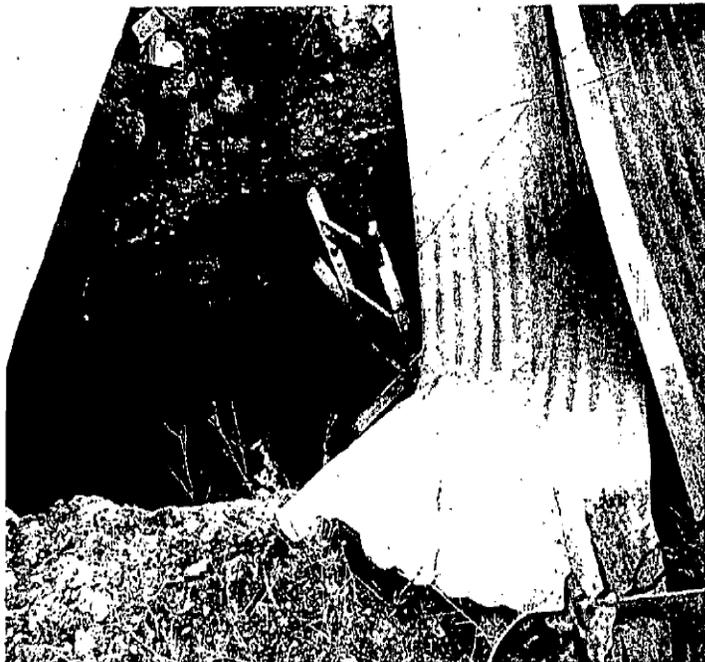
This gatewell was inspected on June 27, 2003. The gatewell is located near Well 7. There was floating product in the gatewell. The orange protective fence around the structure needs repair.

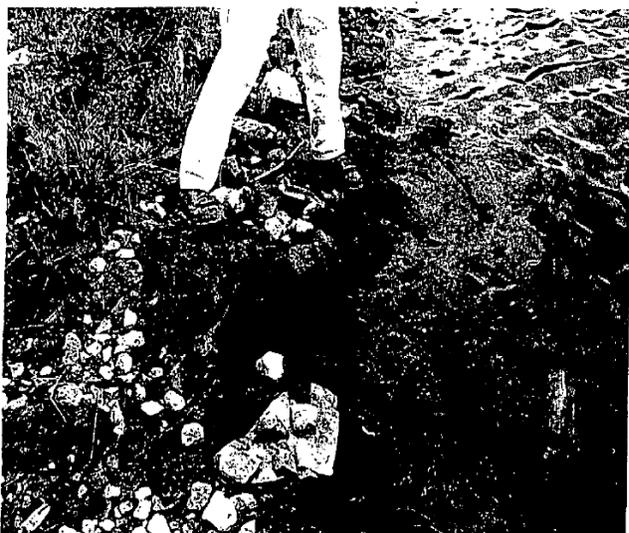
Hardened tar was observed at several locations along the water's edge on the north bank of Slip 6. These seeps appeared to be fairly fresh. The locations were marked by GPS and are shown on Figure 7.

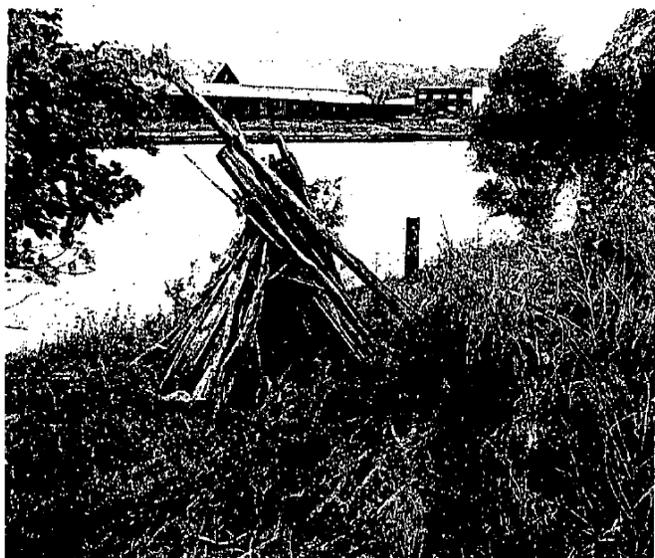
Evidence of trespassing, like that shown here, was observed along the shoreline of the peninsula. Trash, debris, and small fire rings were common across the site.

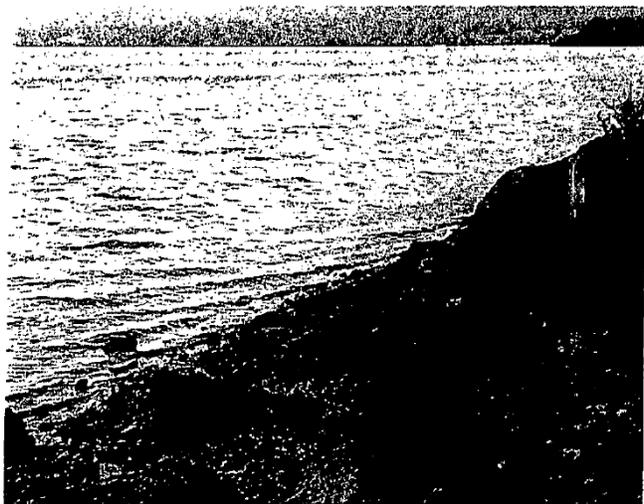
Viewed here is erosion observed at the southern tip of the 59th Avenue peninsula.

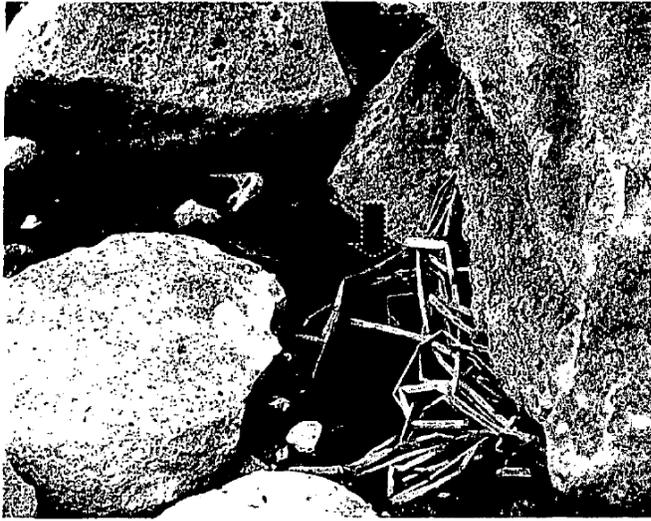
This tar was observed in the same general location that the erosion was noted, The tar and erosion location are approximated on Figure 7 as Area F 3.
