Lessons Learned from Combined Injection and Groundwater Recirculation Trench Pilot Test

USACE-Kansas City District

Pilot Study

ZVI Trench Design

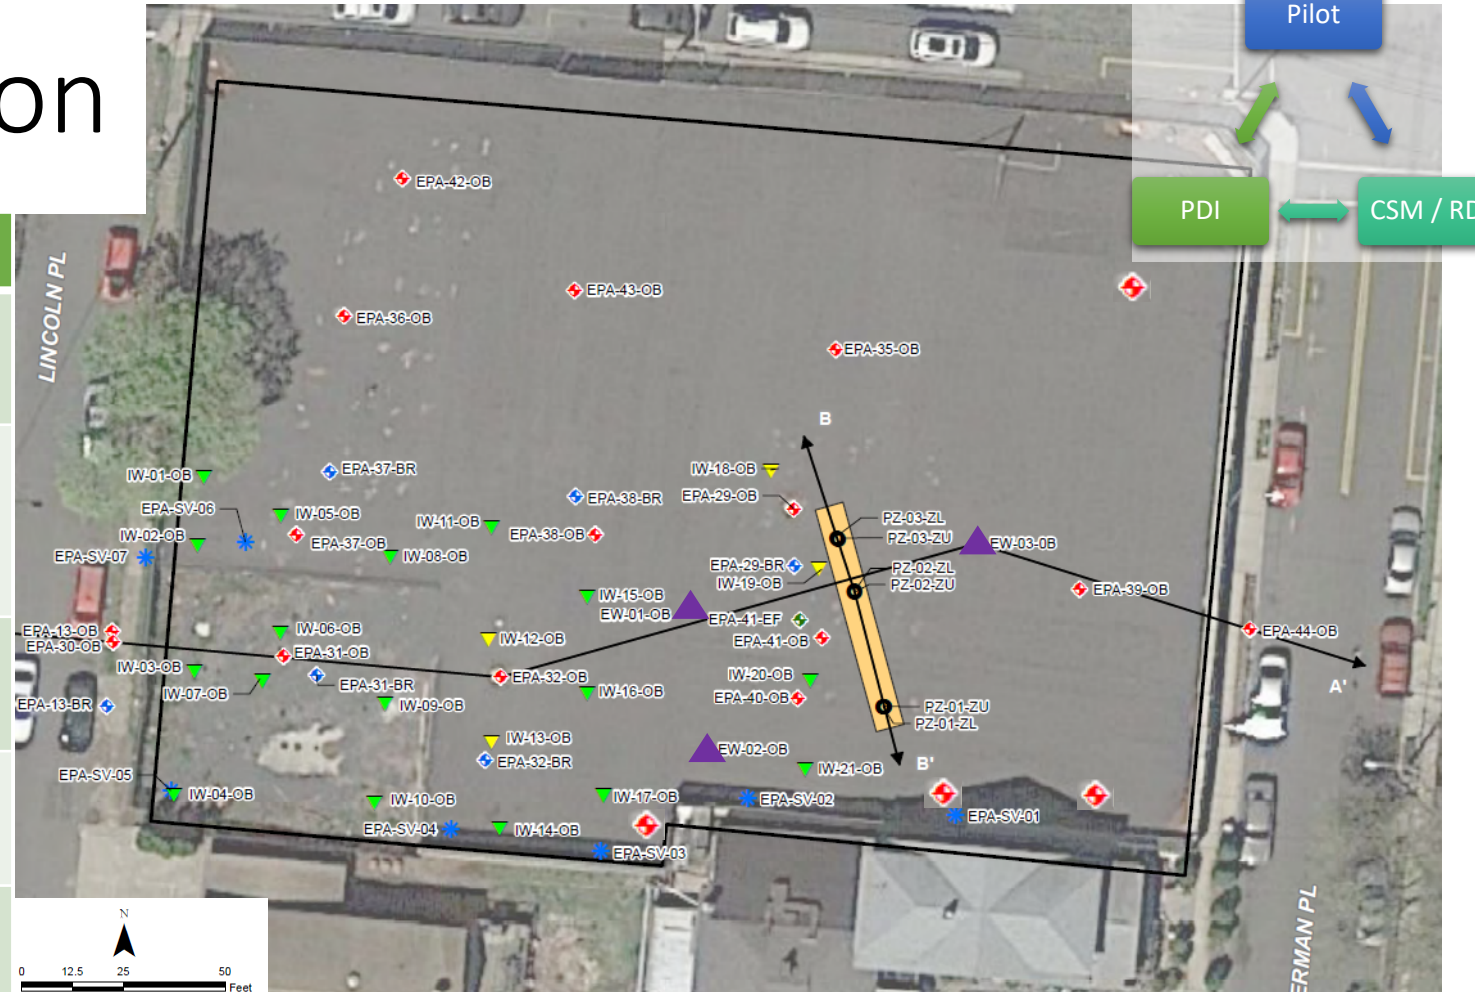
- ◆ Bedrock Monitoring Well
- ◆ Excavation Fill Monitoring Well
- ▼ Injection Well (EVO with Lactate + Buffer)
- ▼ Injection Well (EVO with Lactate + MicroZVI)
- ▲ Overburden Extraction Well
- ◆ Overburden Monitoring Well
- ★ Soil Gas Monitoring Point
- ZVI Trench Piezometer

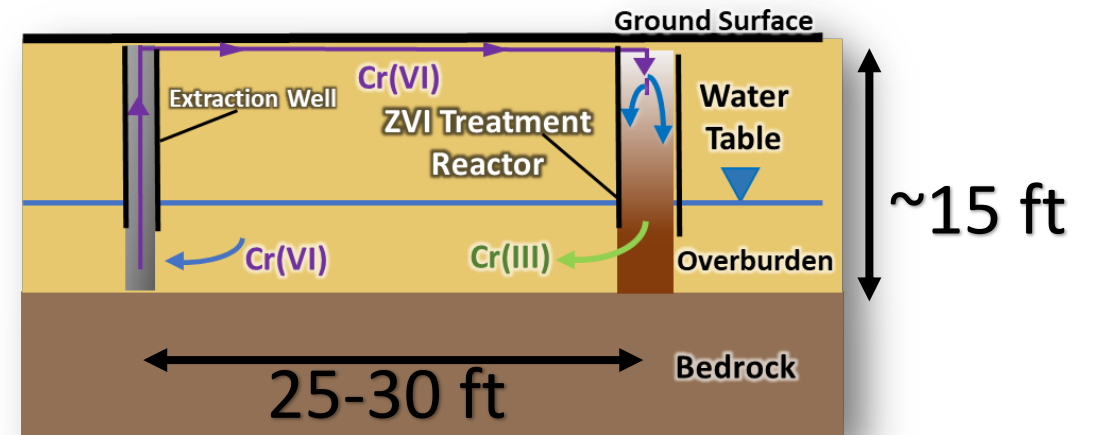
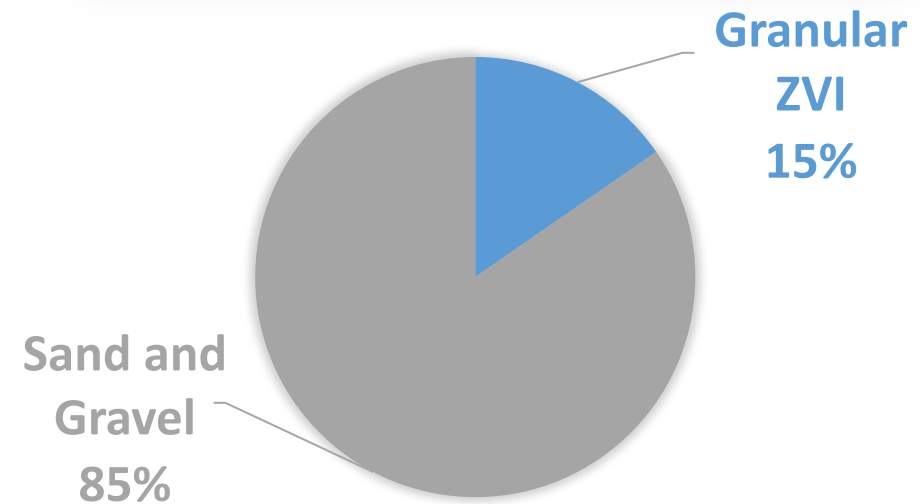
Conceptual x-section

Design Hydraulic Residence Time: ~ 50 minutes

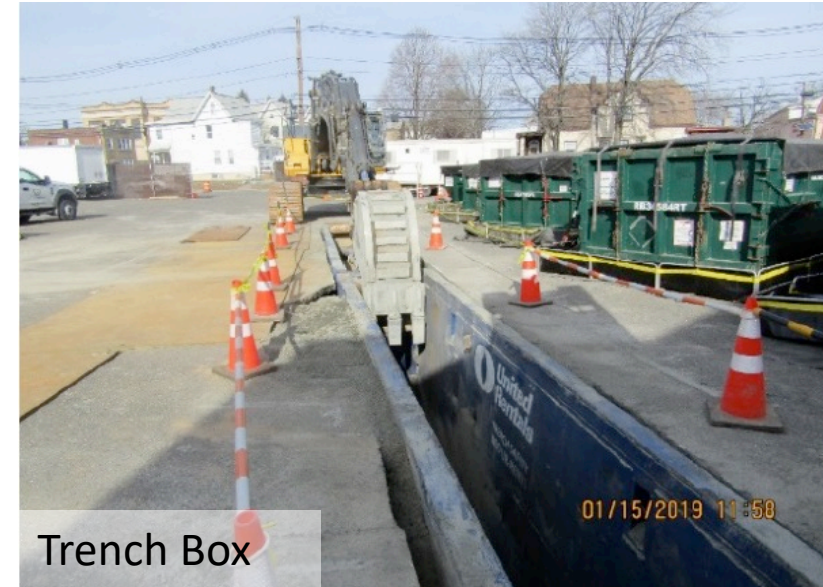
Trench Box

- Trench Installation Method Revised
 - Trench box unsuccessful in saturated soils
 - Custom Slide Rail system added time, but...
 - No dewatering (GW = haz waste)
 - No upwelling of soils or bowing of sides
 - No vibrational impacts 20-25' ft from slide rail
- Trench was 3 ft shallower than expected
 - Why??

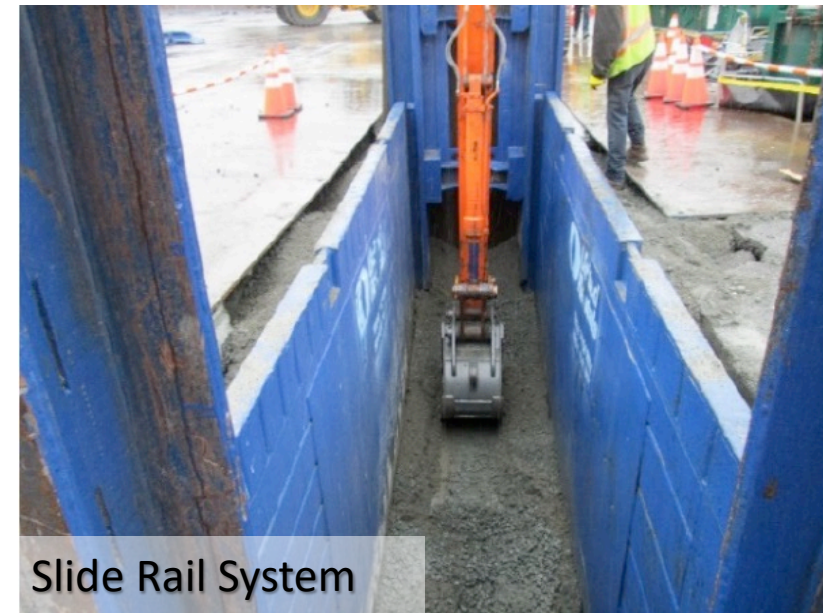
Slide Rail System

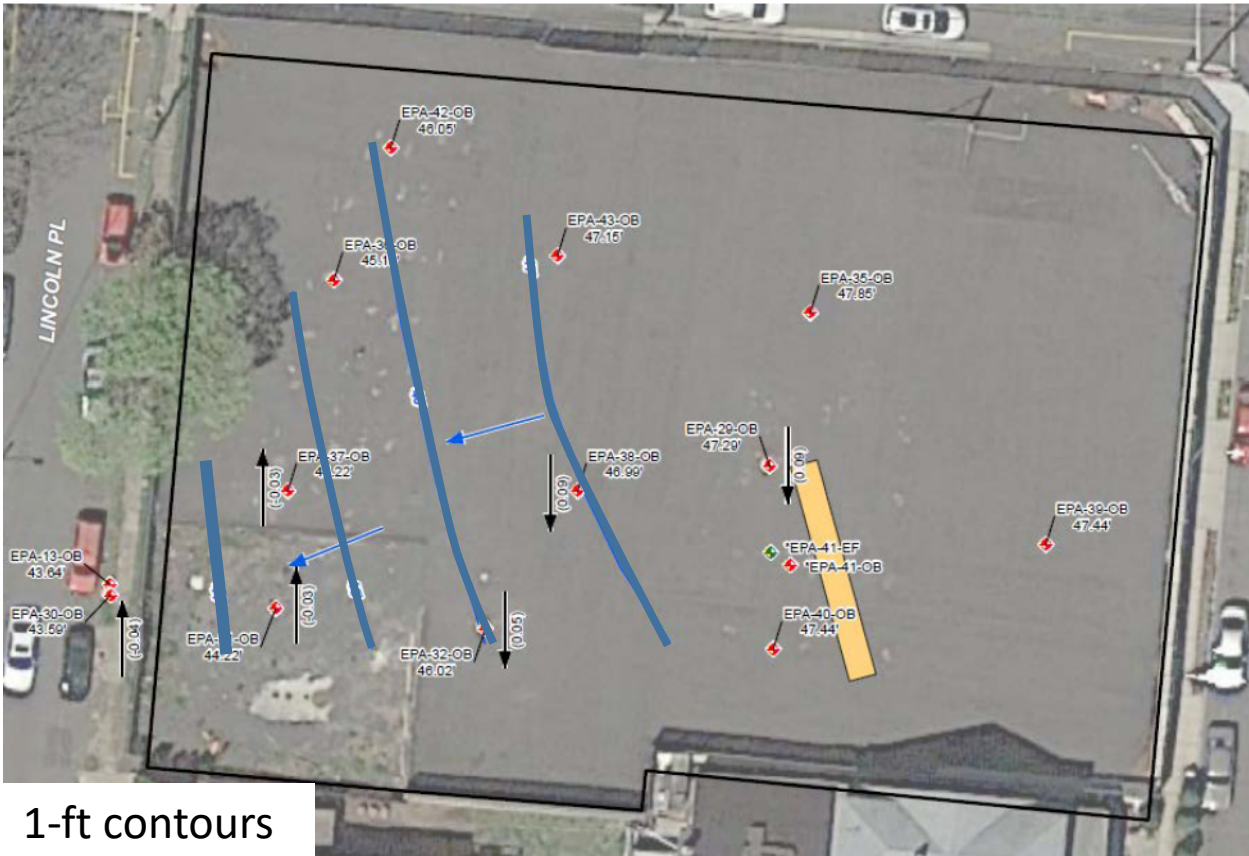
Pre-Injection, Pre-ZVI Trench
Mar 2018

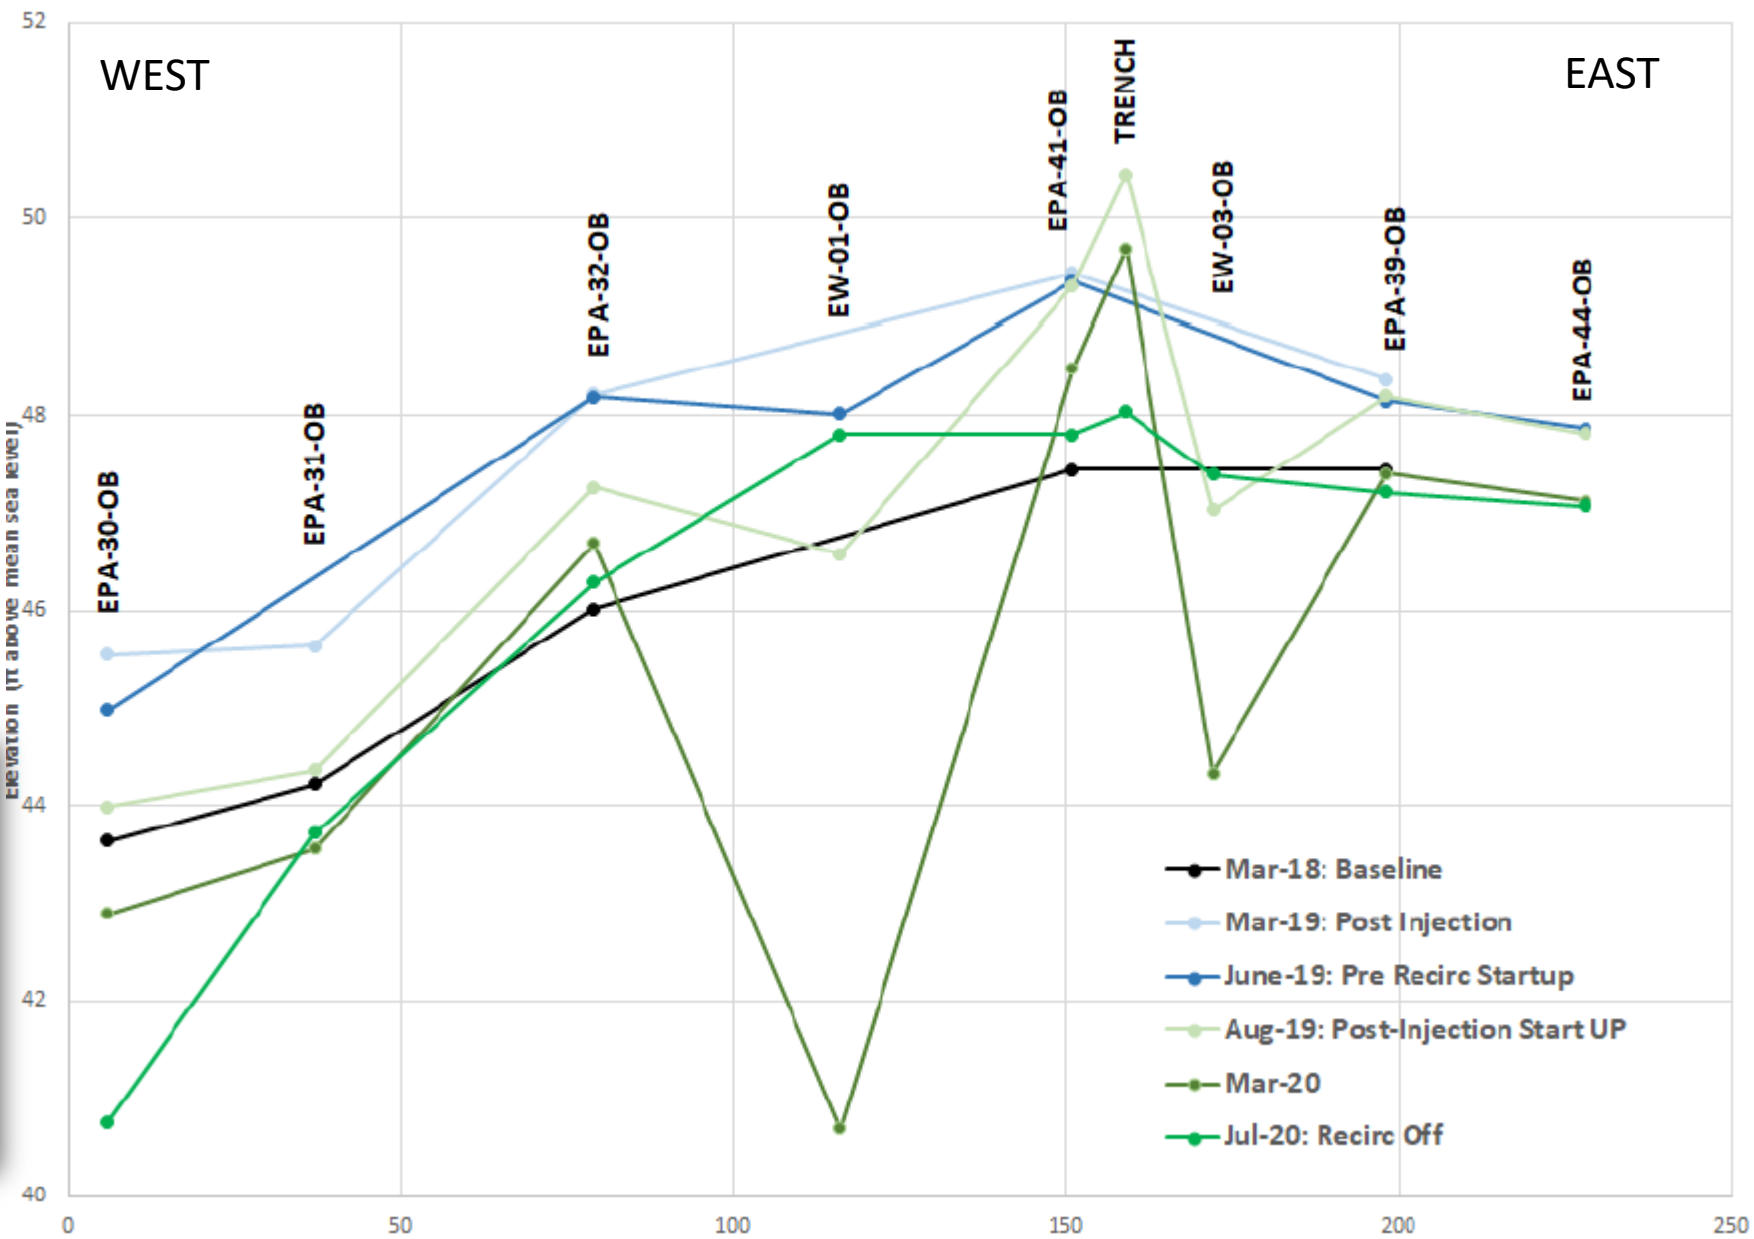
Groundwater Elevation Profile

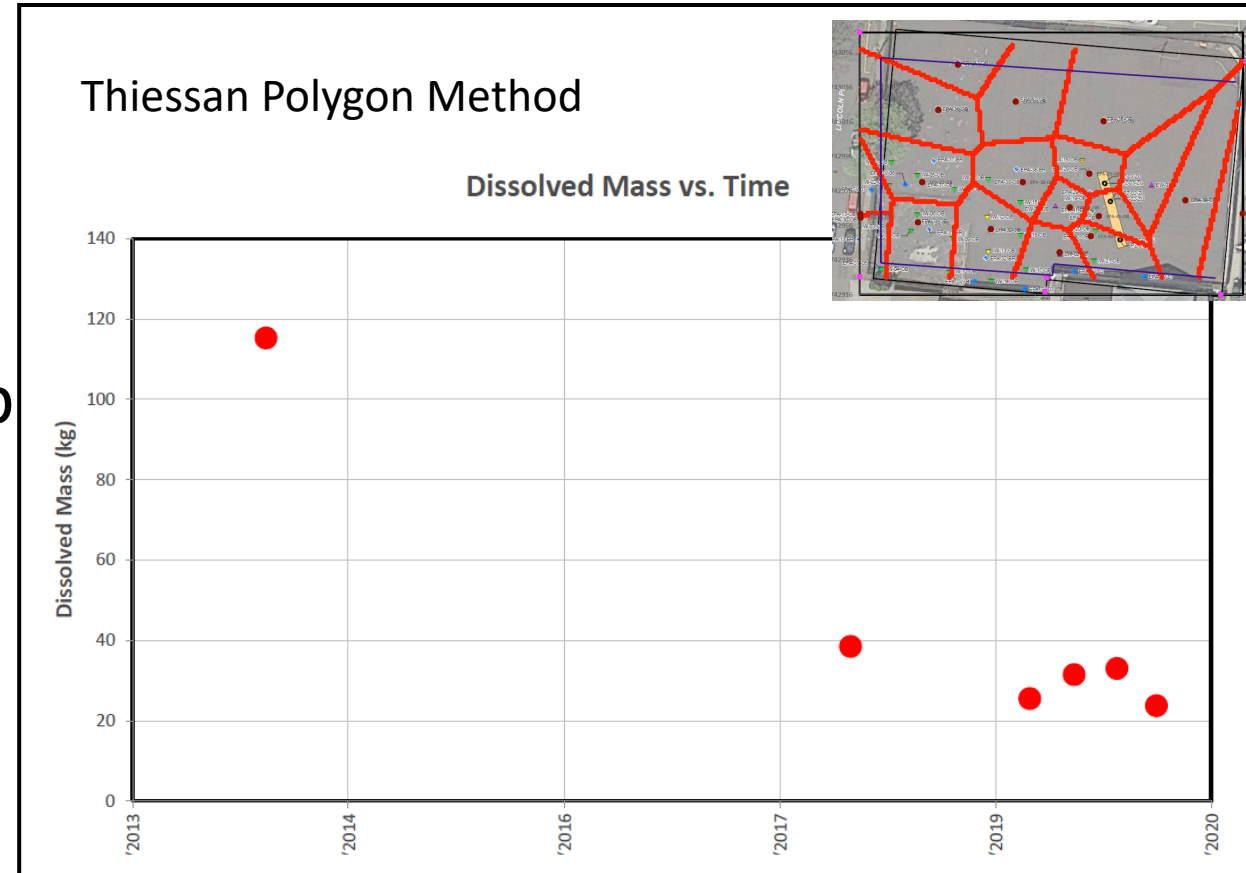
Mass Reduction

- Cr(VI) reduced by 80% since 2014
- Temporary increase after ZVI Startup
- Center of mass shifted to east (EPA-39-OB)
- Limited effect on shallow bedrock
- Significant reducing capacity on western half of site may limit mass flux for years
