Optimizing Remediation to Achieve Closure at Multiple Sites at Vermont Air National Guard Base

E. Matt Germon, P.E.

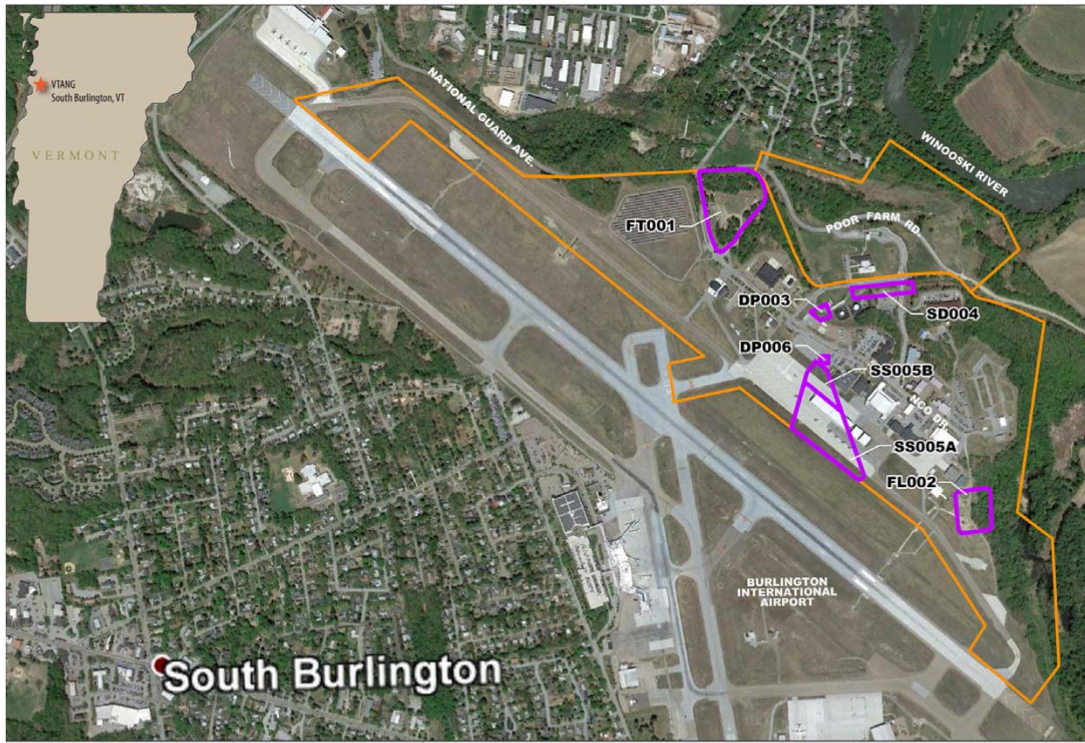
Figure 1
 Site Installation Map
 VTANG, South Burlington, Vermont

LEGEND
 VTANG Base Boundary
 RA Site Boundary

North
 Approximate scale in feet
 1" = 1,600 feet
 0 400 800 1,600

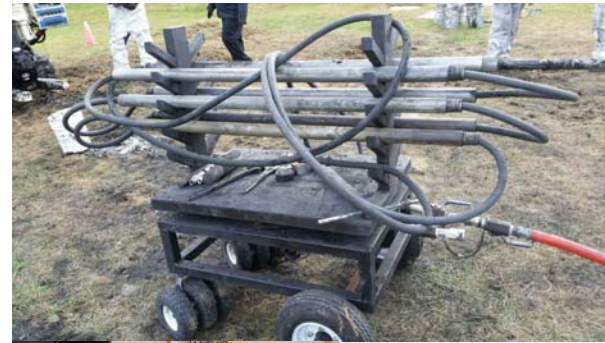
AC-Based injections in areas of COC rebound

- AC-Based injections
- Supplemental AS/SVE Wells
- Packer Installation in HDD AS wells

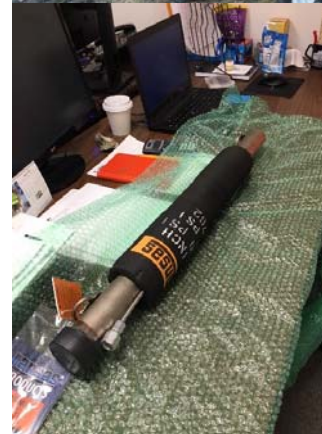
Packer in HDD wells to focus sparge in distal well end

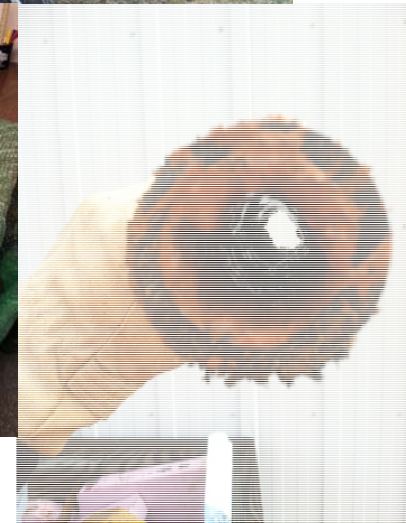
Iron Fouling of Process Pipes

Brushing/cleaning of HDD SVE wells due to corrosion

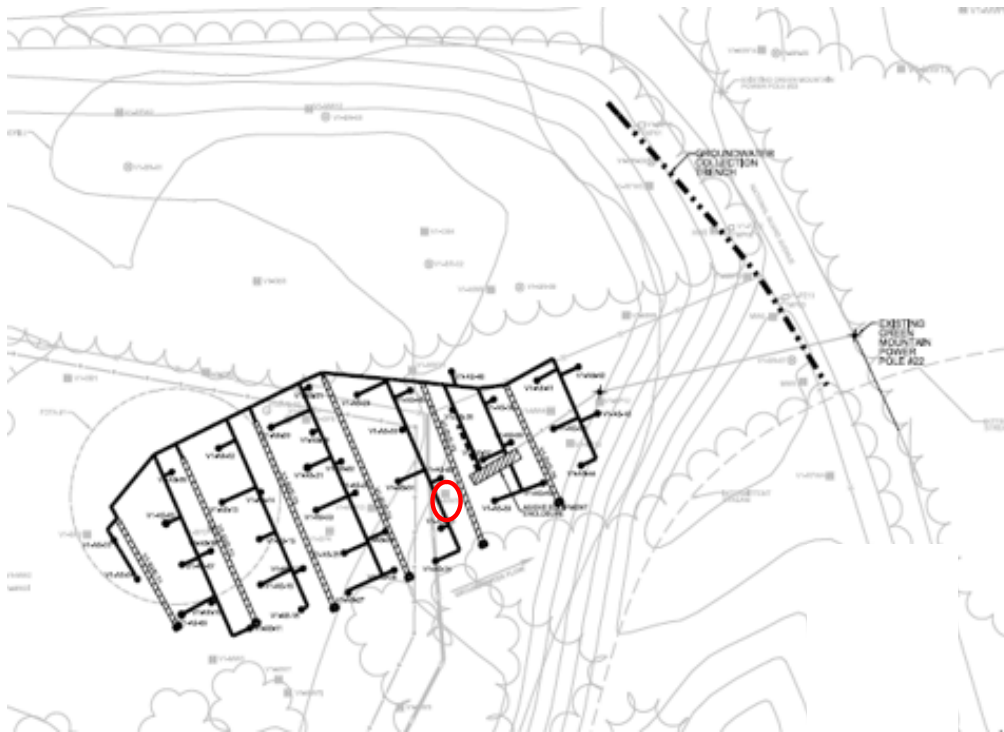
Site 1

- June 2012 – Startup of AS/SVE system
- February 2013 – LNAPL no longer measurable
- November 2014 – Rebound Assessment
- May 2015 – Restart
- August 2015 – Rebound Assessment, V1-MW5 remains above SRGs
- April 2016 – Restart in Focused Areas
- May 2016 – Shutdown
- May 2018 – No Further Remedial Action Required for non-PFAS COCs from VT DEC
- May 2018 to Present – Continued OMM for PFAS treatment system

1,740 lbs VOCs removed

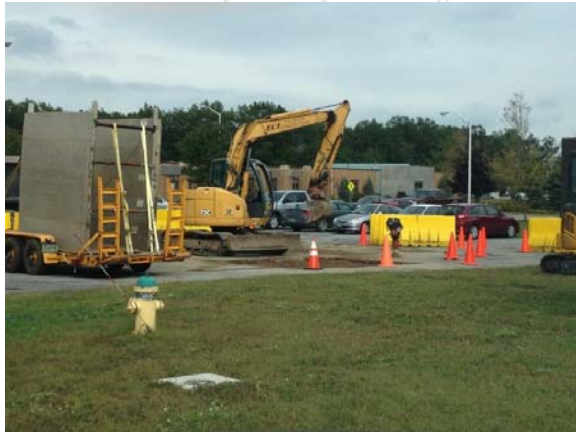
Site 5A

- October 2012 – AS/SVE with HDD Startup
- October 2013 – LNAPL no longer measurable
- February 2014 – Approval to remove catalytic oxidizer vapor treatment
- May 2015 – Rebound Assessment
- June 2015 – Restart with Focused AS/SVE
- June 2016 – Rebound Assessment, V5-MW-11 above SRGs for TMB and naphthalene
- September 2016 – Focused sparging at well AS-A
- March 2017 – Rebound Assessment
- January 2018 – System Operated with SVE due to low gw elevations
- July 2018 – Inflatable Packer installed in AS-A to promote sparging at the distal end of the well
- August 2018 – Restart focused at well AS-A
- November 2018 – System Shutdown
- April 2019 – No Further Remedial Action Required from VT DEC

24,165 lbs VOCs removed
