Former BICC Cables Site Hudson River Sediment Cap

Michael Newton, LSRP, PG and Janos M. Szeman, P.E.

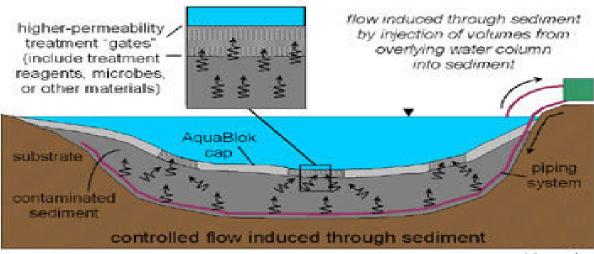
- Cushion Sand Layer
- 2. Active Treatment and Containment Layer
- 3. SCS Ballast Protection Layer
- 4. SCS Armor Protection Layer
- 5. Habitat Mitigation Layer

"Funnel & Gate"-Like Technique With NO Upwelling Ground Water

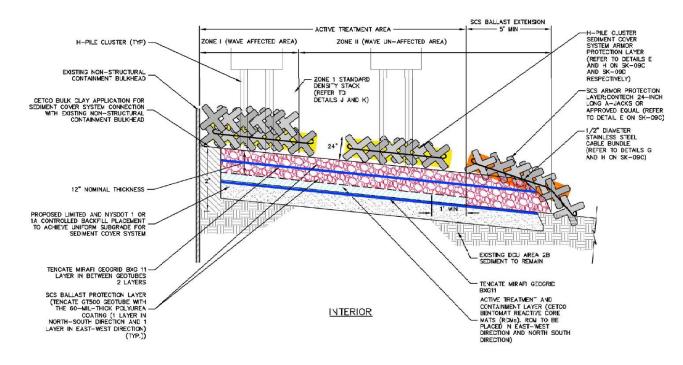
A PROPOSED MULTI-LAYER SEDIMENT COVER SYSTEM DETAIL (TYP.)
NOT TO SCALE

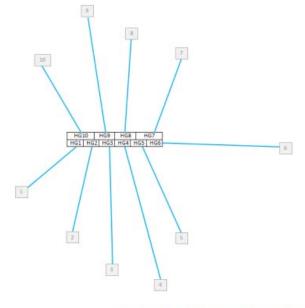
Figure 1: schematic, single wire, HG cable layout

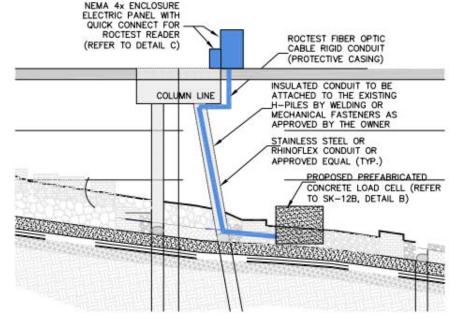
TYPICAL SEDIMENT COVER SYSTEM REMOTE SENSING INSTALLATION DETAIL NOT TO SCALE

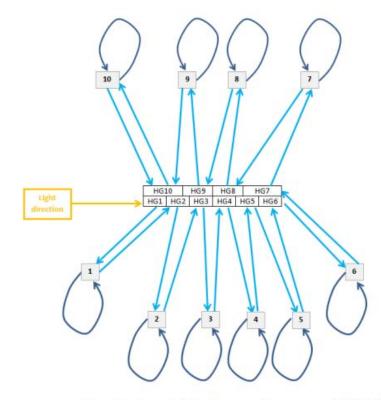
Figure 2: schematic HG cable connection scheme with light direction

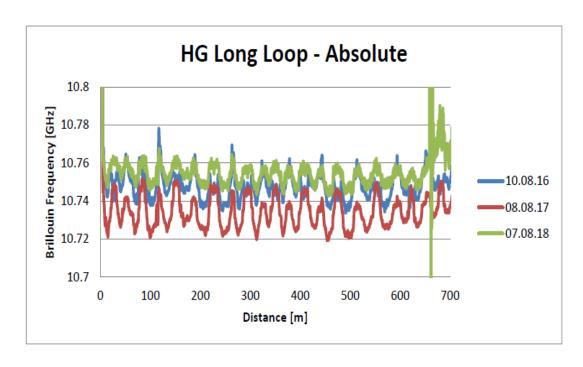
Figure 10: Brillouin Frequency along the sensing line _ loop configuration 0.5 m spatial resolution

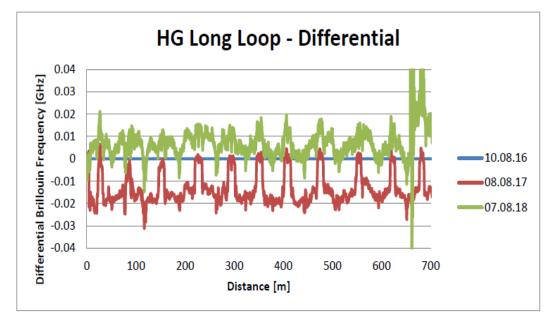
Figure 11: differential Brillouin Frequency along the sensing line _ loop configuration 0.5 m spatial resolution
