Case Study: Macon Naval Ordnance Plant (MNOP)

Background

- Former: Ordnance production operated by Navy 1941-1965
- Currently: industrial park with various tenants
- Problem: TCE plume with some DNAPL
- Potential sources: metal plating, transformer buildings, ASTs/USTs, stormwater outfall, sewage treatment plant, explosives handling

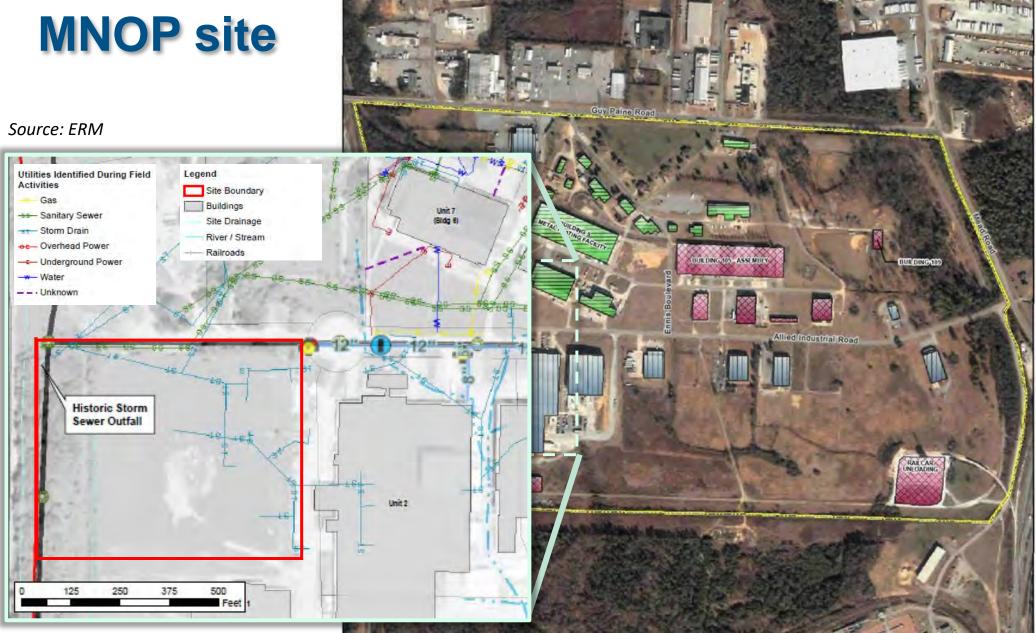
FIGURE 2 PROPERTY LAYOUT

Legend WWTP Discharge Former Waste Water Treatment Plant Former Macon Naval Ordnance Plant Structures Former Macon Naval Ordnance Explosives Handling and Storage Areas New Structures Property Boundary 0 150 300 1:7,200 Aerial Photograph: Bing Maps, 2009 References 6; 8; 13, pp. 52, 54; 17, p. 25 MACON NAVAL ORDNANCE PLANT MACON, BIBB COUNTY, GEORGIA TDD No. TTEMI-05-003-0127

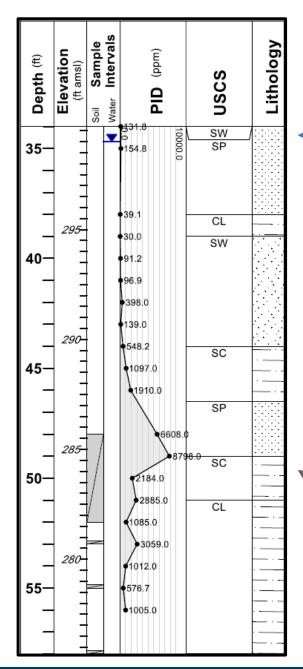
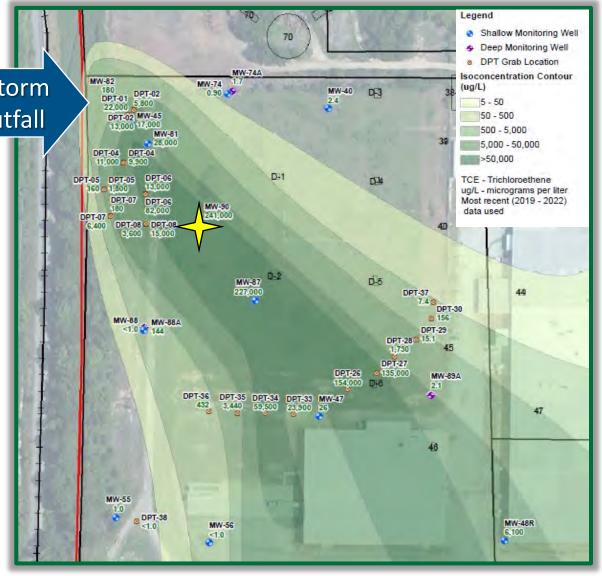
TCE concentrations in GW (ERM)

← Water level

Sand Clay Sand Historic Storm sewer Outfall

PID = >8,000 ppm

Clay (confining unit)

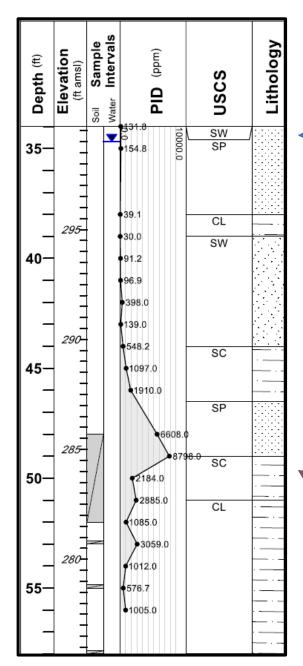
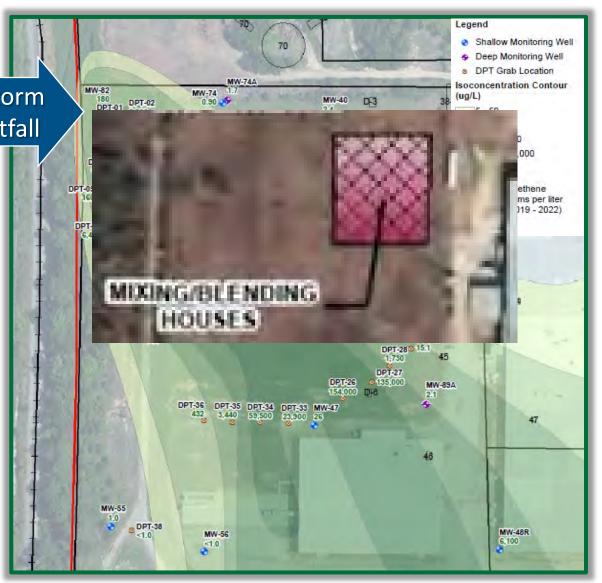
TCE concentrations in GW (ERM)

← Water level

Sand Clay Sand Historic Storm sewer Outfall

PID = >8,000 ppm

Clay (confining unit)

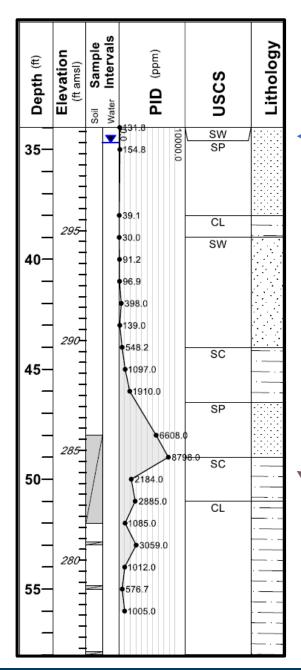
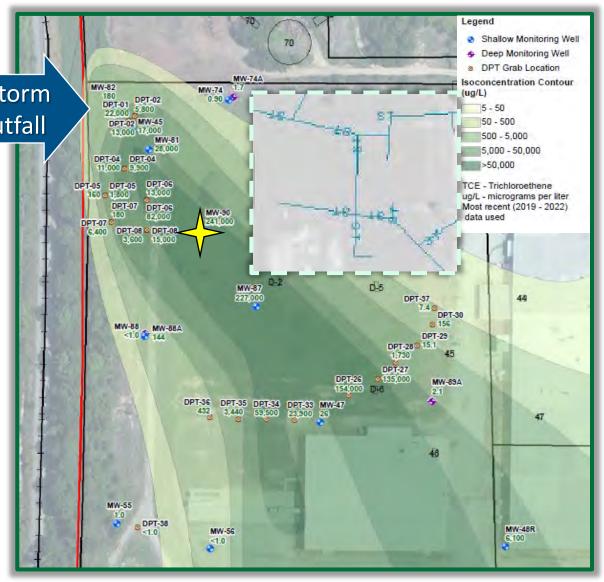
TCE concentrations in GW (ERM)

← Water level

Sand Clay Sand Historic Storm sewer Outfall

PID = >8,000 ppm

Clay (confining unit)

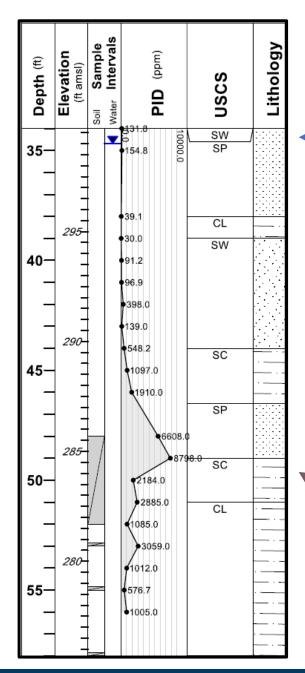
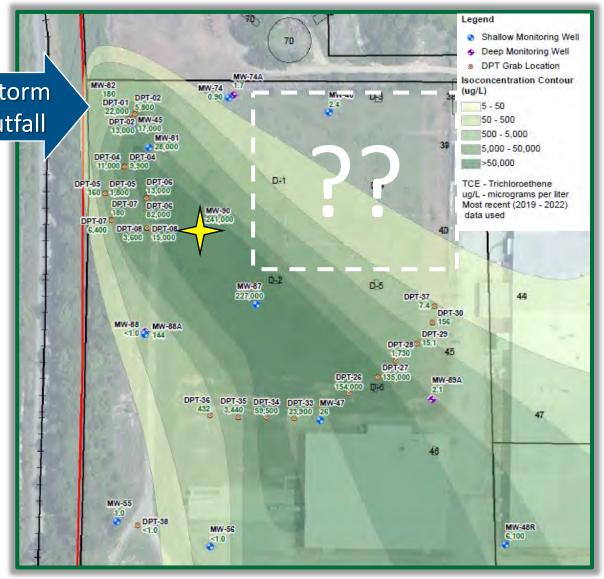
TCE concentrations in GW (ERM)

← Water level

Sand Clay Sand Historic Storm sewer Outfall

PID = >8,000 ppm

Clay (confining unit)

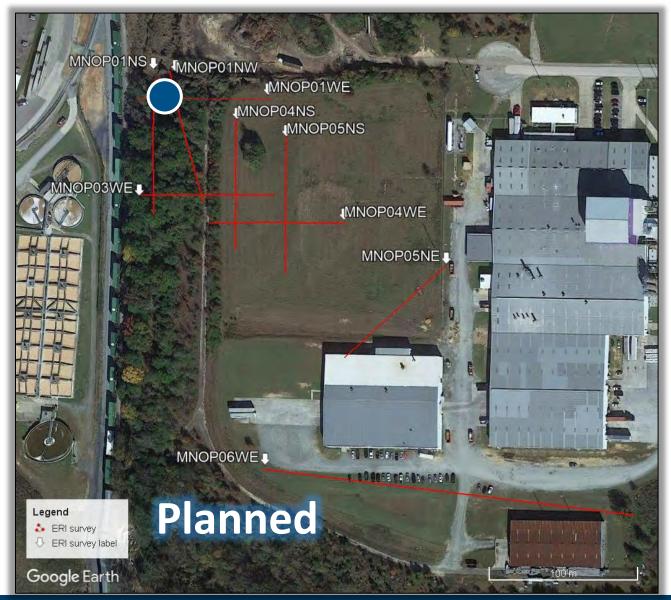
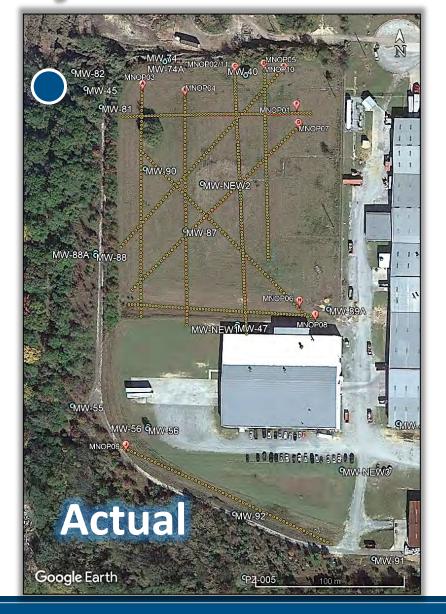
Phase 1 ERI surveys

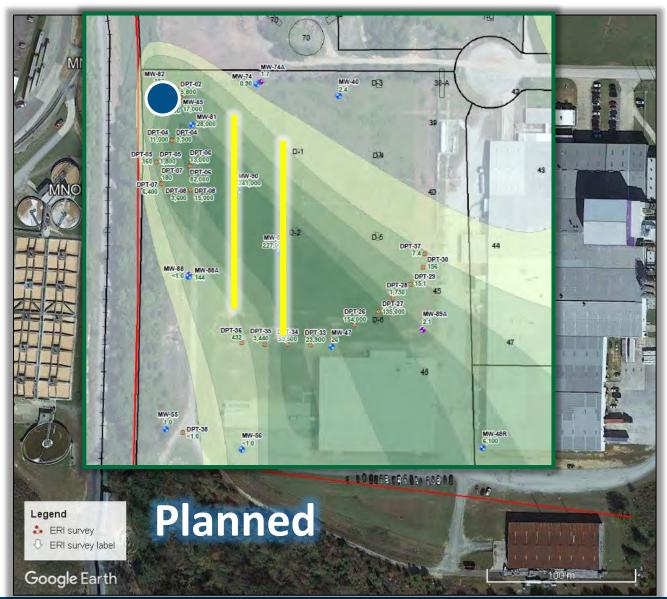
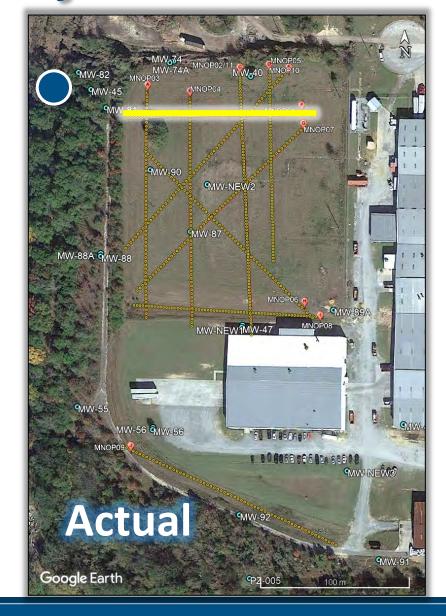
TCE concentrations in GW

Phase 1 ERI surveys

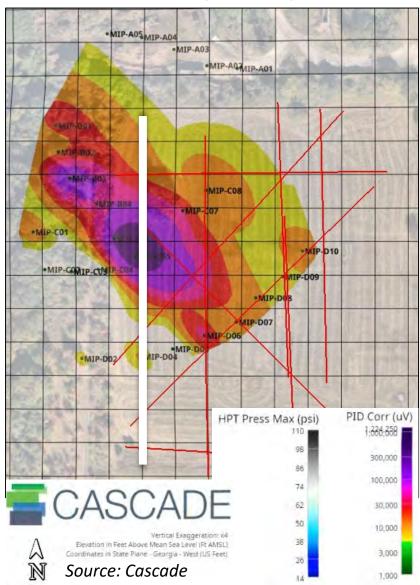
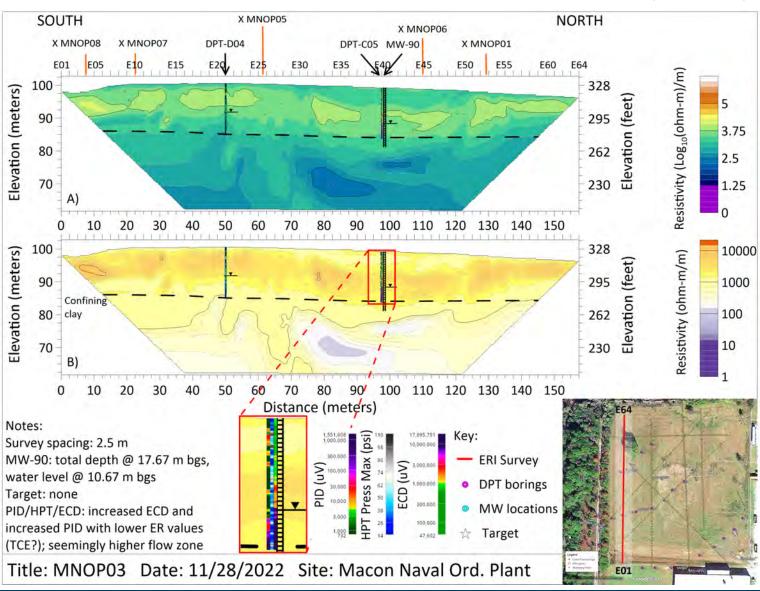
Phase 1 Results

PID concentrations (Cascade)

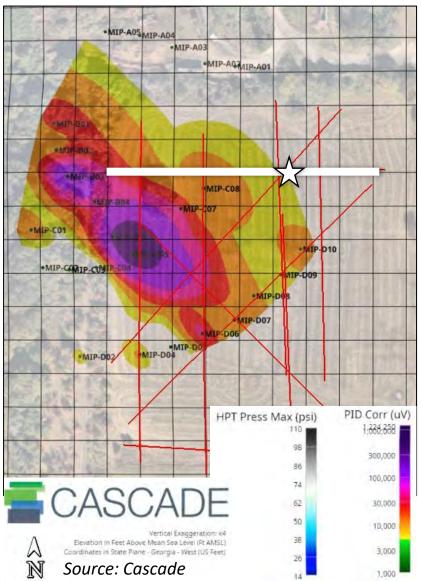
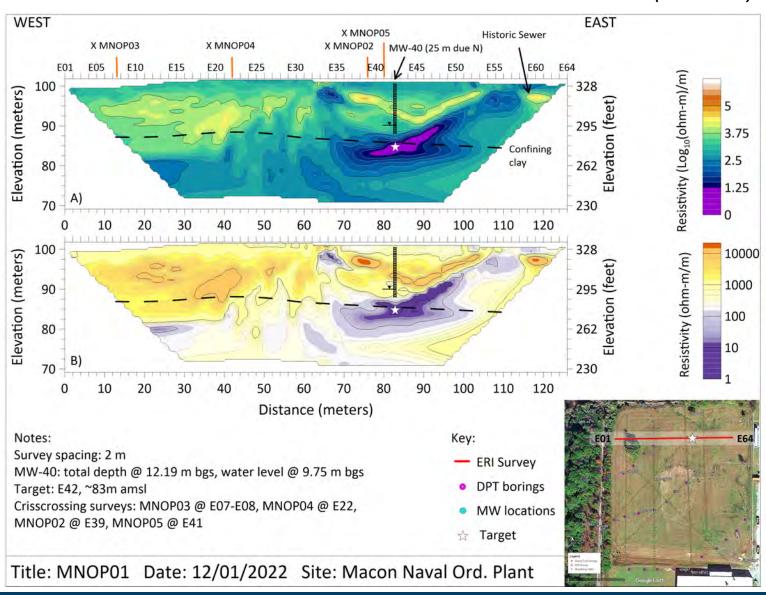
Phase 1 Results

PID concentrations (Cascade)

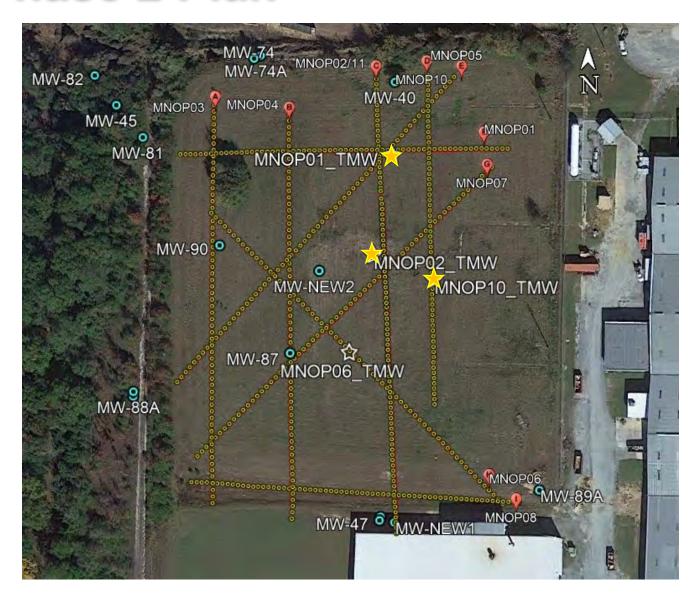
Phase 2 Plan

- Model verification;
 Drilling targets
 - Four locations
 - Variable depth: 53 ft, 40 ft,
 37 ft, and 12 ft bgs.
 - Confining clay depth: ~50 ft bgs.
 - Soil core sampling
 - Groundwater sampling (if present)
- VOC analysis
 - TCE and breakdown products

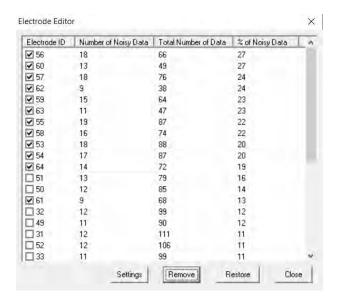
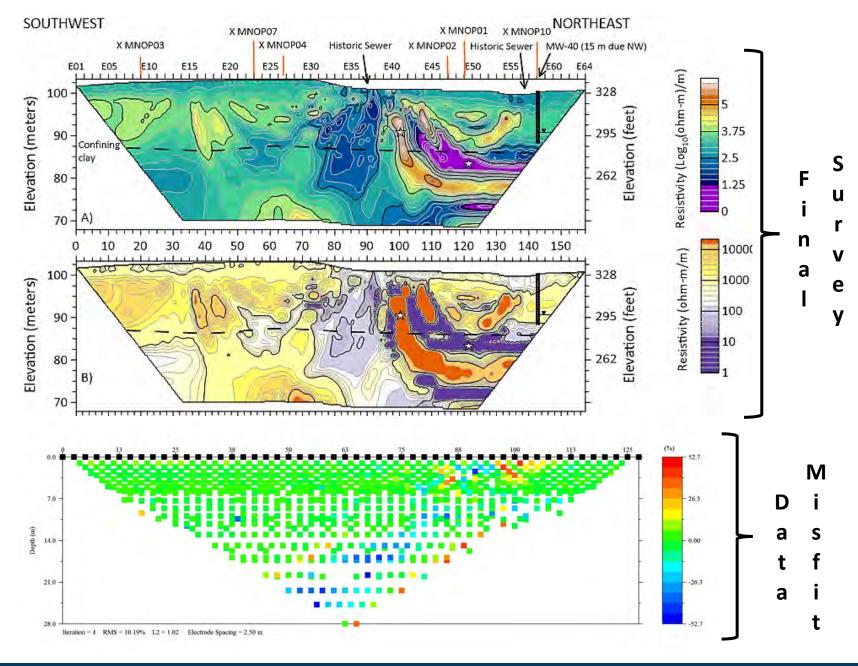
Data quality importance

Removed electrodes which were sources of error; reprocessed data.

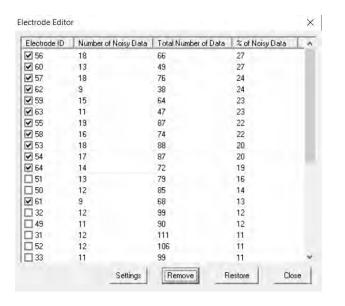
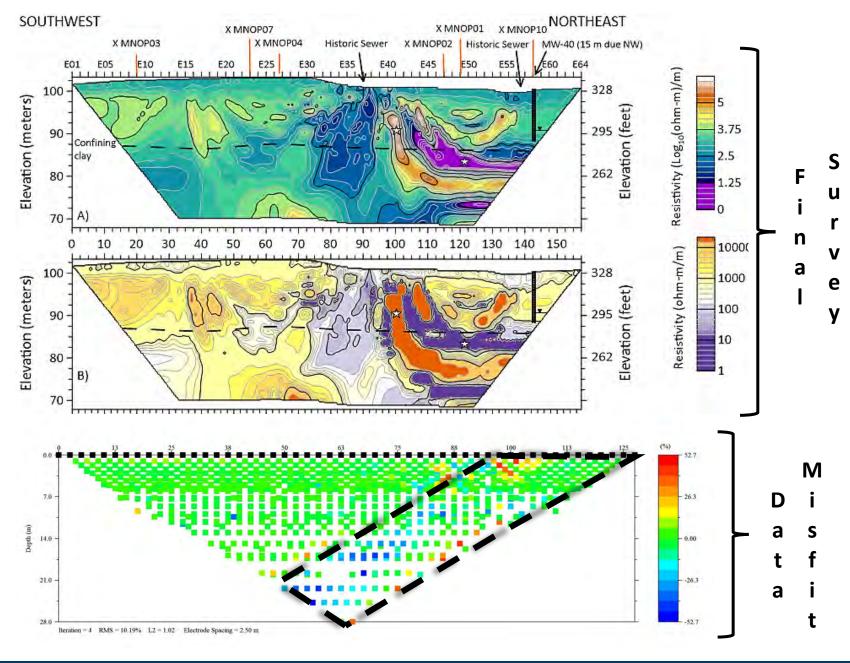
Data quality importance

Removed electrodes which were sources of error; reprocessed data.

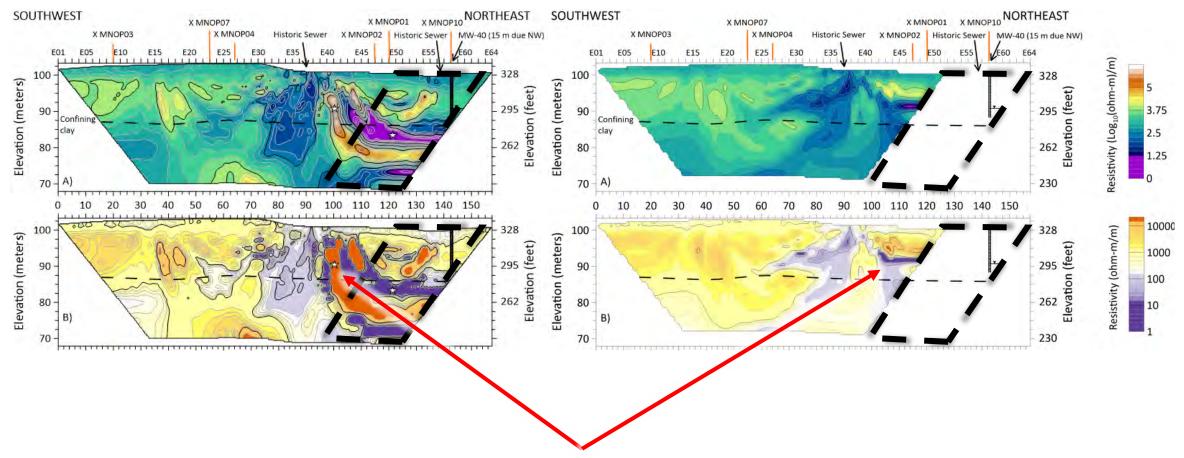
Removal of low-quality data

Signature greatly diminished after removal of erroneous data

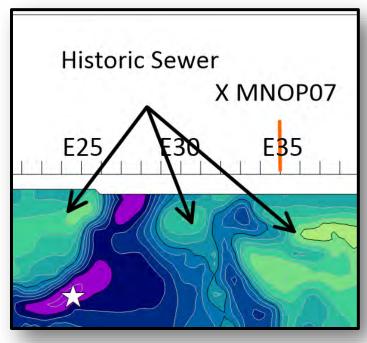
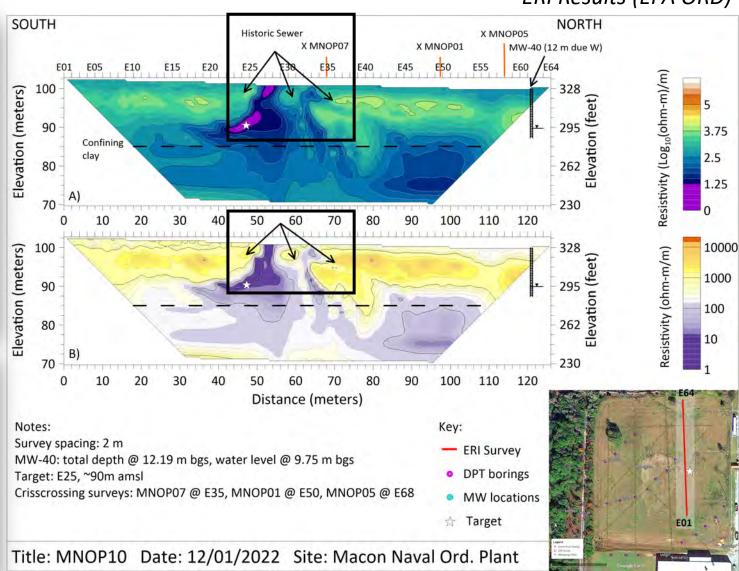
Potential for interference

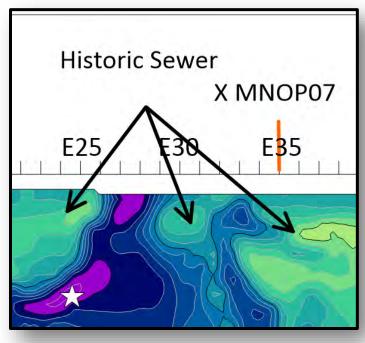
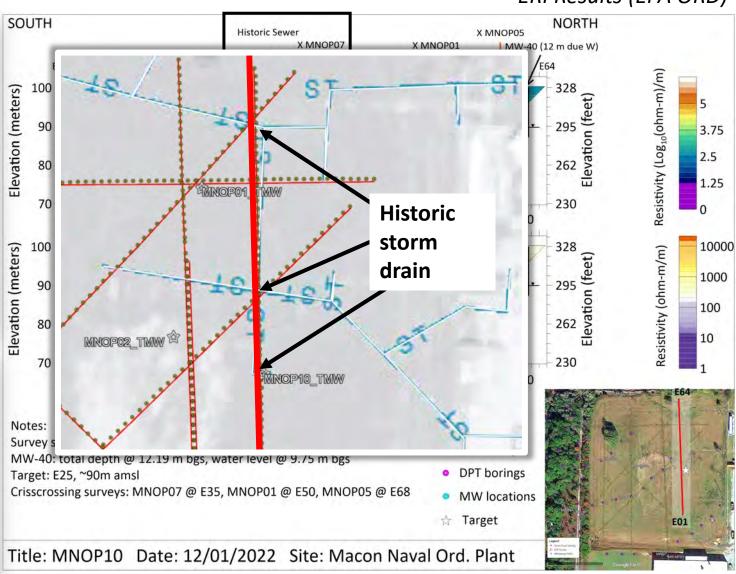
Potential for interference
