M2S2-NAOC Remedial Designs and MMRP

Case Study: Former Camp Claiborne MRS-05
Data Gap Remedial Design

Case Study: Fort Huachuca MRS03
Phased RA

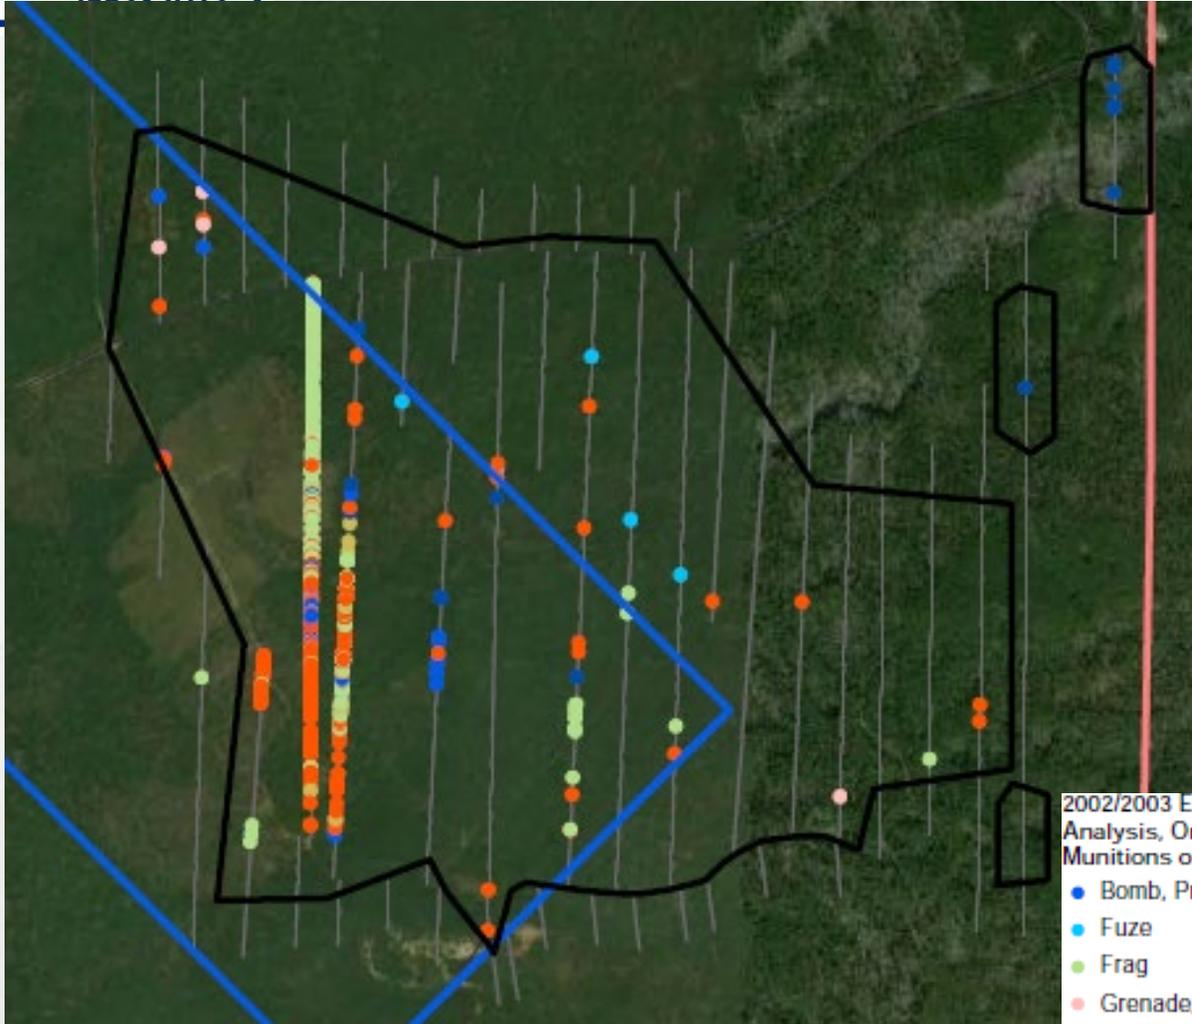
2002/2003 Engineering Evaluation / Cost Analysis, Ordnance and Explosive Waste Munitions of Explosive Concern

- Bomb, Practice
- Fuze
- Frag
- Grenade, Rifle, Practice/Smoke
- Projectile
- Rocket
- Small Arms
