## **Soil Vapor Extraction (SVE) Pilot Study**

**Sangamo Weston, Inc. Plant Site  
Pickens, South Carolina**

**February 2009**

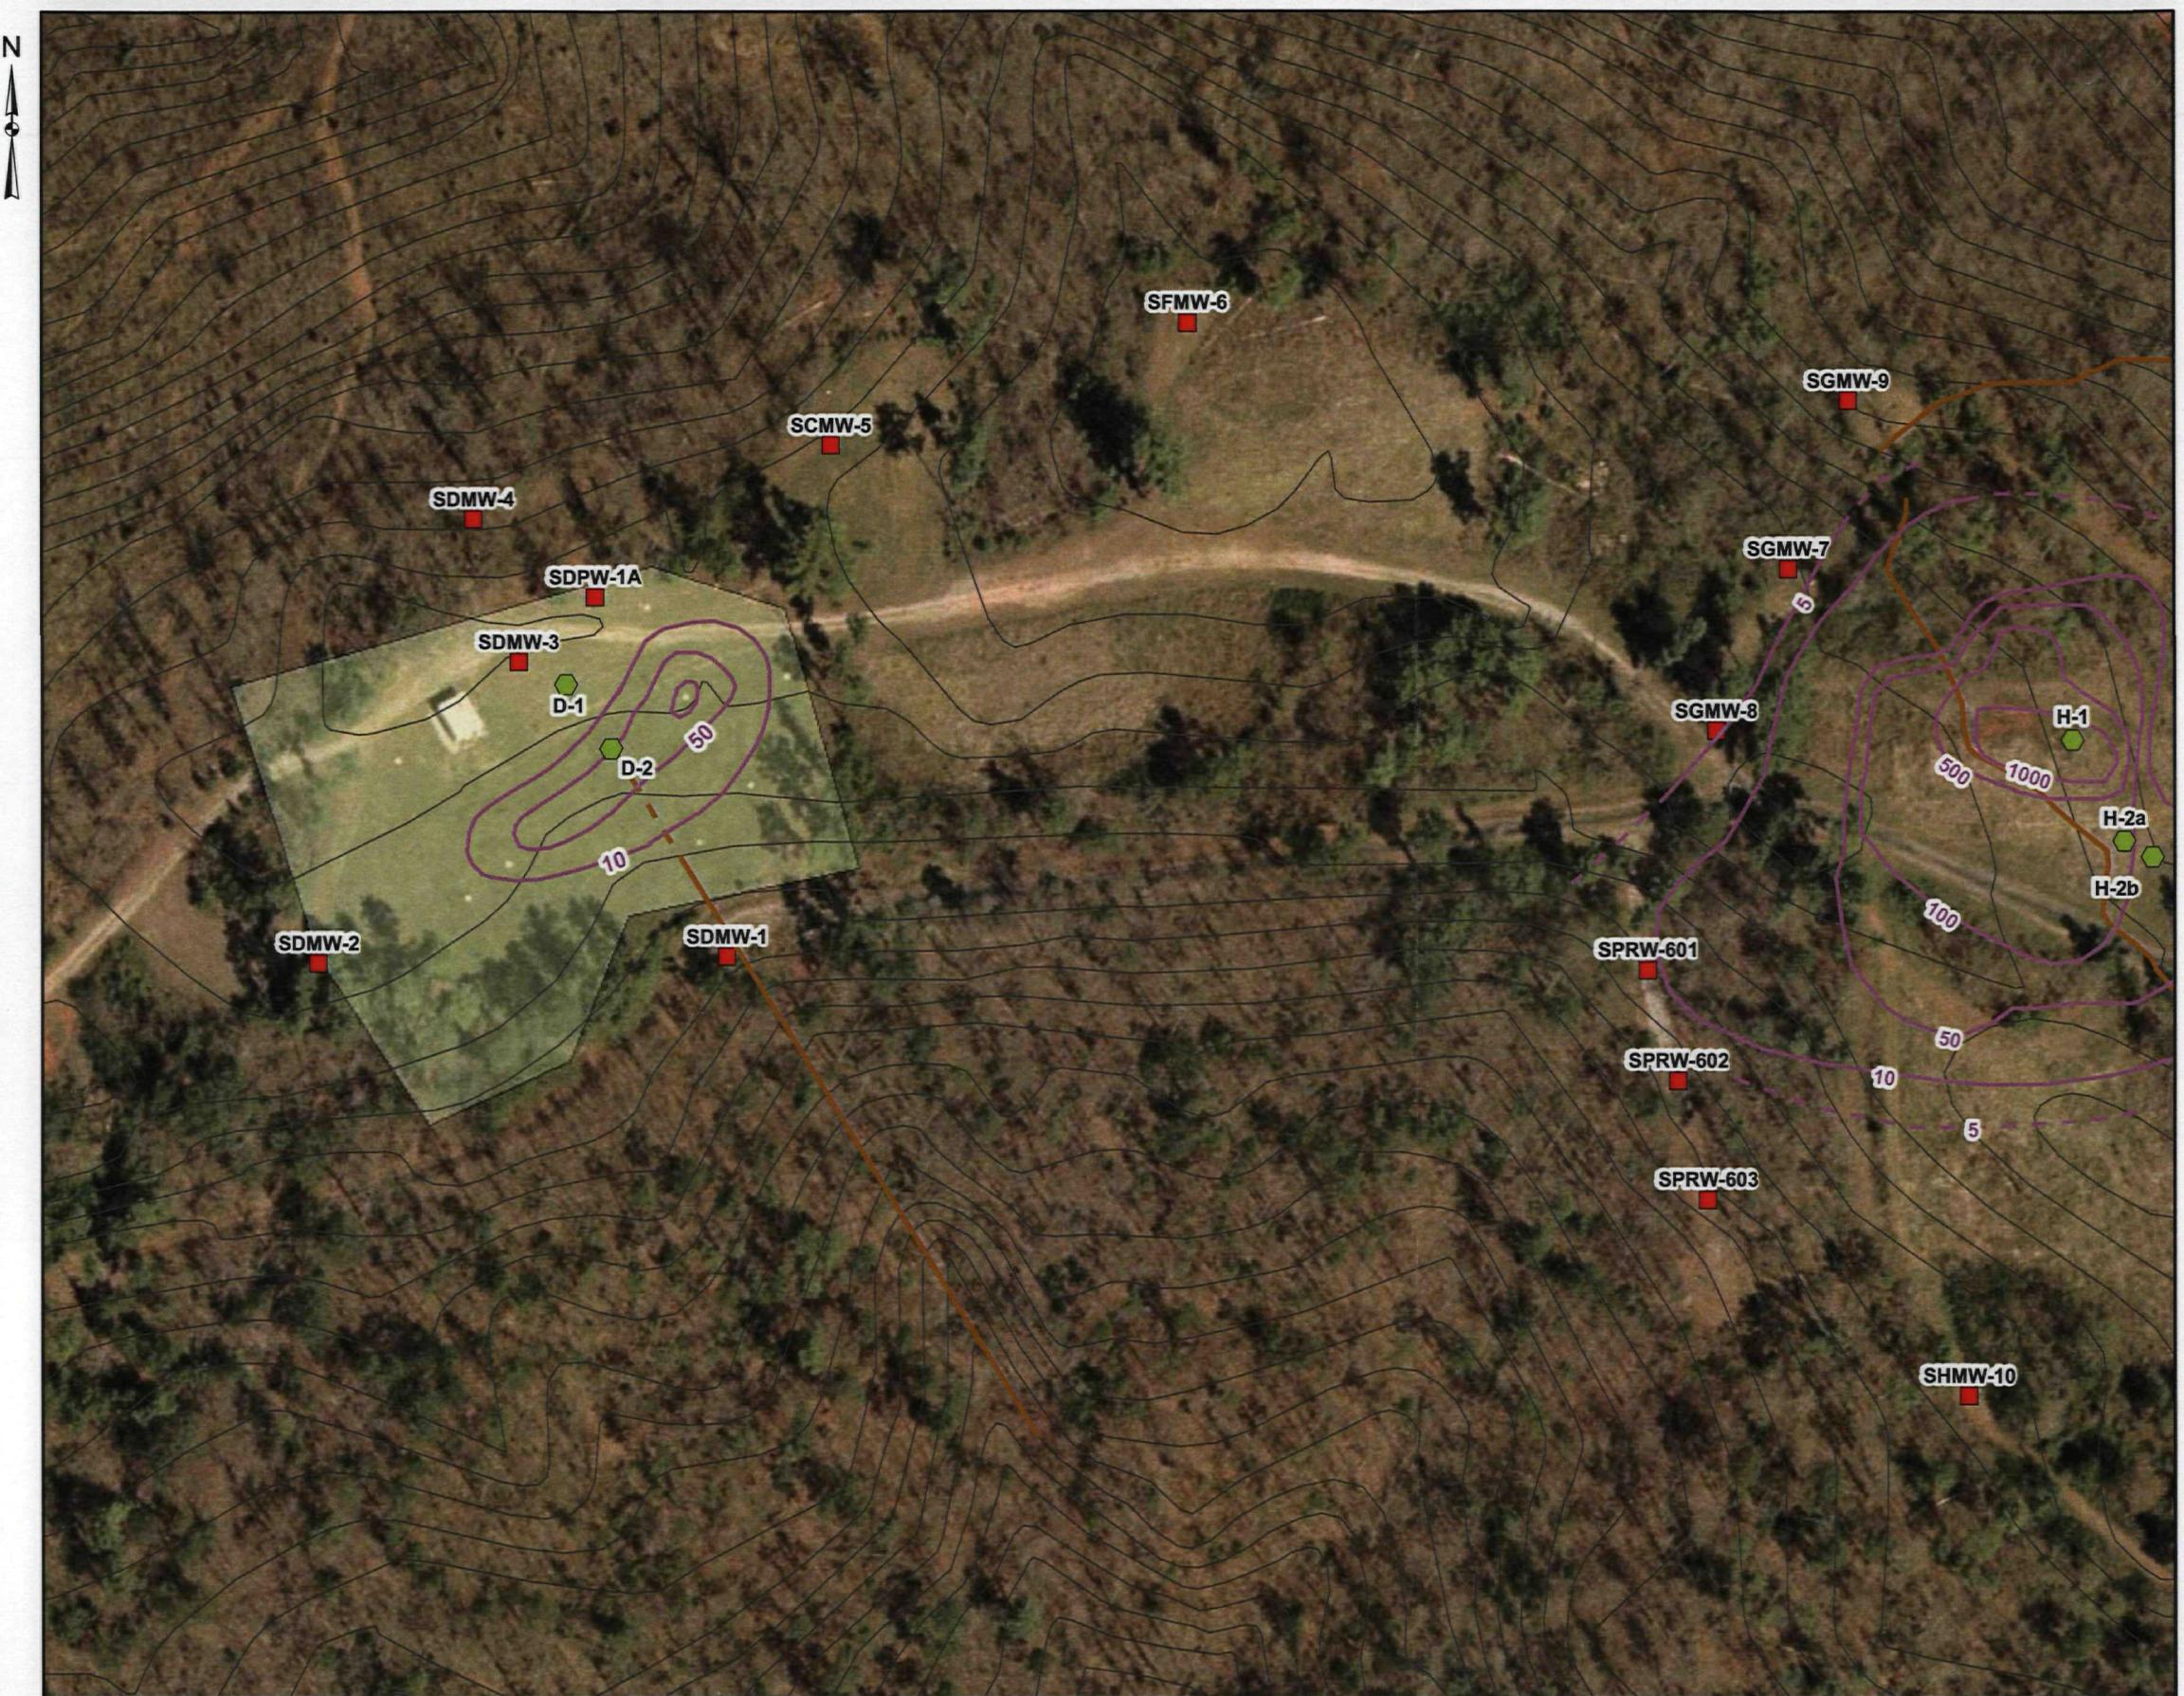
DRAWN BY: TLH	SCALE AS NOTED	PROJECT NO.: 71238.35 T5
CHECKED BY: TAT		DATE: JANUARY 2009
APPROVED BY: TAT		FIGURE NO.: 2

- SVE Well Location
- Existing Monitoring Well
- Trace of Fracture/Fault
- Soil Gas Contour (ppm)
- Topographic Contour
- Area D

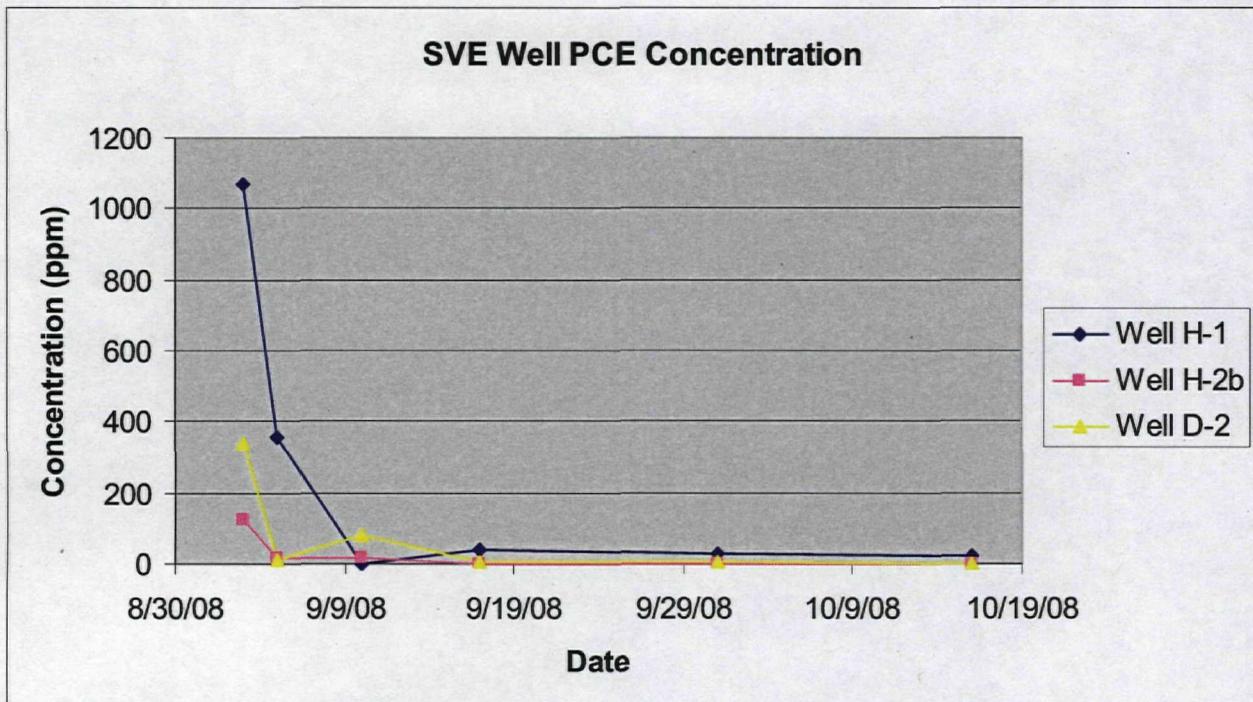
**Figure 3**  
**PCE Concentrations in Wells H-1, H-2b, and D-2**

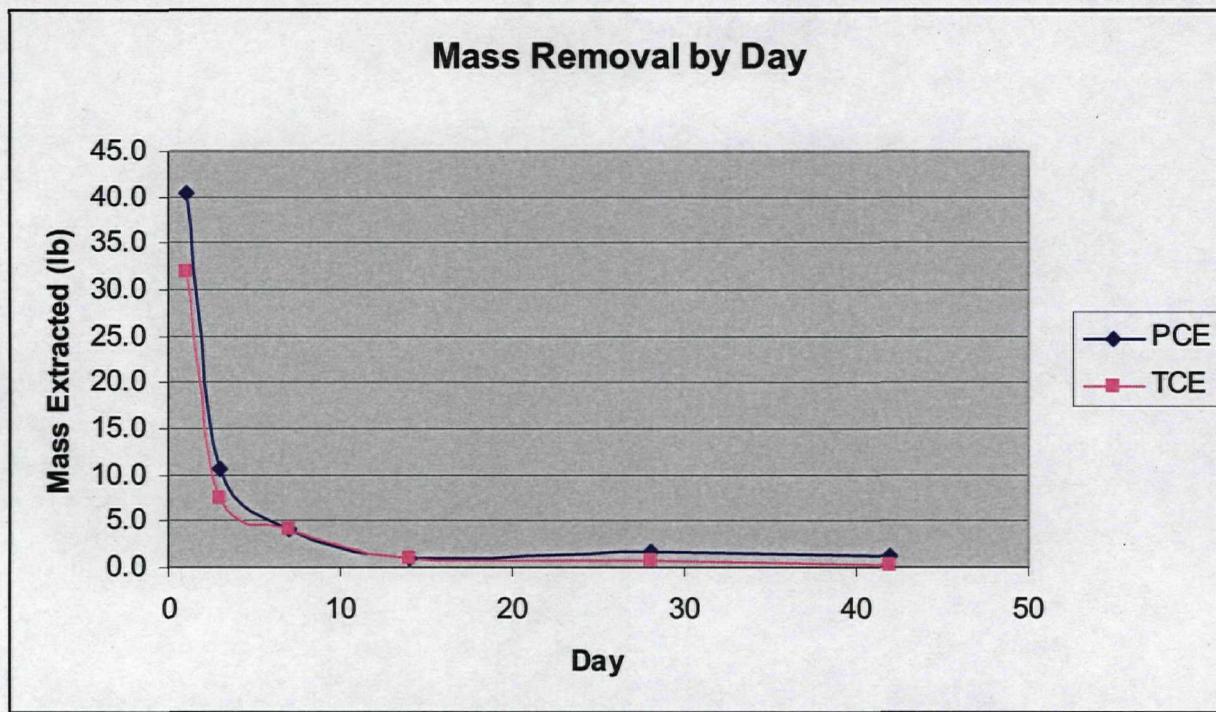
**Figure 4**  
**Total Mass of PCE and TCE Removed by Day**

Almost 90 percent of the total mass of TCE and PCE removed was from three of the nine SVE wells (206 lb out of a total of 235 lb). Based on the results from the Phase I and Phase II soil gas studies, the largest residual mass of TCE and PCE were expected to be extracted from Area H. The pilot study corroborates this assessment, with a total mass removed of TCE and PCE of 192 lb. from Area H during the six week trial. Initial soil gas readings in Area P wells were lower than the Area H, and the estimated mass of contaminated soil was less, but the relatively small quantity (12.11 lb) of TCE and PCE removed was unexpected. Table 5 provides a summary of the total mass removed from each well.

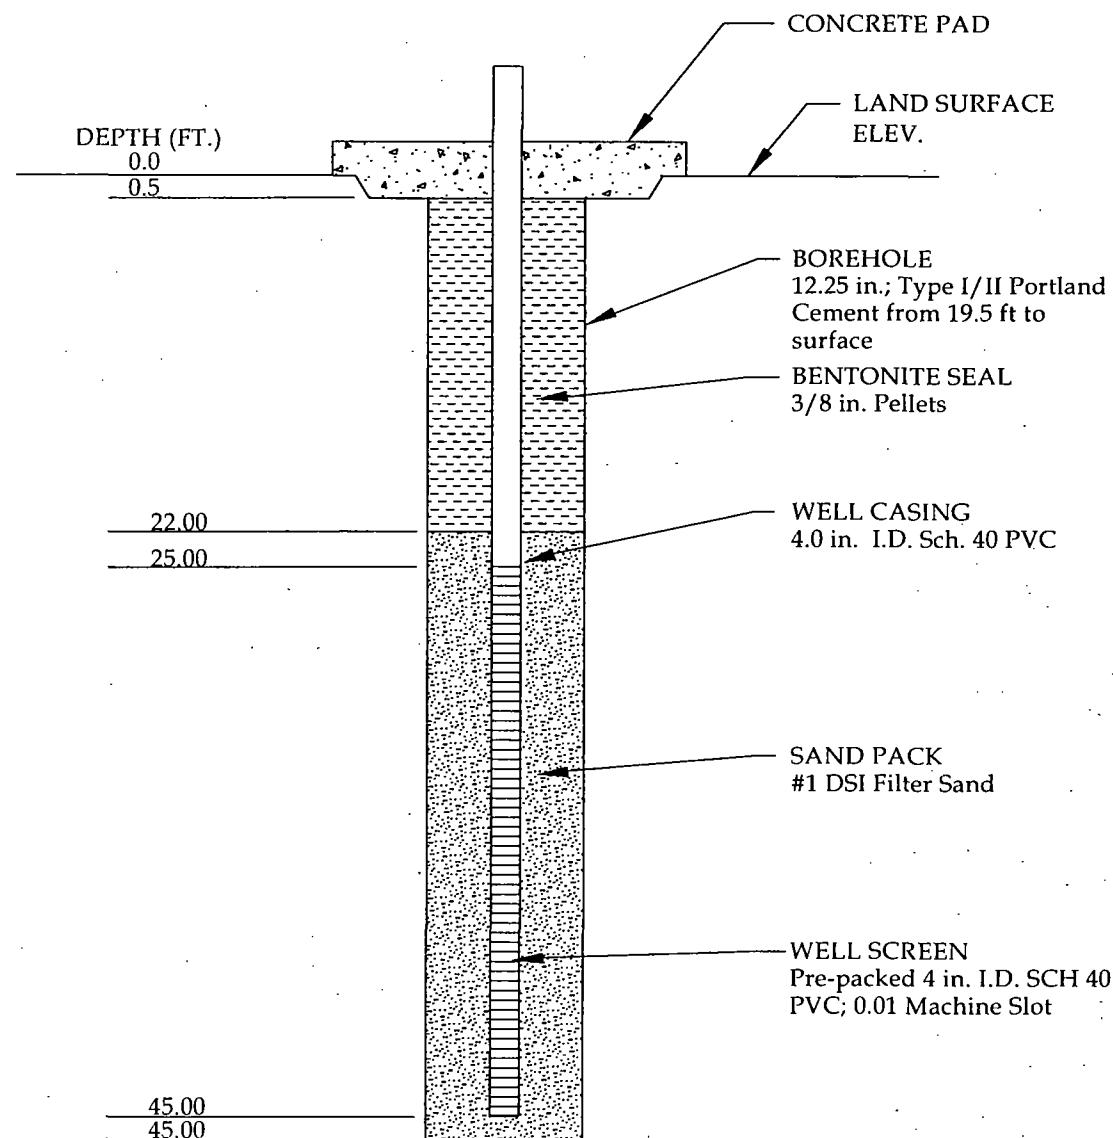
### VAPOR MONITORING WELL CONSTRUCTION DIAGRAM

PROJECT Schlumberger  
PROJECT NO. 71238.35  
WELL NO. D-1  
DATE INSTALLED 7/22/2008  
DRILLING CONTRACTOR Parratt-Wolff  
RMT GEOLOGIST JJC

SVE Well D-1 produced very low air flow rates (<5 scfm) during operation of the SVE system in Area D. This well was screened in a clayey silt layer which was not characteristic of the soil types encountered at the other locations and may have contributed to the low flow rate. RMT discontinued operation of SVE Well D-1 on September 18, 2008. In an attempt to stimulate flow and determine if the reduced flow was due to skin effects caused by the drilling process, the well was filled with a surfactant dose recommended by the licensed driller who installed the well, surged, and redeveloped. The well was refilled with water each weekday until September 25, 2008, and the water was allowed to seep out into the surrounding formation. The formation was observed to be accepting the water at a rate of approximately 0.8 gallons per minute (gal/min).

On September 25, 2008, the licensed driller was on the site with a boom truck and four inch surge block. The well was repeatedly filled with water and surged in an attempt to remove any clayey soil that may have been smeared on the well screen during well installation. Moderate changes in formation permeability were observed when the well was again filled with water, but no change in air flow was observed once the well was drained and reconnected to the SVE unit. The well was left connected to the SVE system for the remainder of the pilot study.

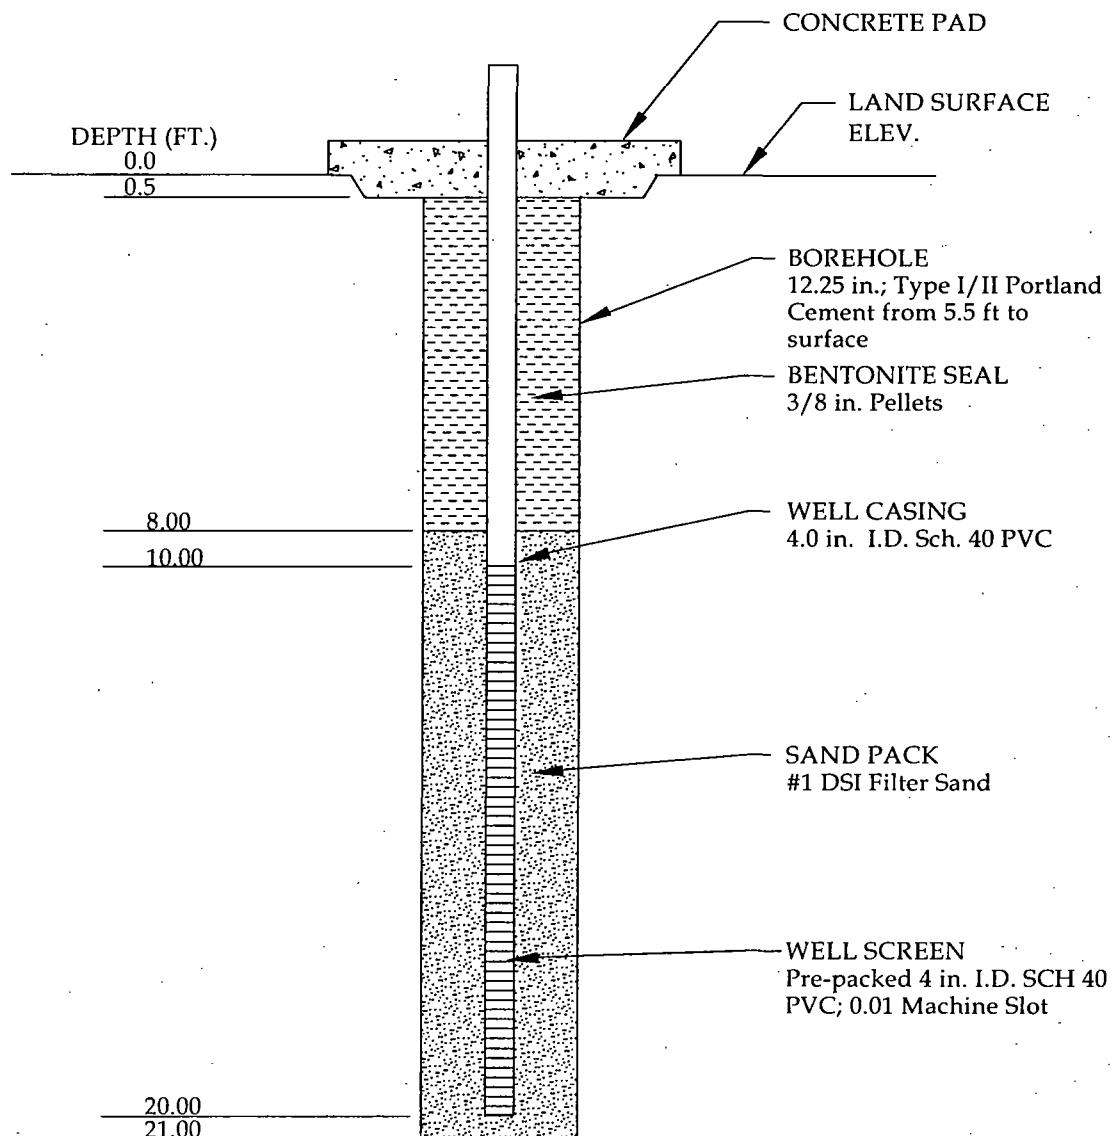
### VAPOR MONITORING WELL CONSTRUCTION DIAGRAM

PROJECT	Schlumberger
PROJECT NO.	71238.35
WELL NO.	D-2
DATE INSTALLED	7/24/2008
DRILLING CONTRACTOR	Parratt-Wolff
RMT GEOLOGIST	JJC

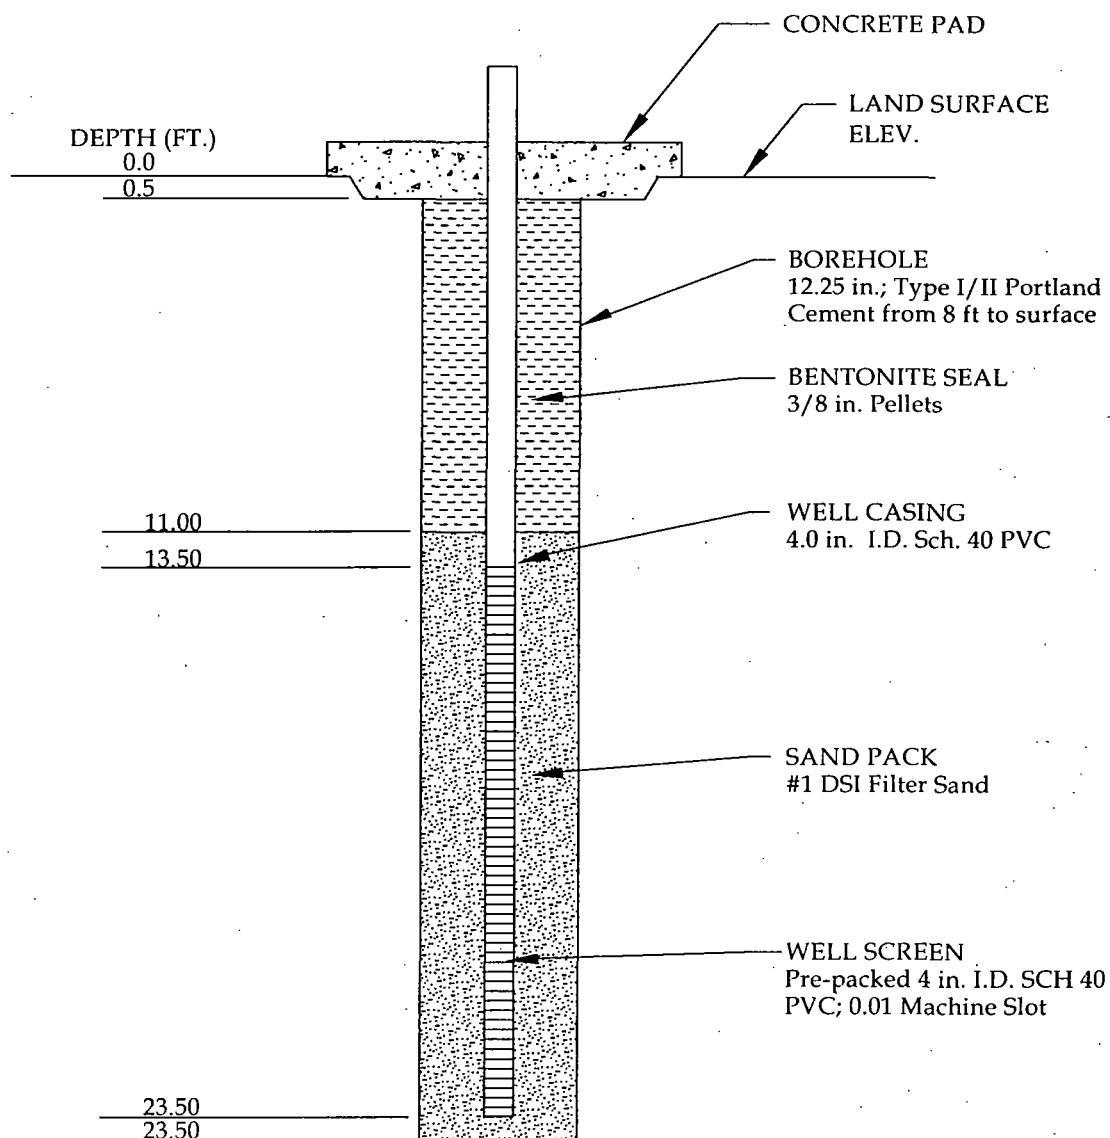
### VAPOR MONITORING WELL CONSTRUCTION DIAGRAM

PROJECT	
PROJECT NO.	71238.35
WELL NO.	H-1
DATE INSTALLED	7/24/2008
DRILLING CONTRACTOR	Parratt-Wolff
RMT GEOLOGIST	JJC

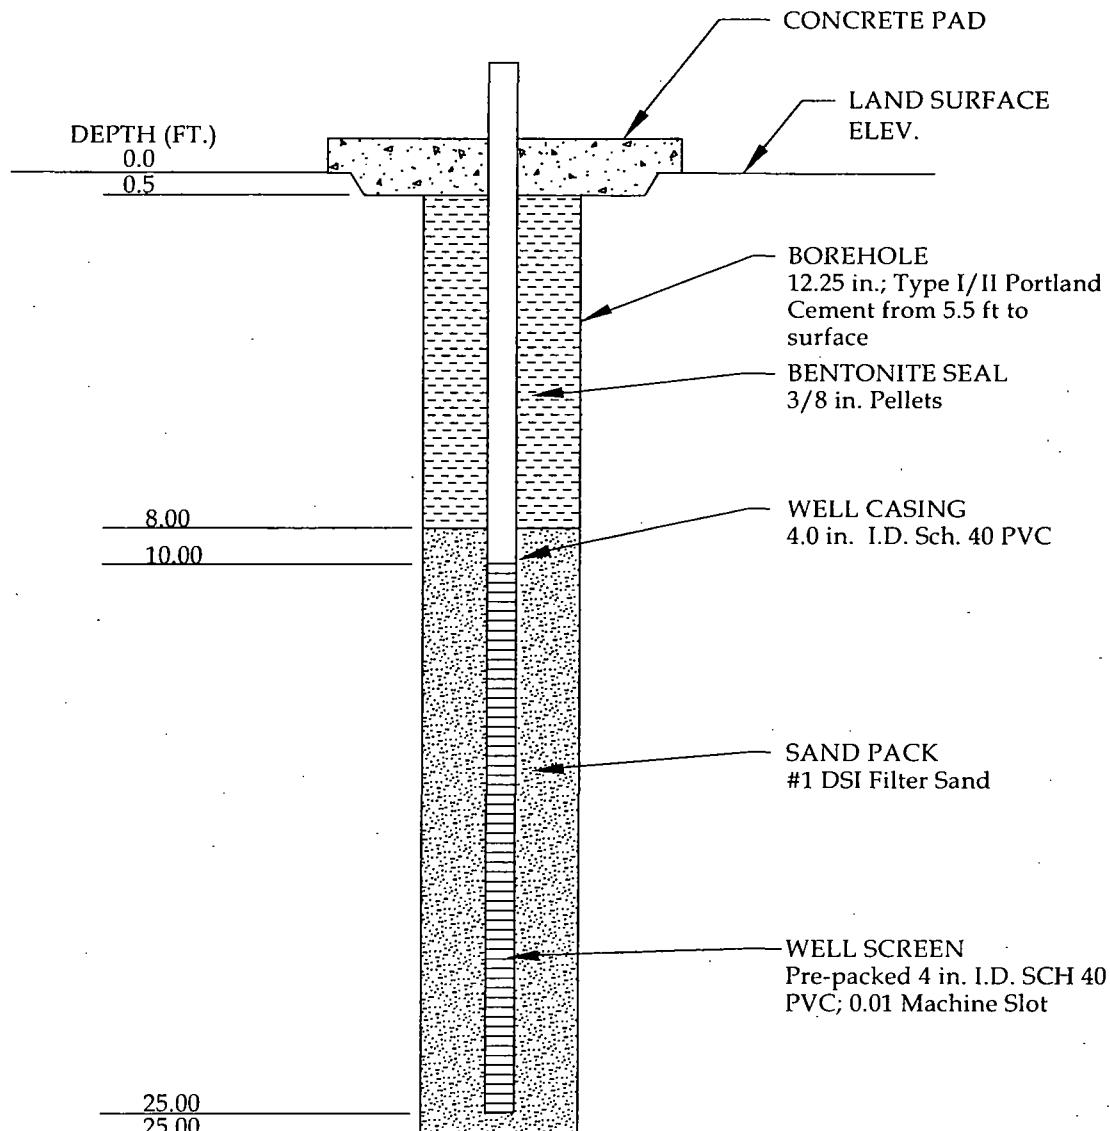
### VAPOR MONITORING WELL CONSTRUCTION DIAGRAM

PROJECT Schlumberger  
PROJECT NO. 71238.35  
WELL NO. H-2a  
DATE INSTALLED 7/23/2008  
DRILLING CONTRACTOR Parratt-Wolff  
RMT GEOLOGIST JJC

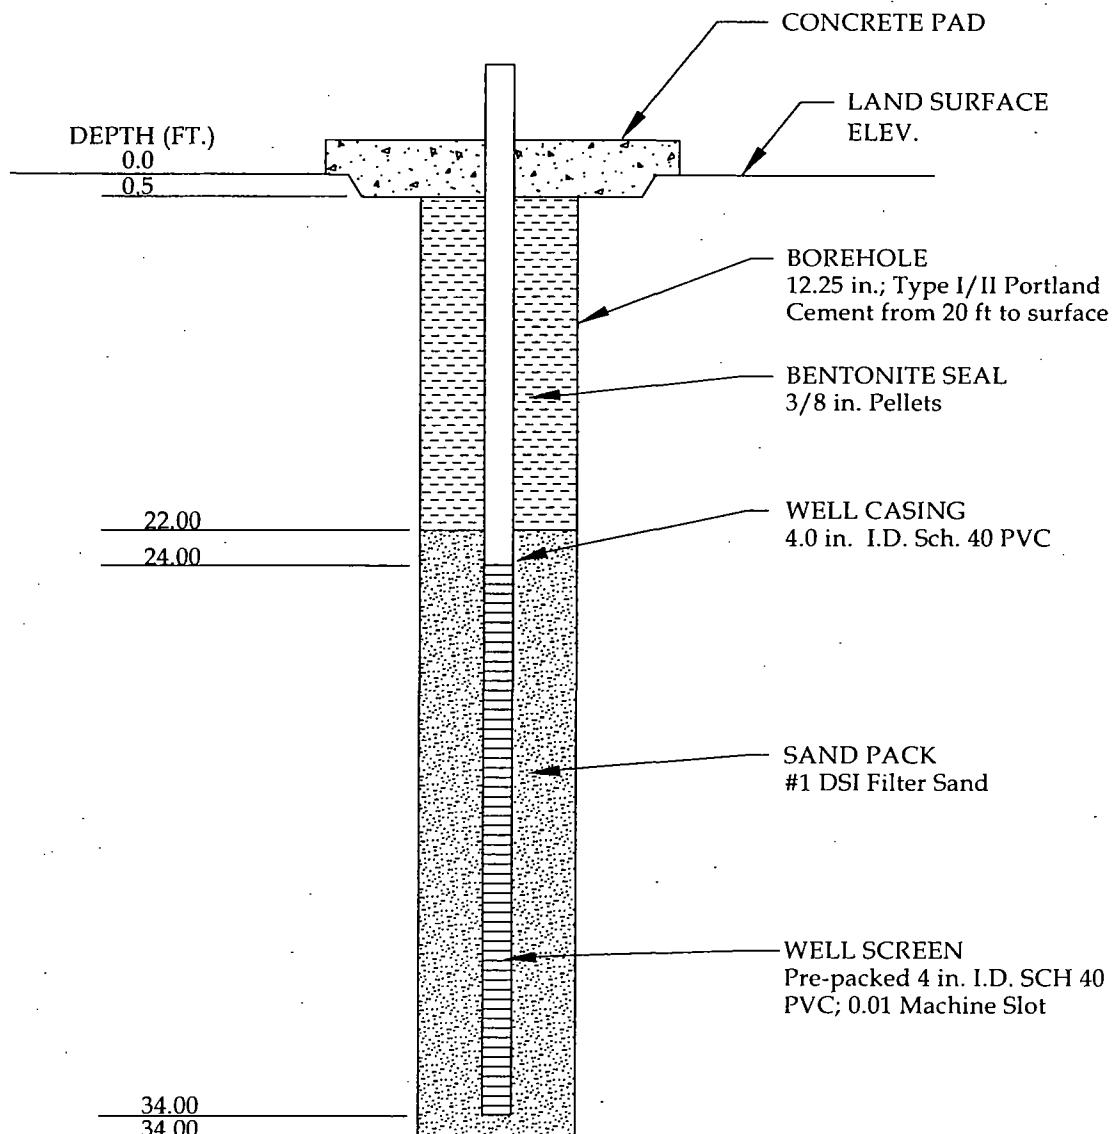
### VAPOR MONITORING WELL CONSTRUCTION DIAGRAM

PROJECT	Schlumberger
PROJECT NO.	71238.35
WELL NO.	H-2b
DATE INSTALLED	7/23/2008
DRILLING CONTRACTOR	Parratt-Wolff
RMT GEOLOGIST	JJC

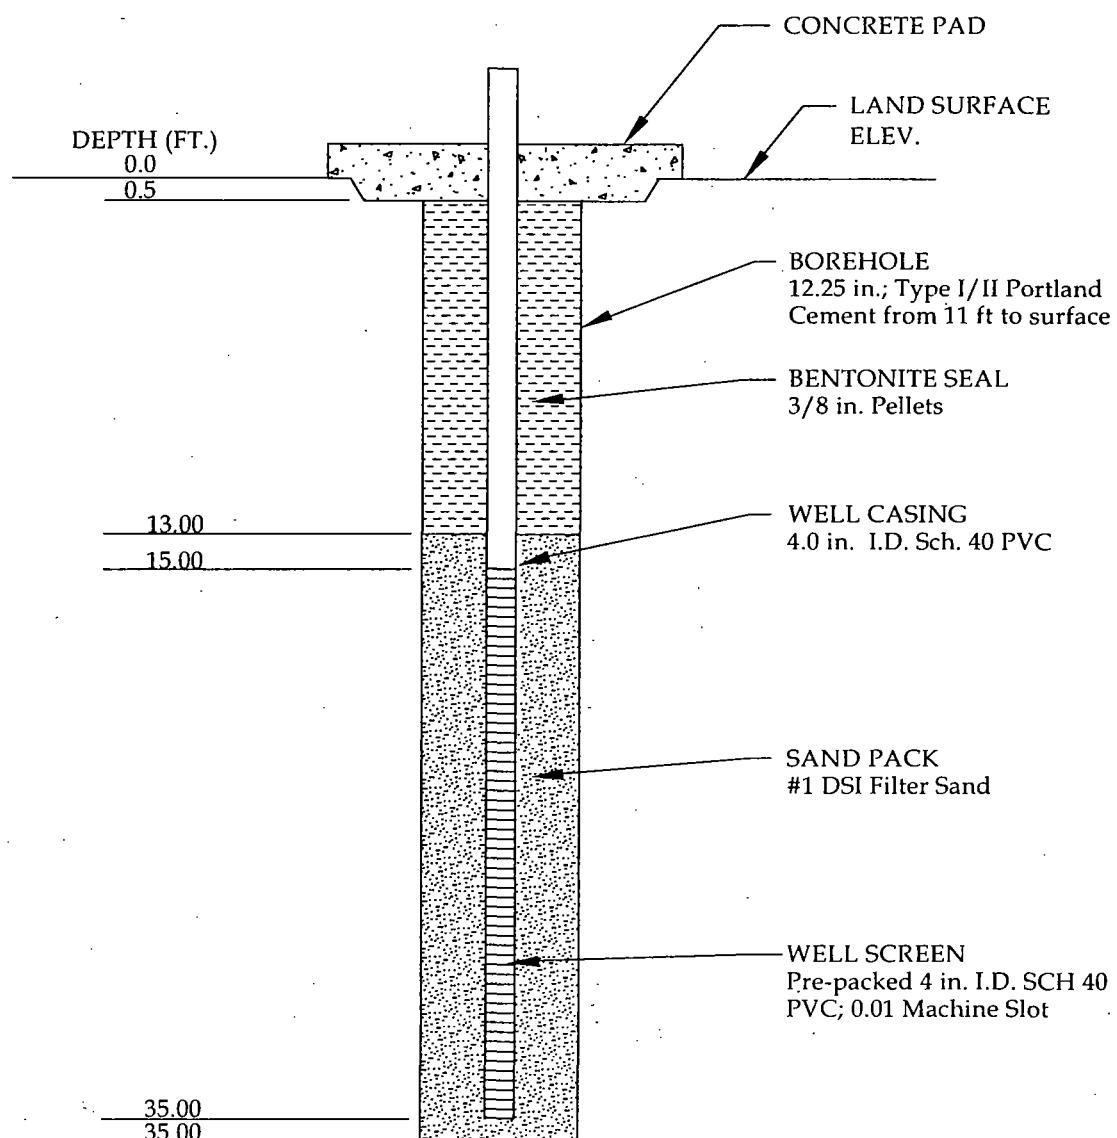
### VAPOR MONITORING WELL CONSTRUCTION DIAGRAM

PROJECT Schlumberger  
PROJECT NO. 71238.35  
WELL NO. P-1  
DATE INSTALLED 7/17/2008  
DRILLING CONTRACTOR Parratt-Wolff  
RMT GEOLOGIST JJC

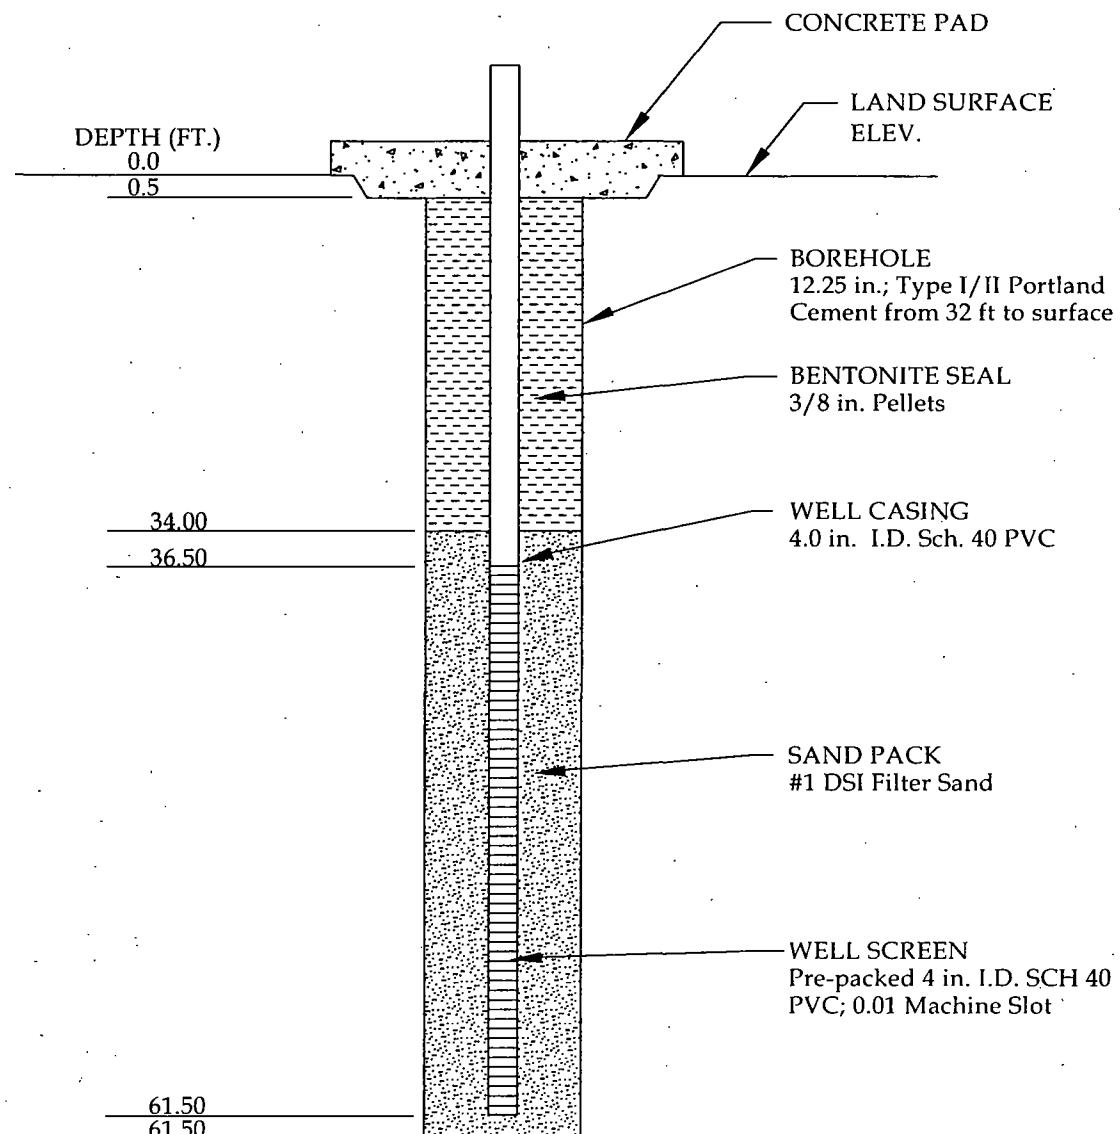
### VAPOR MONITORING WELL CONSTRUCTION DIAGRAM

PROJECT Schlumberger  
PROJECT NO. 71238.35  
WELL NO. P-2  
DATE INSTALLED 7/16/2008  
DRILLING CONTRACTOR Parratt-Wolff  
RMT GEOLOGIST JJC

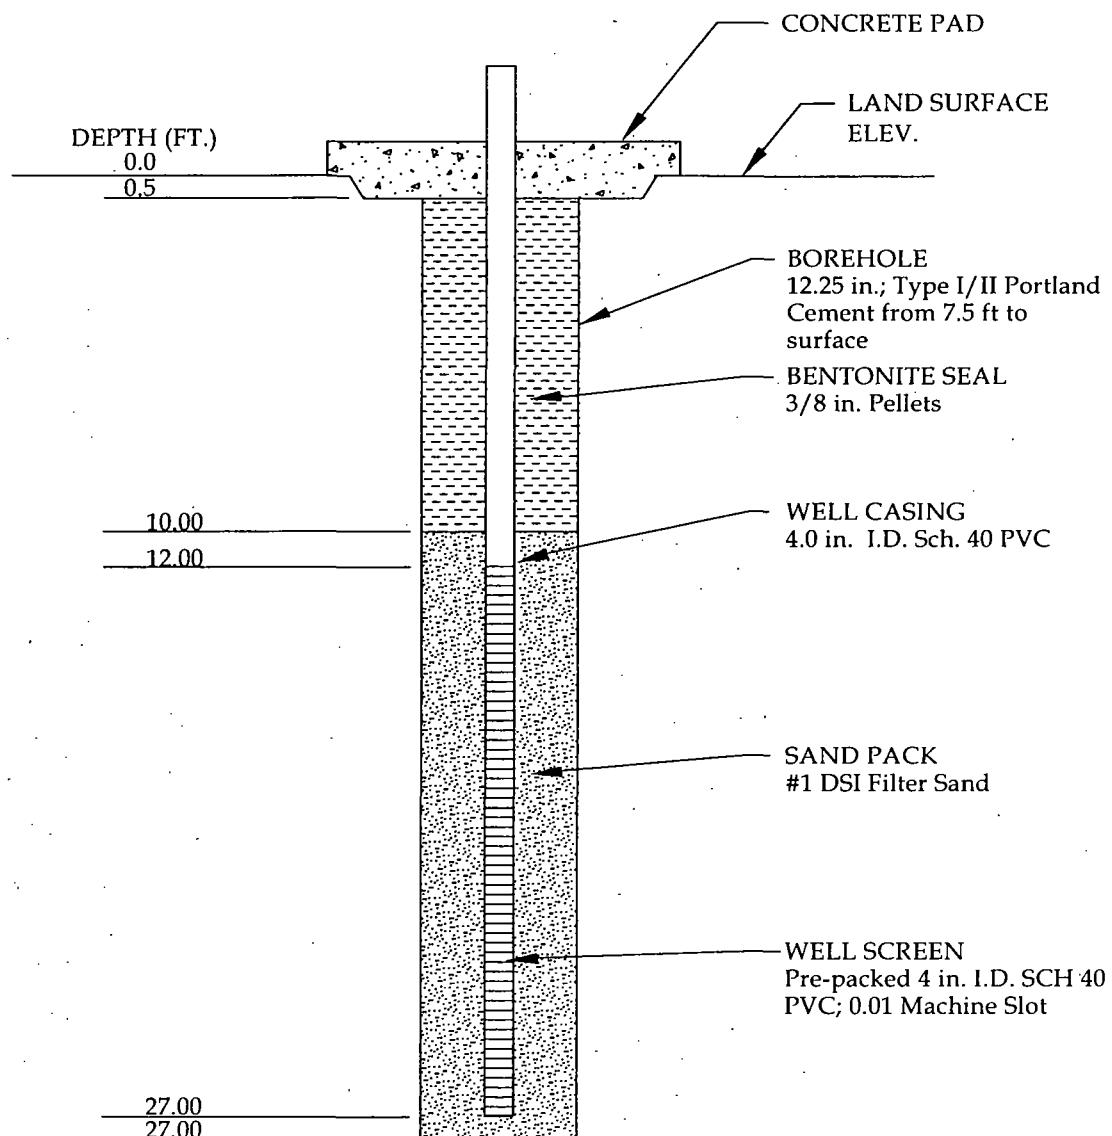
### VAPOR MONITORING WELL CONSTRUCTION DIAGRAM

PROJECT Schlumberger  
PROJECT NO. 71238.35  
WELL NO. P-3a  
DATE INSTALLED 7/21/2008  
DRILLING CONTRACTOR Parratt-Wolff  
RMT GEOLOGIST JJC

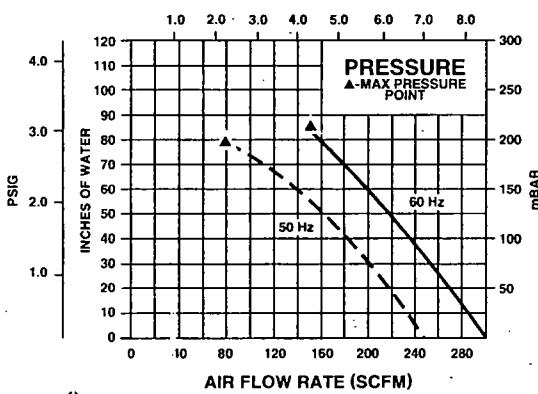
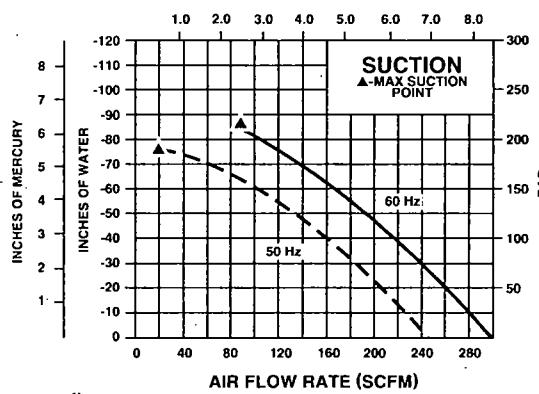
**BLOWER PERFORMANCE AT STANDARD CONDITIONS**AIR FLOW RATE (M<sup>3</sup>/MIN)

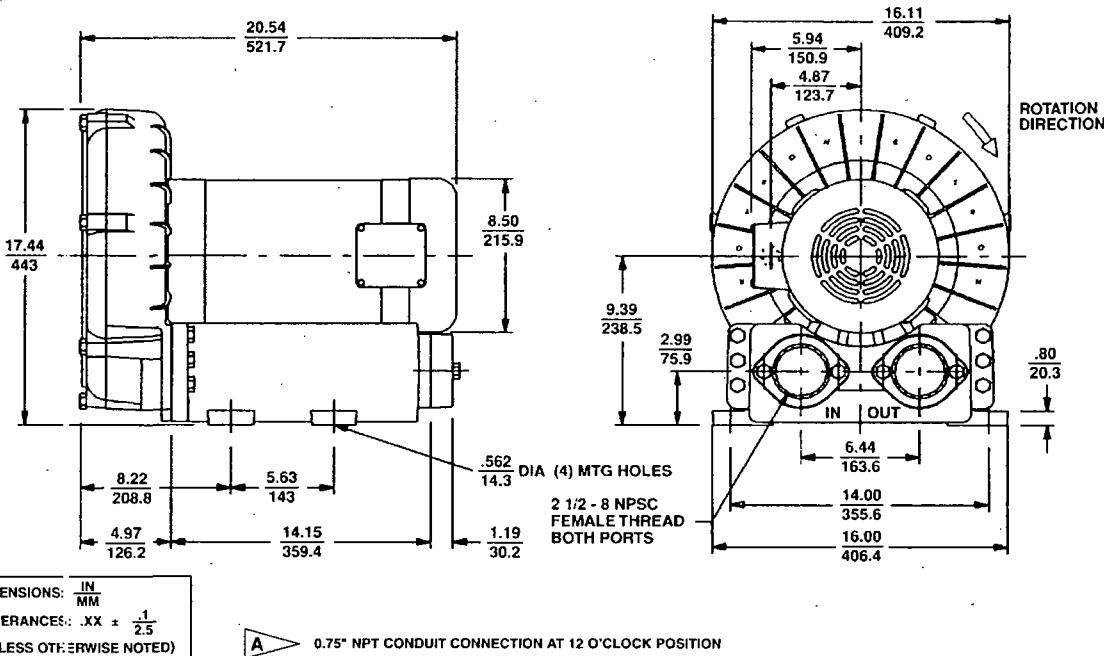
**ROTRON® Regenerative Blowers****EN 707 & CP 707 Three-Phase  
Sealed Regenerative Blower w/Explosion-Proof Motor**

Scale CAD drawing available upon request.

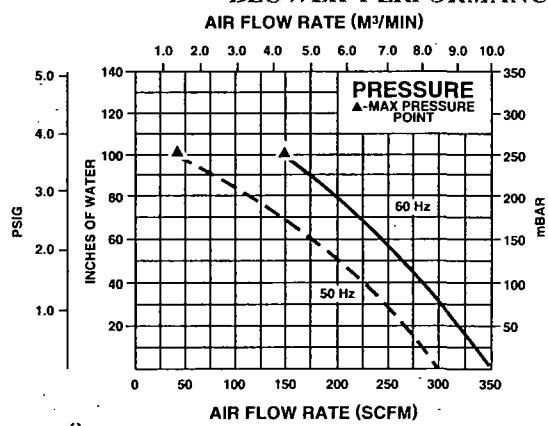
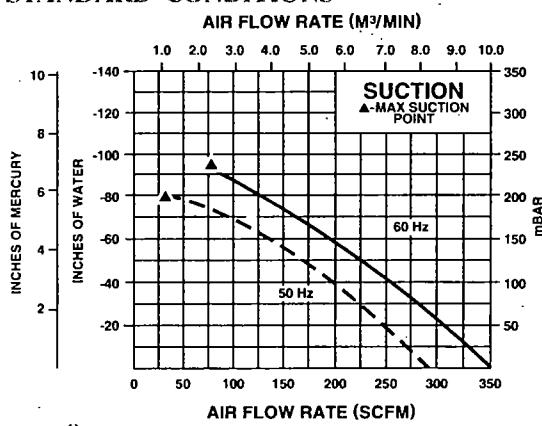
**BLOWER PERFORMANCE AT STANDARD CONDITIONS**

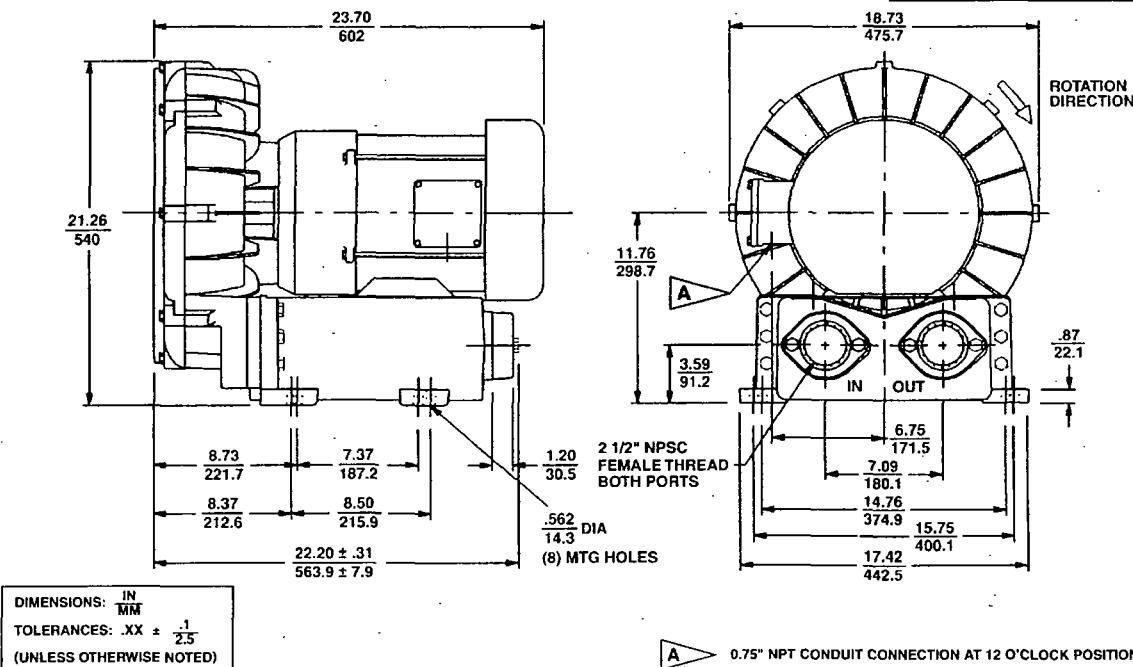
**ROTRON Regenerative Blowers****EN 808 & CP 808 Three-Phase Sealed Regenerative Blower w/Explosion-Proof Motor**

Scale CAD drawing available upon request.

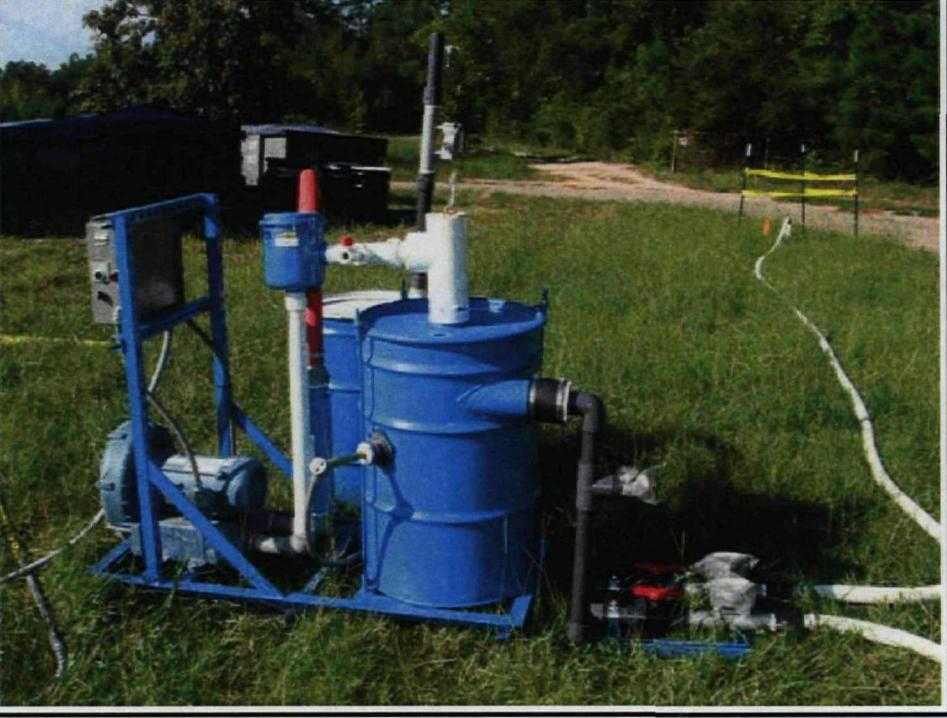
<b>Photo No.</b>	
1

A photograph showing a blue cylindrical storage drum connected to a white pump unit and various pipes. The system is mounted on a blue metal frame in a grassy field with trees in the background.
<b>Description</b>	Plant Site System
<b>Photo No.</b>	
2

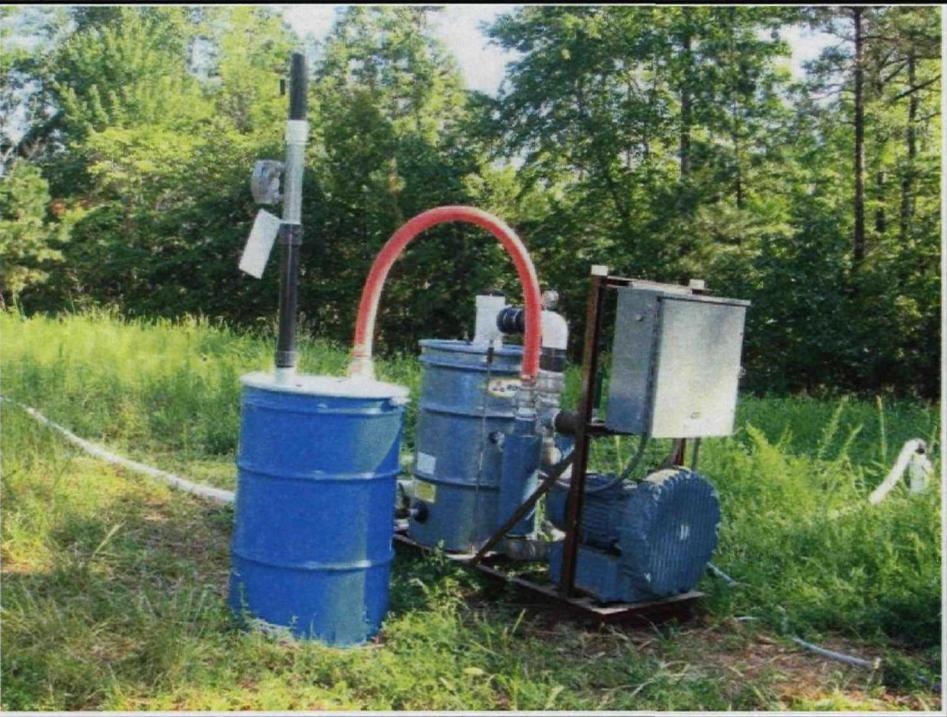
A photograph of a similar setup to Photo 1, featuring a blue drum and a pump unit, but with a red flexible hose attached to the top of the drum. The equipment is located in a grassy area with a dense forest of evergreen trees behind it.
<b>Description</b>	Area H System 1

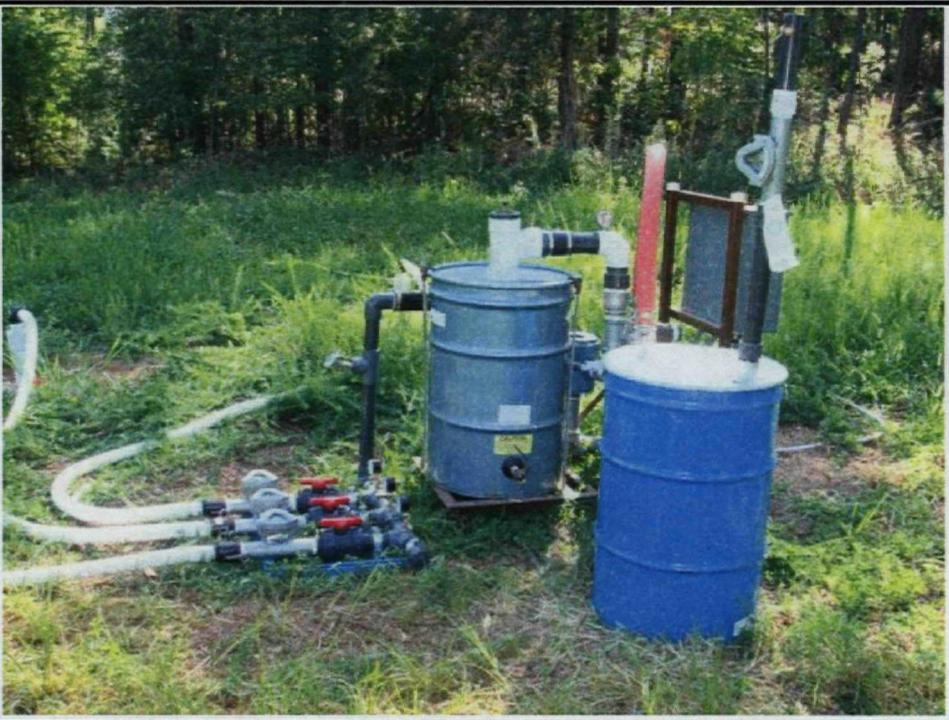
<b>Photo No.</b>	
3	
<b>Description</b>	
Area H System 2

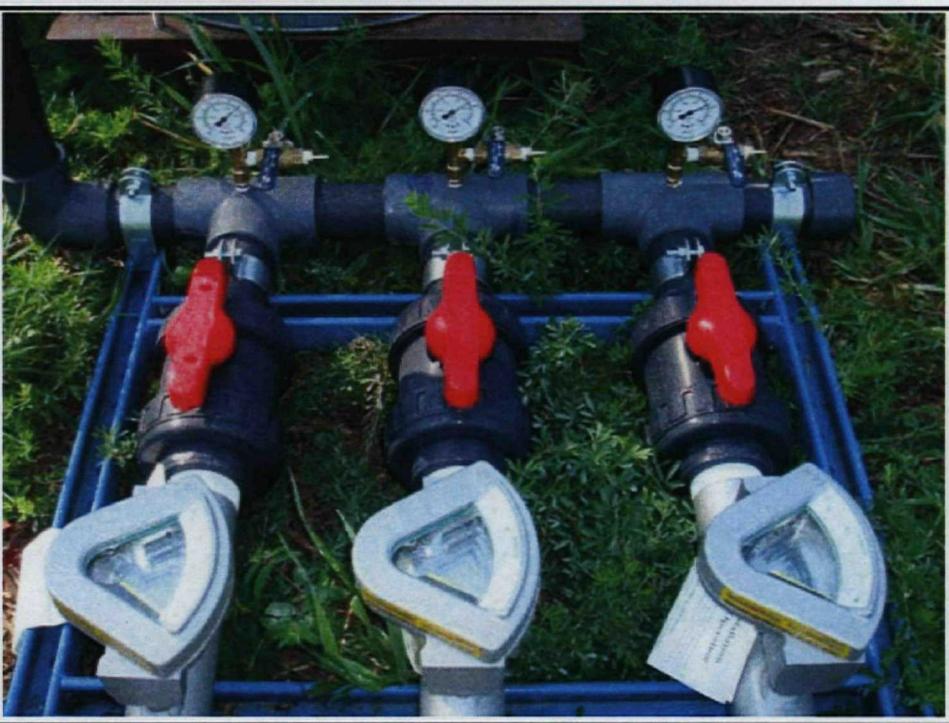
<b>Photo No.</b>	
4	
<b>Description</b>	
Three Zone Manifold

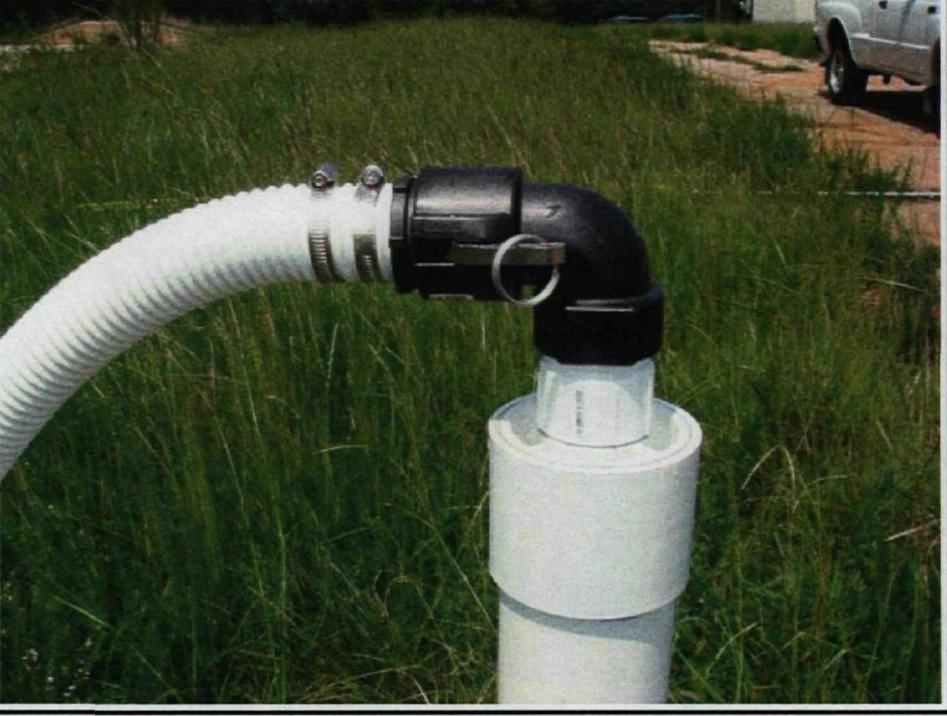
<b>Photo No.</b> 5

<b>Description</b> Well Head Connection	
<b>Photo No.</b> 6

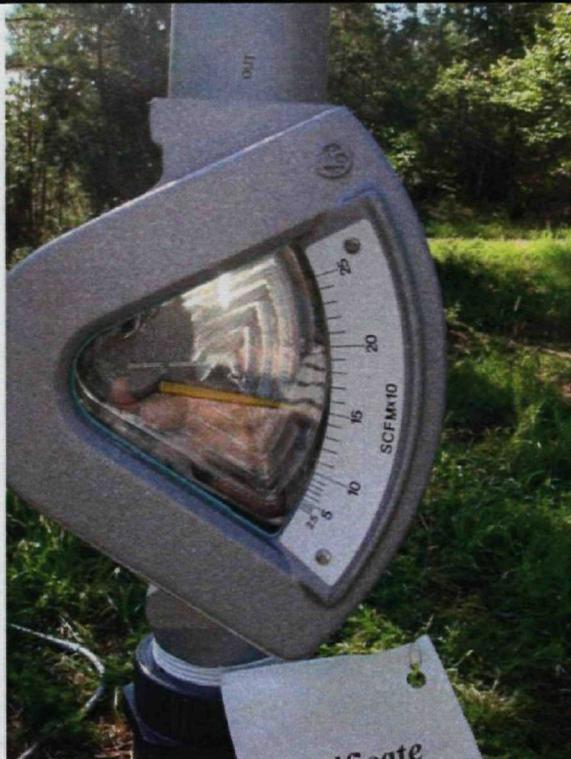
<b>Description</b> Area H Stack Flow
