# ATLAS TACK CORPORATION FAIRHAVEN, MASSACHUSETTS SUPERFUND CASE STUDY

## Agencies Work Together to Preserve and Create Fresh and Saltwater Wetlands at Former Manufacturing Facility

## ECOLOGICAL REVITALIZATION OF CONTAMINATED SITES CASE STUDY

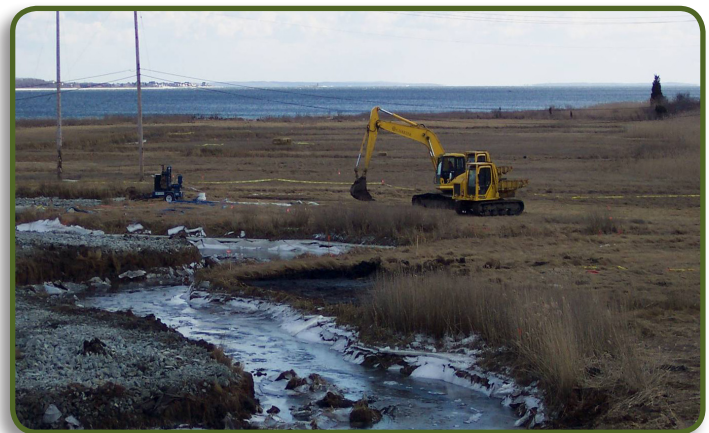
Salt Marsh Excavation

- » Phase III activities included excavating a total of 36,400 cy of contaminated marsh and creek bed sediment at Boys Creek and restoring these areas as well as the entire site. Based on analytical results, the contaminated sediment was disposed of at nonhazardous waste landfills. The marsh restoration began in May 2007, and construction was completed in September 2007. The cost of this cleanup phase was about \$6.5 million. Monitored natural attenuation for the groundwater is under way.

The entire area north of the dike (4.5 acres) was excavated, as well as 1.5 acres of the area south of the dike. Soil was removed in the winter, when the ground was frozen, and some of the invasive *Phragmites* was also removed while removing the soil.

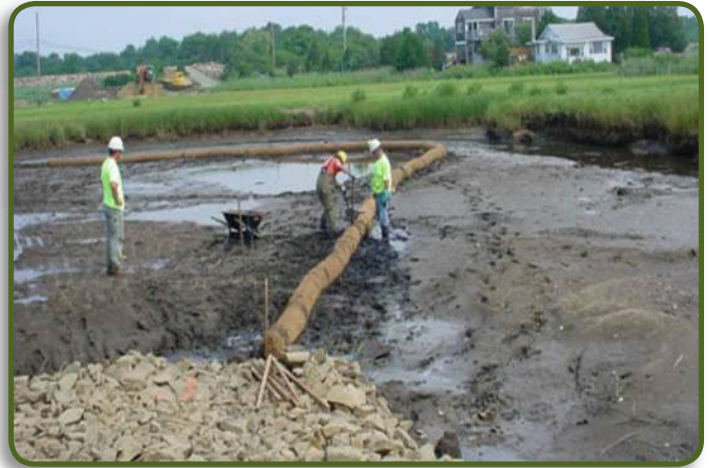
**Earthen Berm Installation**

The remediation plan was designed to restore the existing marsh and create additional marsh areas as well as provide a means to eliminate storm water flooding. The revitalization included construction of a clay core earthen berm in the wetland north of an existing dike to create separate fresh and salt water wetlands. EPA, USACE, and NOAA jointly designed the new wetlands

An existing culvert through the hurricane dike was under-designed and restricted tidal flow into the northern salt marsh. The amount of water coming through the dike could not sustain the original marsh and resulted in a large stand of *Phragmites* and a significantly lower value habitat. Cleanup funding could not be used to open the culvert through the dike, and it was estimated to cost several million dollars to replace the culvert. As a result, EPA, USACE, and NOAA designed (1) a freshwater wetland where the *Phragmites* once stood, and (2) a smaller saltwater marsh, which was separated by a clay core earthen berm and would be sustainable with water that could pass through the existing culvert, all of which could be completed using CERCLA funding. The earthen berm caused surface and groundwater to pond and create the freshwater emergent wetland. Spillways were also installed to allow excess fresh water to flow

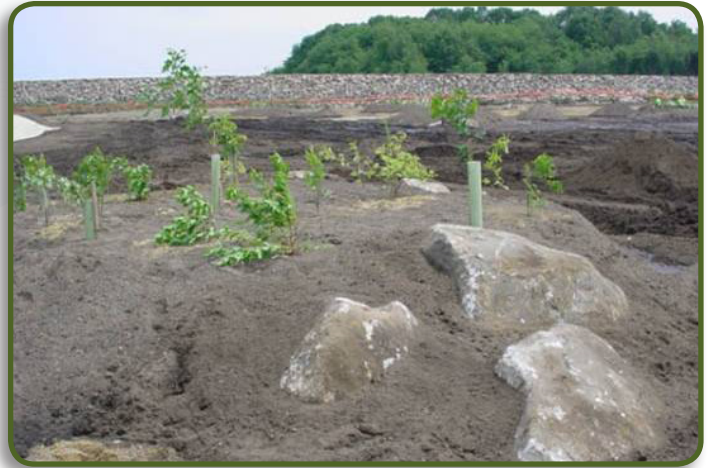
Island Plant Plugs

Ten small upland islands were created in the freshwater wetland and planted with herbaceous freshwater plants, trees, and shrubs; these plants helped to maximize valuable habitat space. Woody debris and rock formations were also used as materials during construction of the islands to help provide a variety of habitats throughout the wetland. Native northeast New England wildflowers were also seeded to encourage the return of native birds and pollinators to the area.

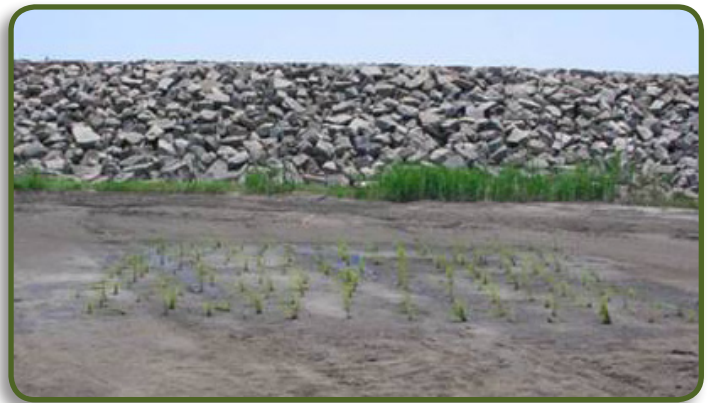
High Marsh Plantings

More than 14,000 low and high marsh wetland plant plugs were planted, as well as shrubs and trees in the upland areas. Species such as seashore saltgrass (*Distichlis spicata*), saltmeadow rush (*Juncus gerardi*), saltmarsh cordgrass (*Spartina alterniflora*), and salt hay (*Spartina patens*) were planted in the salt water marsh. The freshwater wetland was planted with a variety of species, including spatterdock (*Nuphar advena*), water smartweed (*polygonum*
