Jordan River & Midvale Slag Beneficial Use

Marian Hubbard-Rice
Salt Lake County Watershed Planning

Erna Waterman
U.S. EPA Region 8

Midvale Slag
Beneficial Use

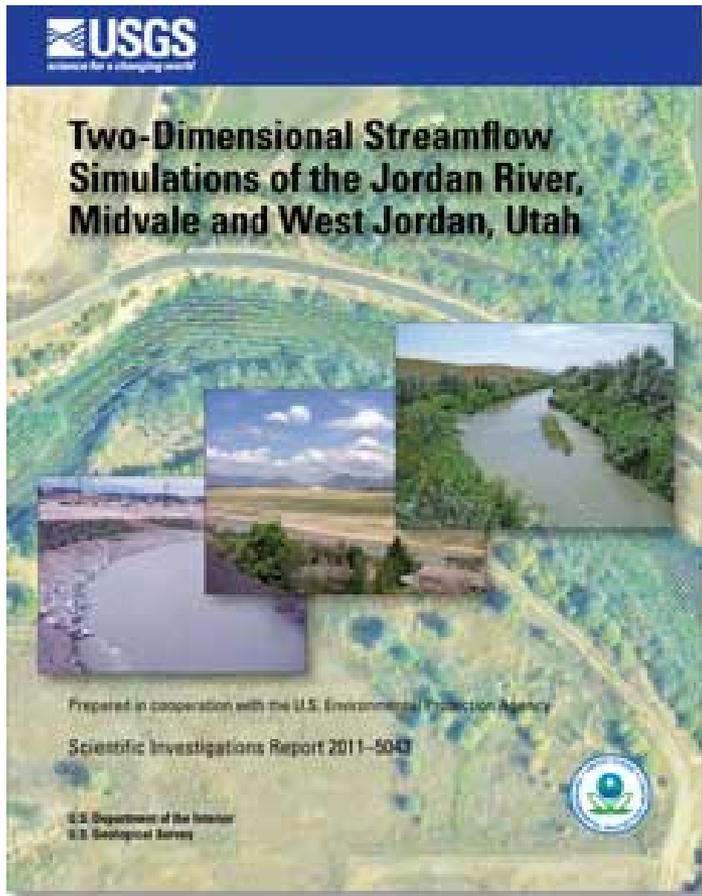
United States Geological Survey (USGS)

2008-EPA hires USGS:

- Create a 2D model to evaluate the river's velocities and also where the river is constrained, eroding, and migrating out of current channel
- Borehole sample map to avoid pockets of slag during construction

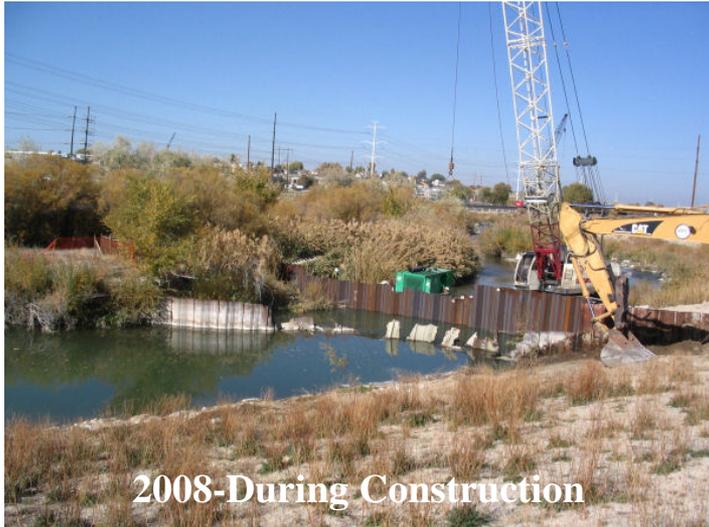
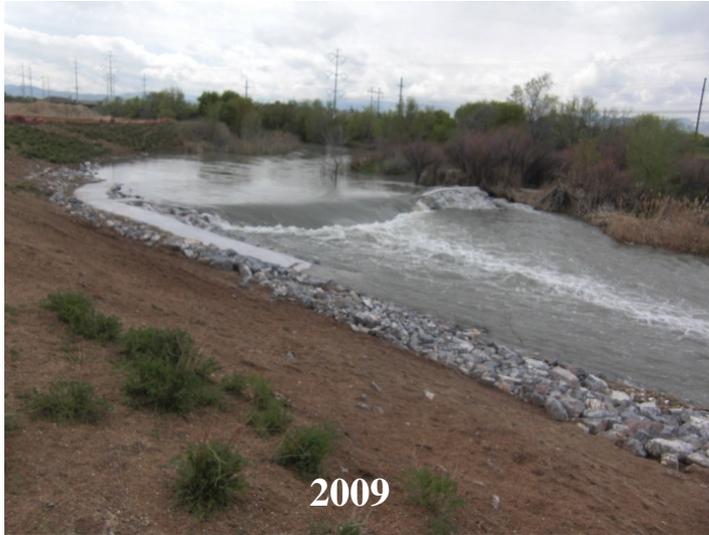
Sheet Pile Dam-Grouted Boulder Structure

EPA replaced damaged sheet pile dam

- 2008-Sheet pile dam was dangerous and replaced with a grouted boulder structure
- 2008-Three spur dikes installed east (Midvale) bank of river to redirect flow to away from bank
- 2009-Secondary high flow channel created due to scouring from high flows

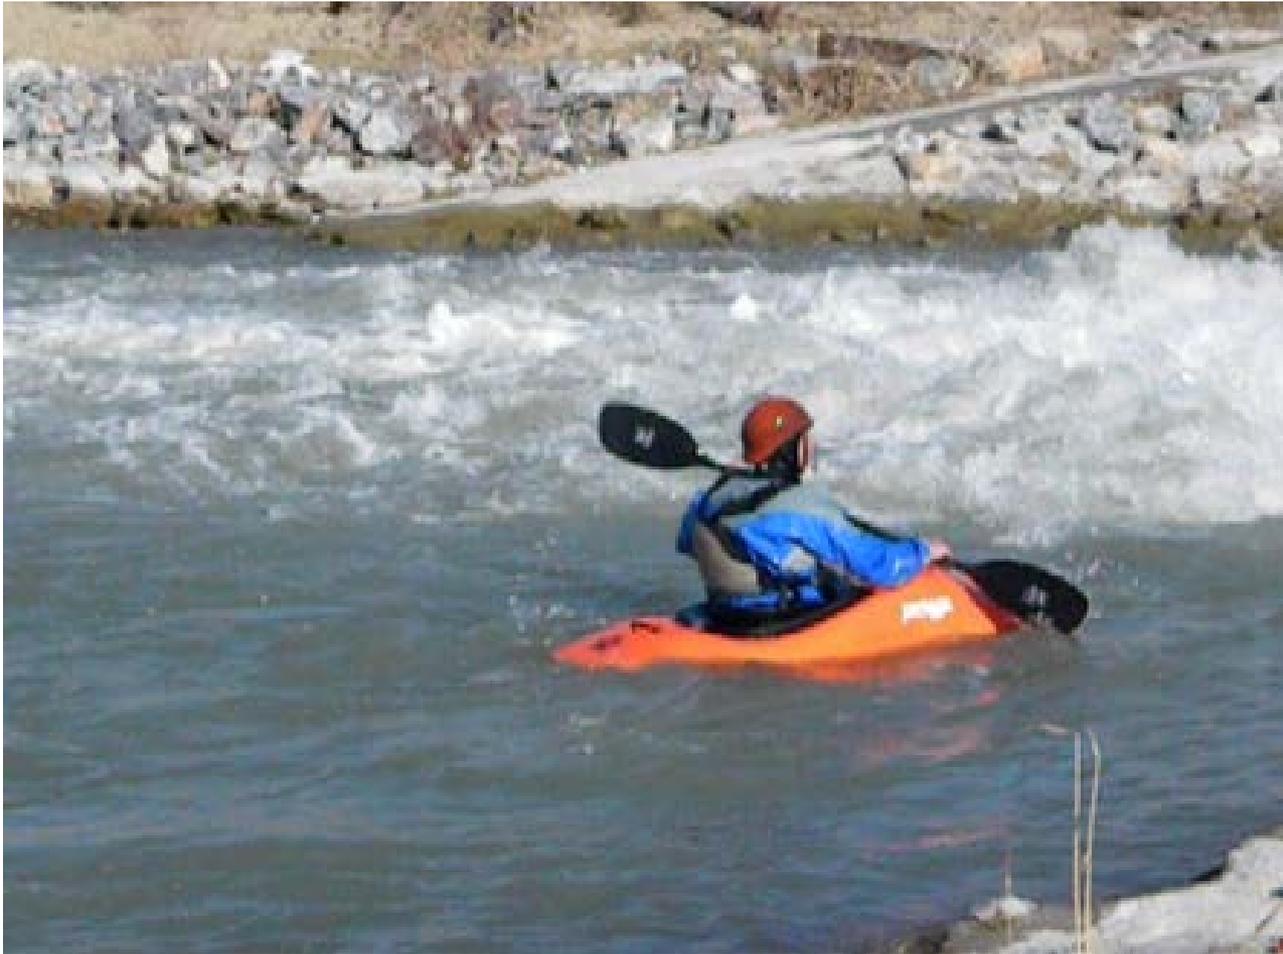
Sheet Pile Dam

Grouted boulder structure becomes a kayakers recreational amenity

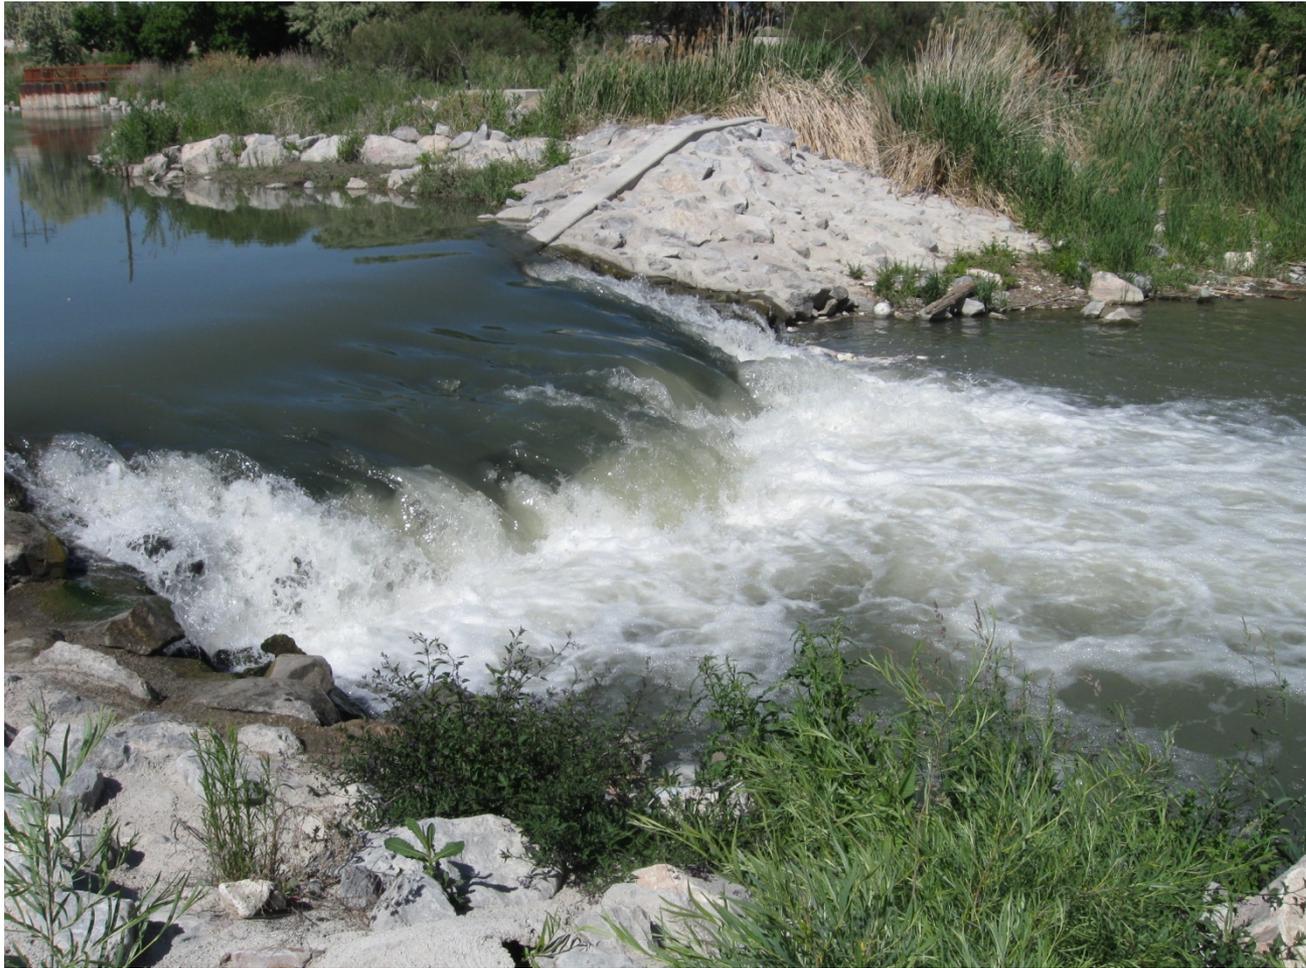
Sheet Pile Dam-Grouted Boulder Structure

2010 and 2011- High Flows cause damage to the grouted boulder structure

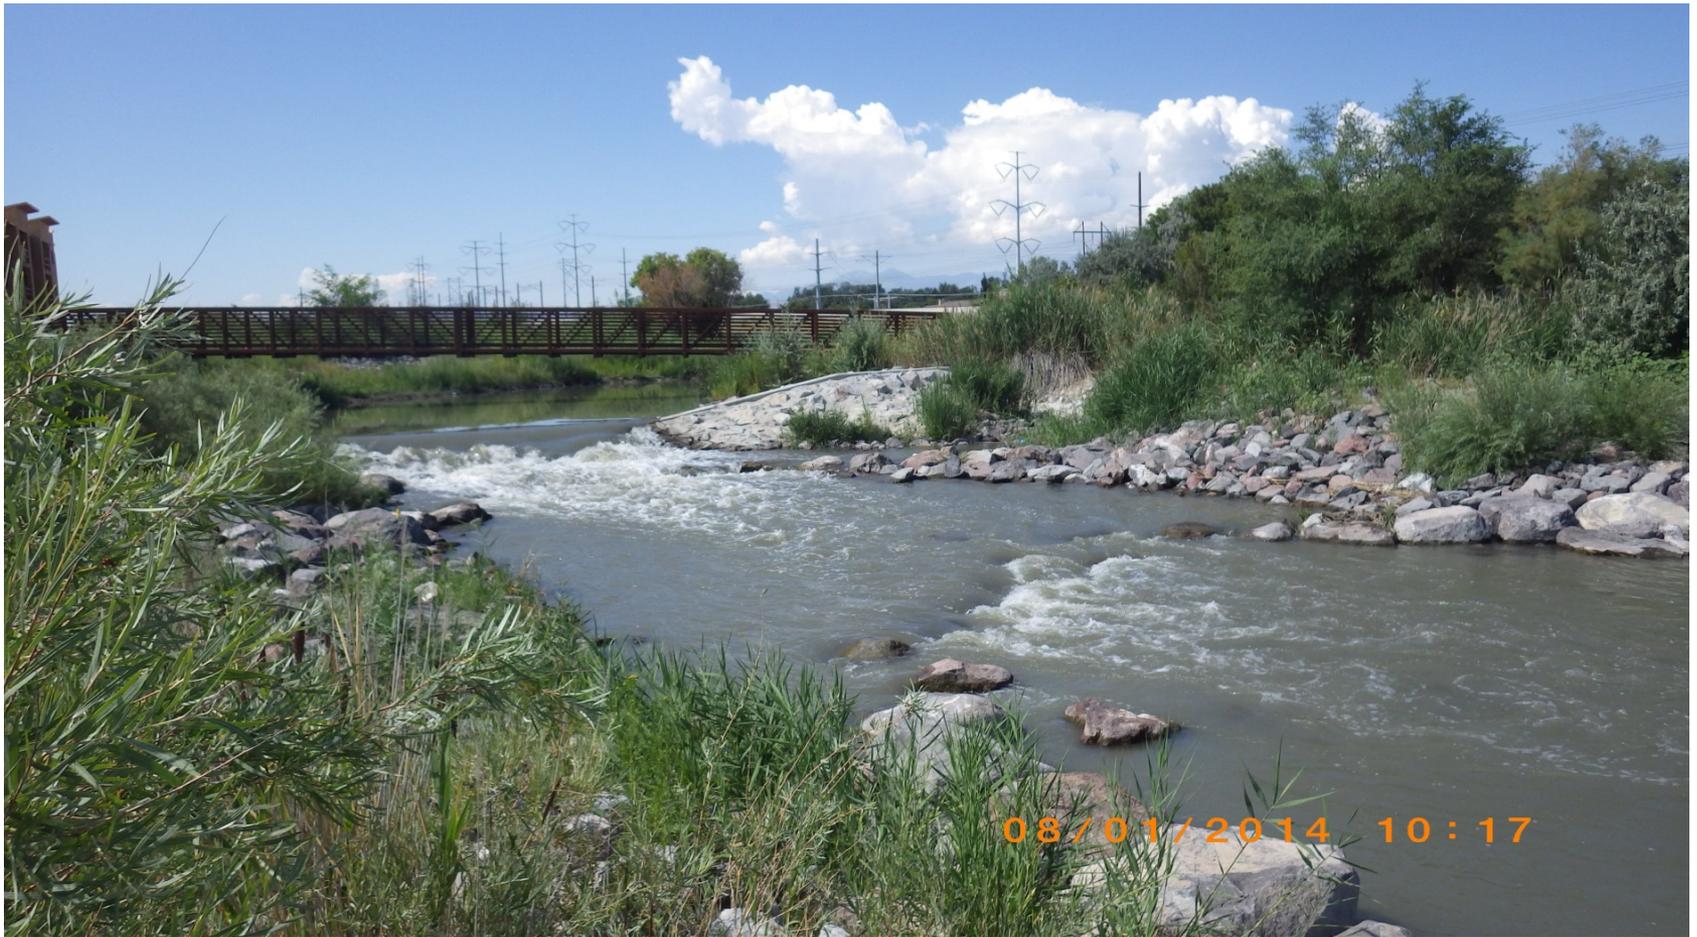
Sheet Pile Dam-Grouted Boulder Structure

2014-Grouted boulder structure repaired with two added cross-veins to aid in navigability

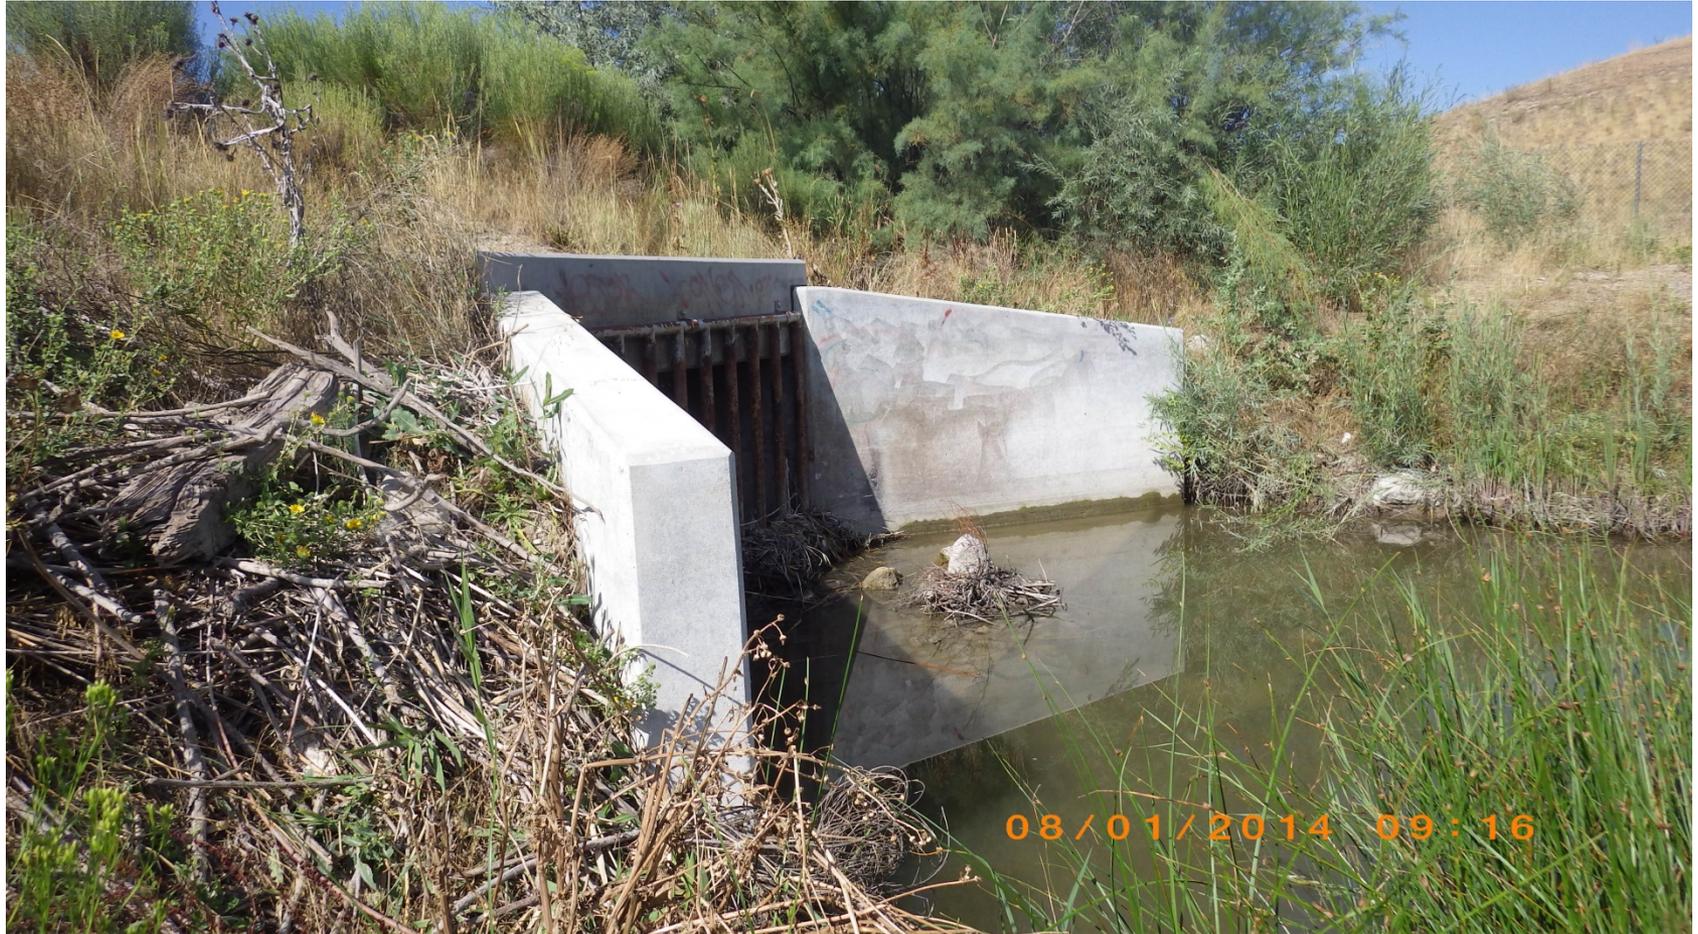
Box Culverts

2009-EPA installed two design build box culverts to increase holding capacity of river

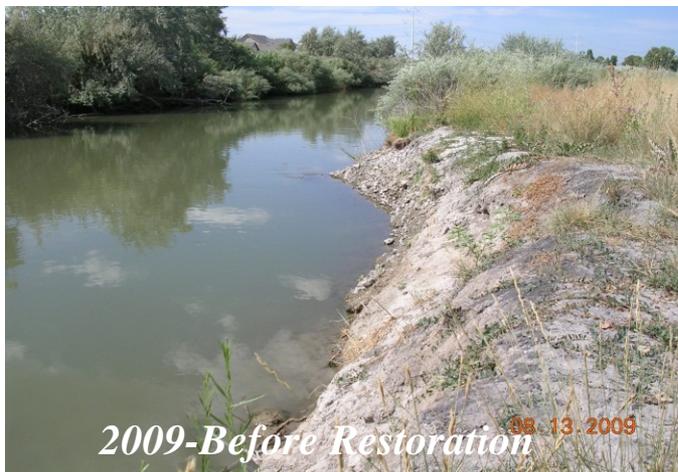
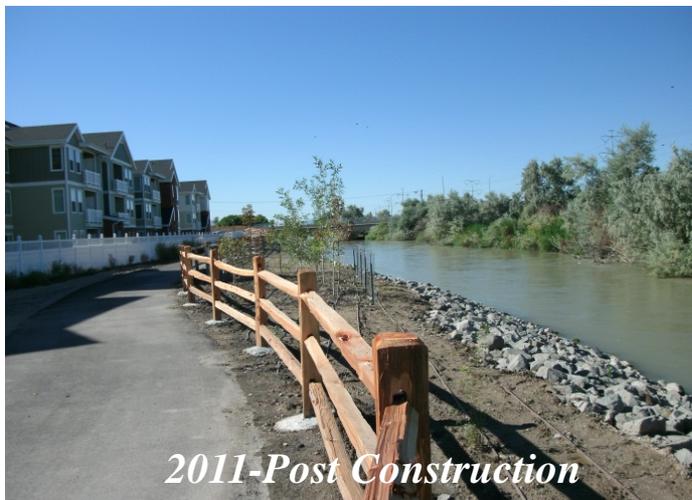
Ecosystem Restoration Challenges and Opportunities

Minimal excavation due to regulated material

- *USGS Borehole map to determine where could excavate*
- *Toe protection and RipRap in areas unable to excavate*

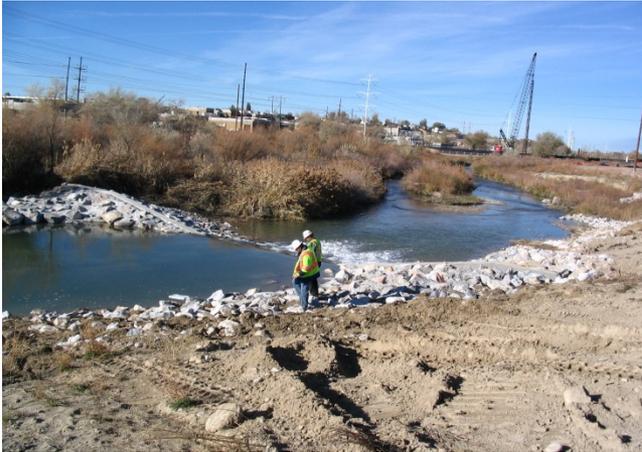
Jan 8 2009 Flow (Q) 30 cfs

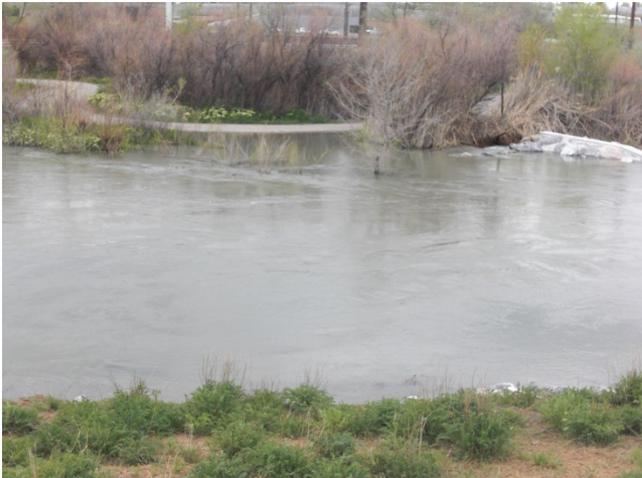
May 4 2009 Flow (Q) 1080 cfs

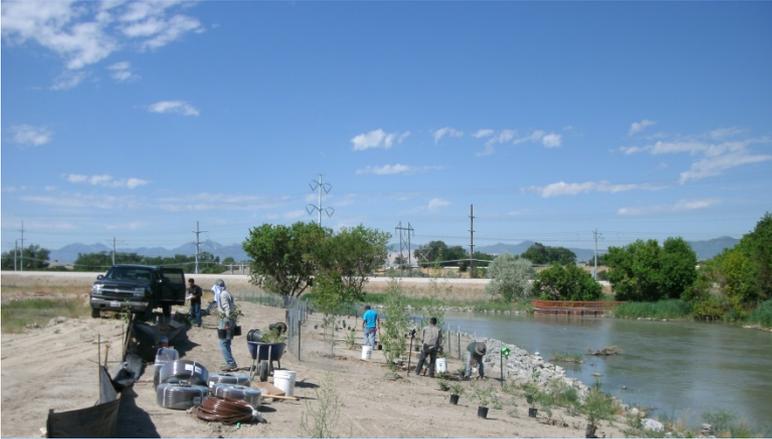
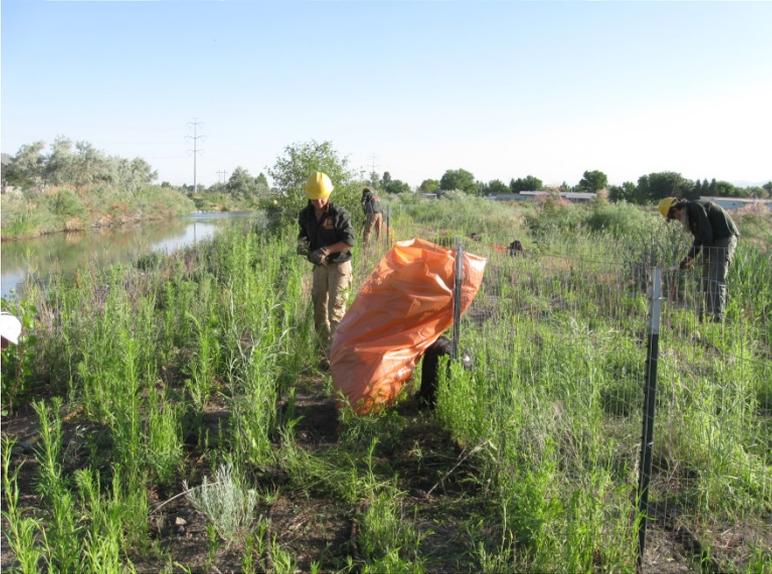
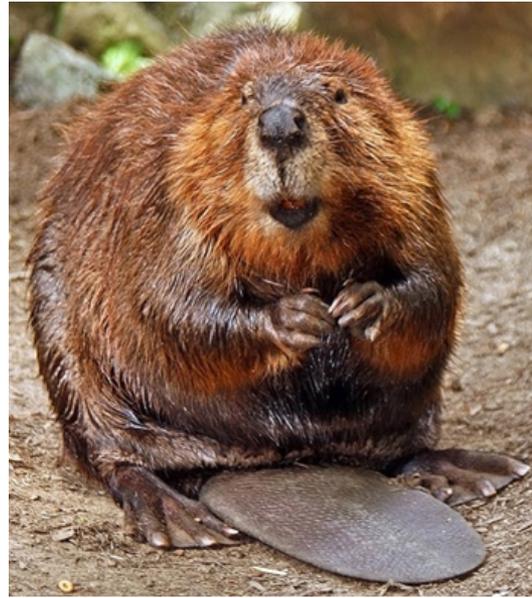
Vegetation Establishment

- *Drip Irrigation*
- *Native upland and riparian vegetation*
- *Weed mapping and mitigation*

- *Soil Survey*
- *Beaver fencing*

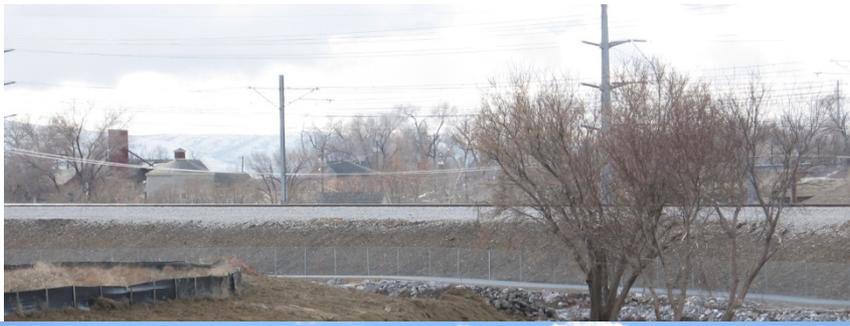
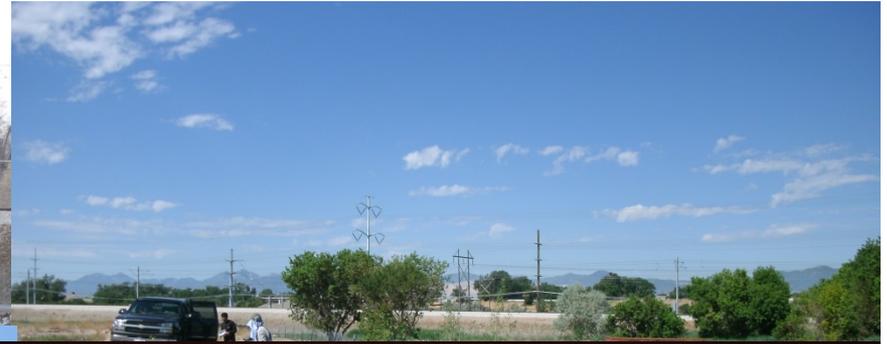
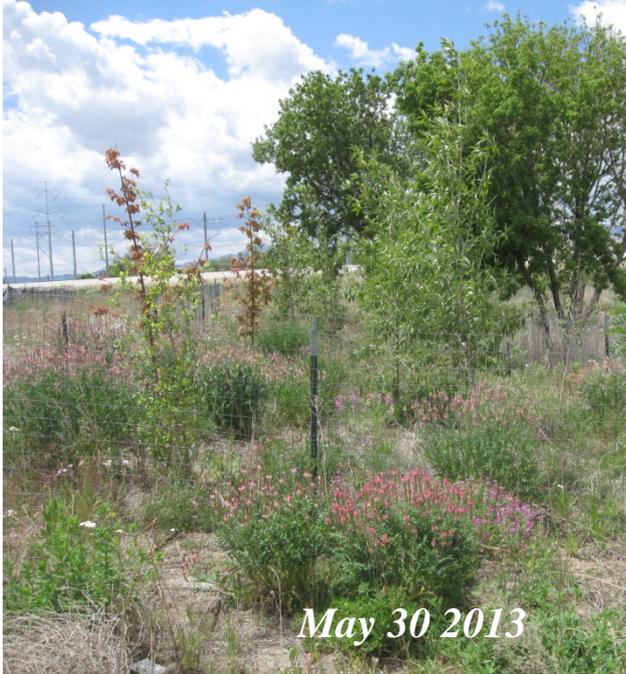
May 30 2013

Drop Structure Site- Emergent Bench
