# ***Ukraine Strategic Arms Elimination Program***

## ***Liquid Missile Propellant and Storage Facilities Elimination Project***

# *Risk Management at Former Military Sites*

*Environmental Aspects of the Liubashevka*

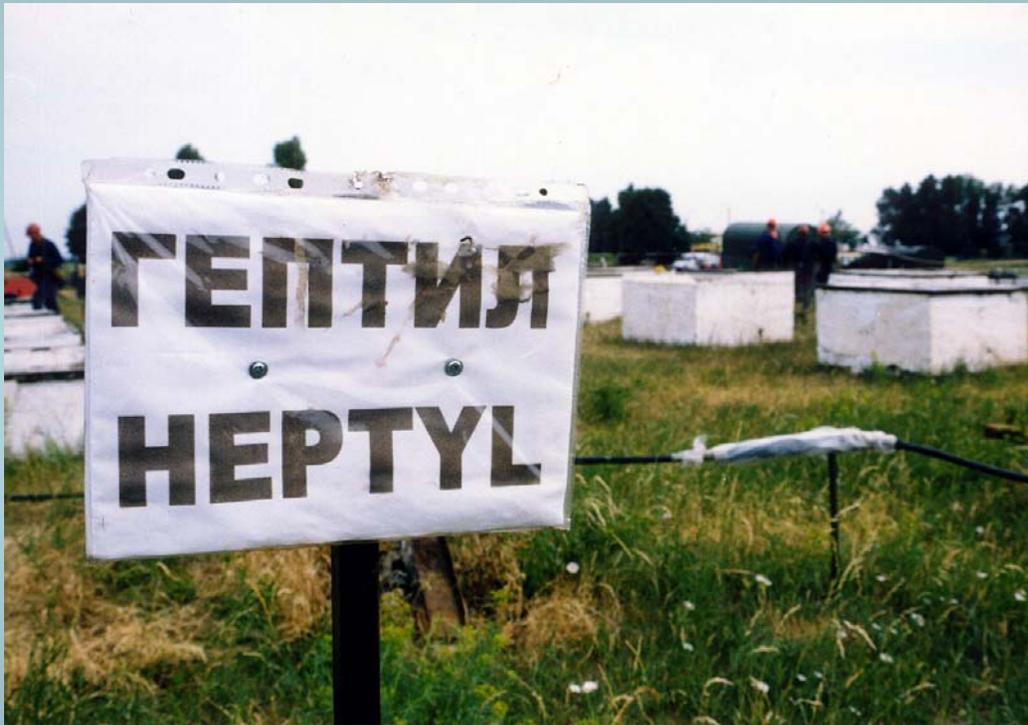
Marker for Topsoil Area Excessively Contaminated With Heptyl

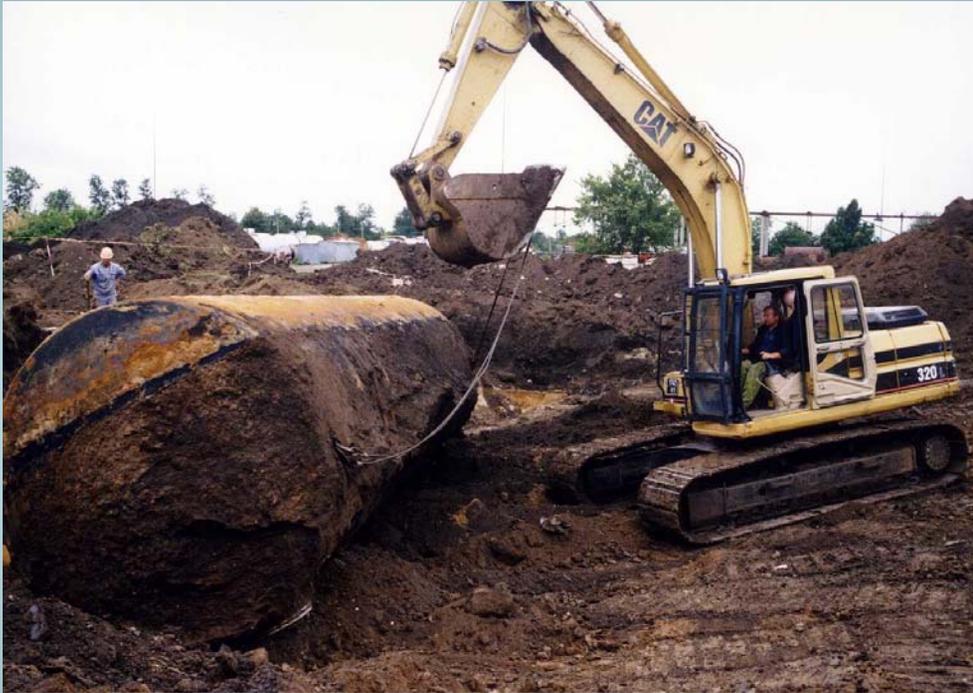
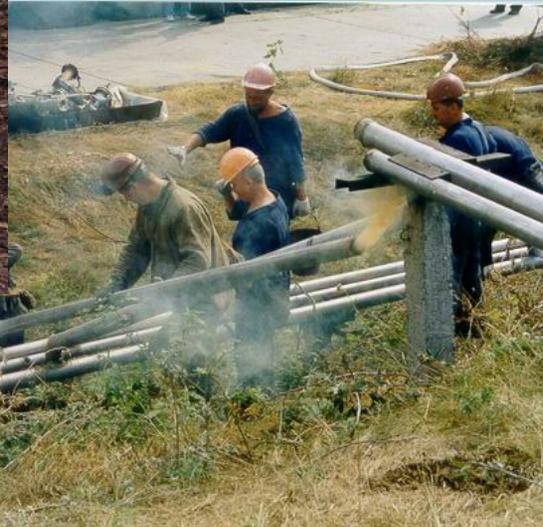
Removal of underground tanks and associated infrastructure

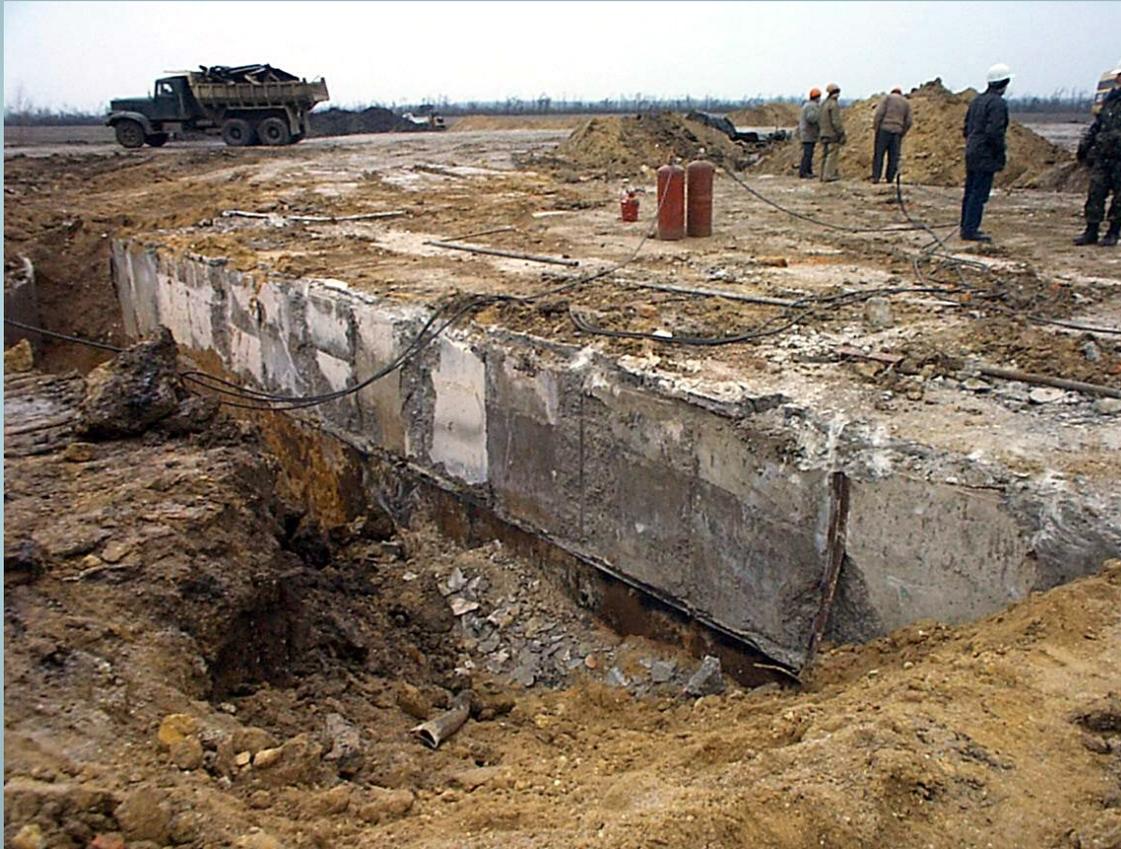
Elimination of foundations and sumps

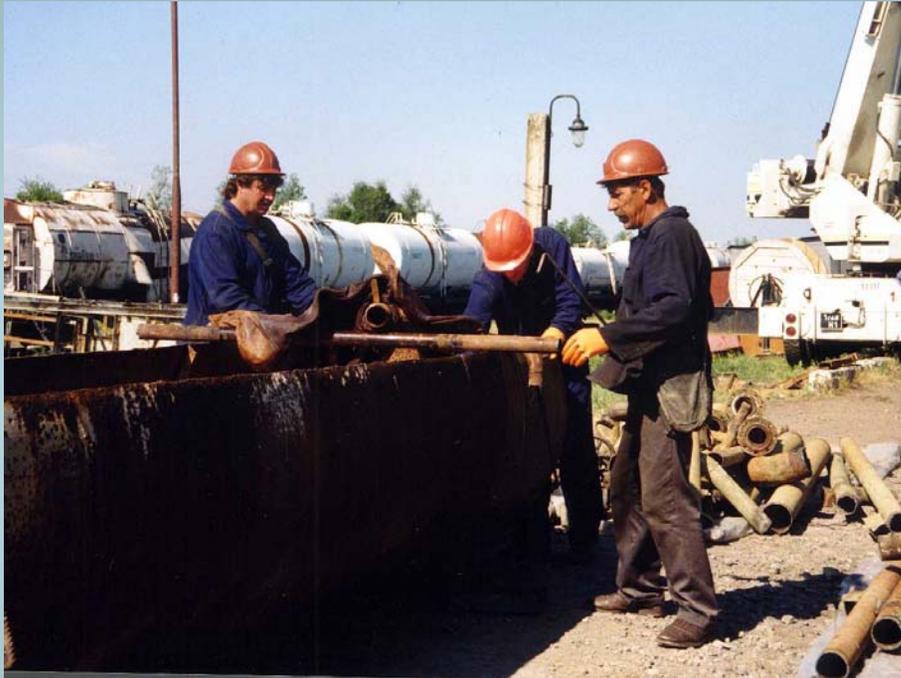
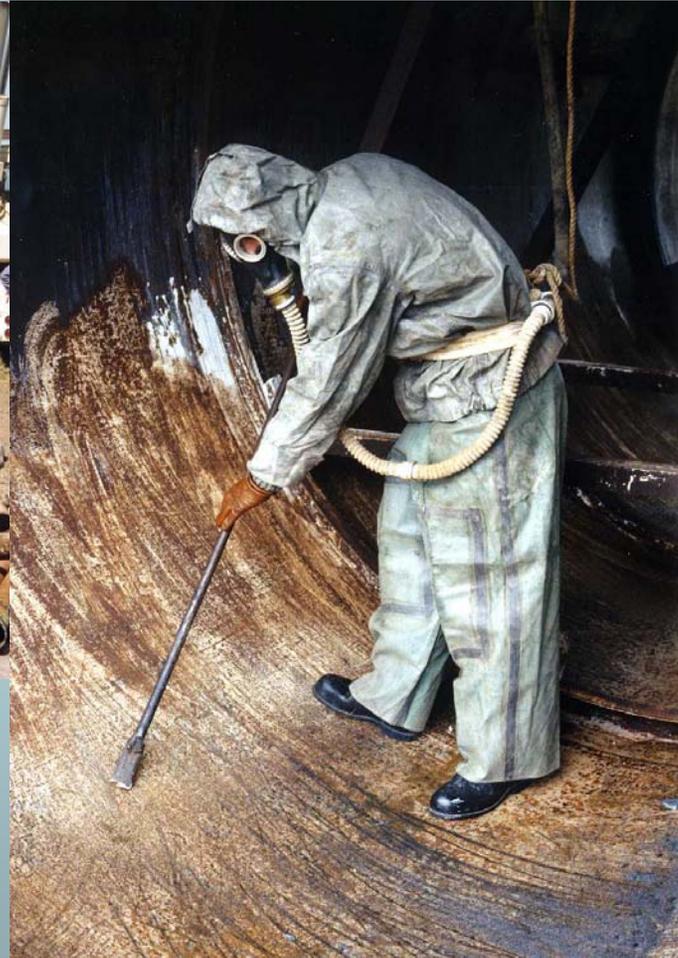
Steel salvage

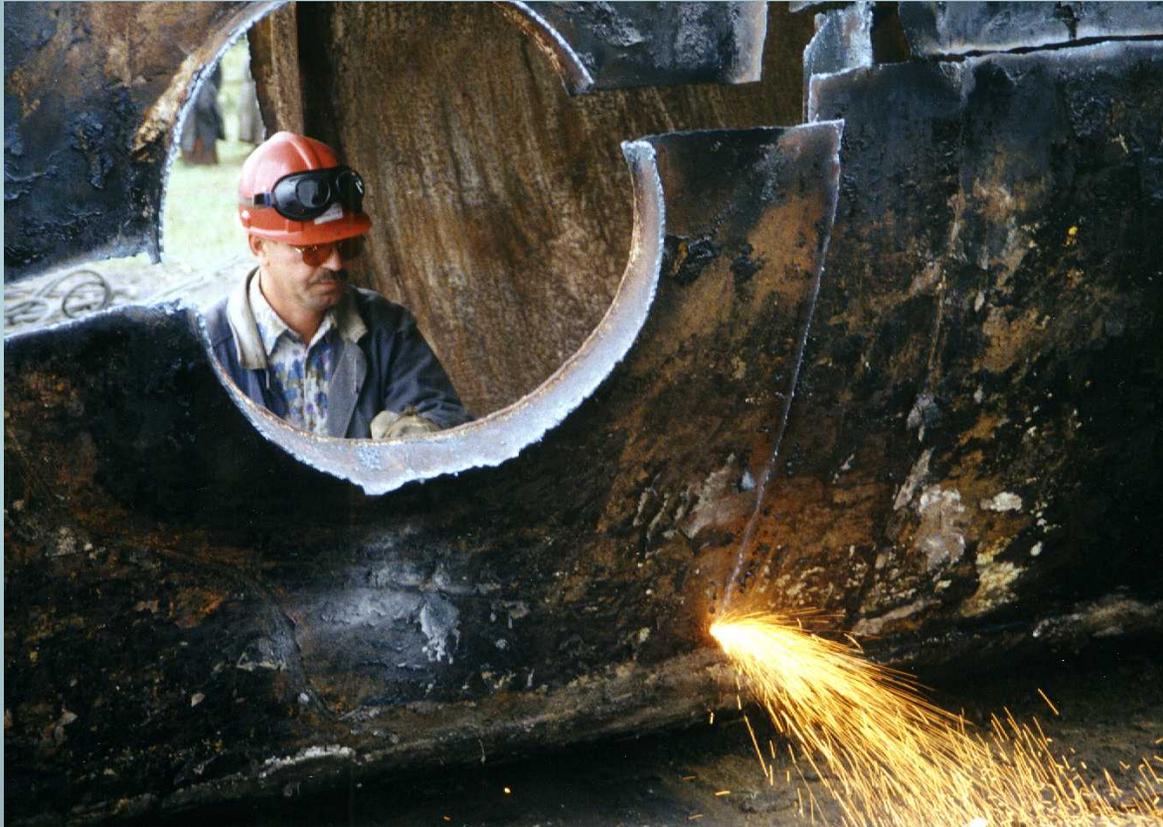
Steel salvage

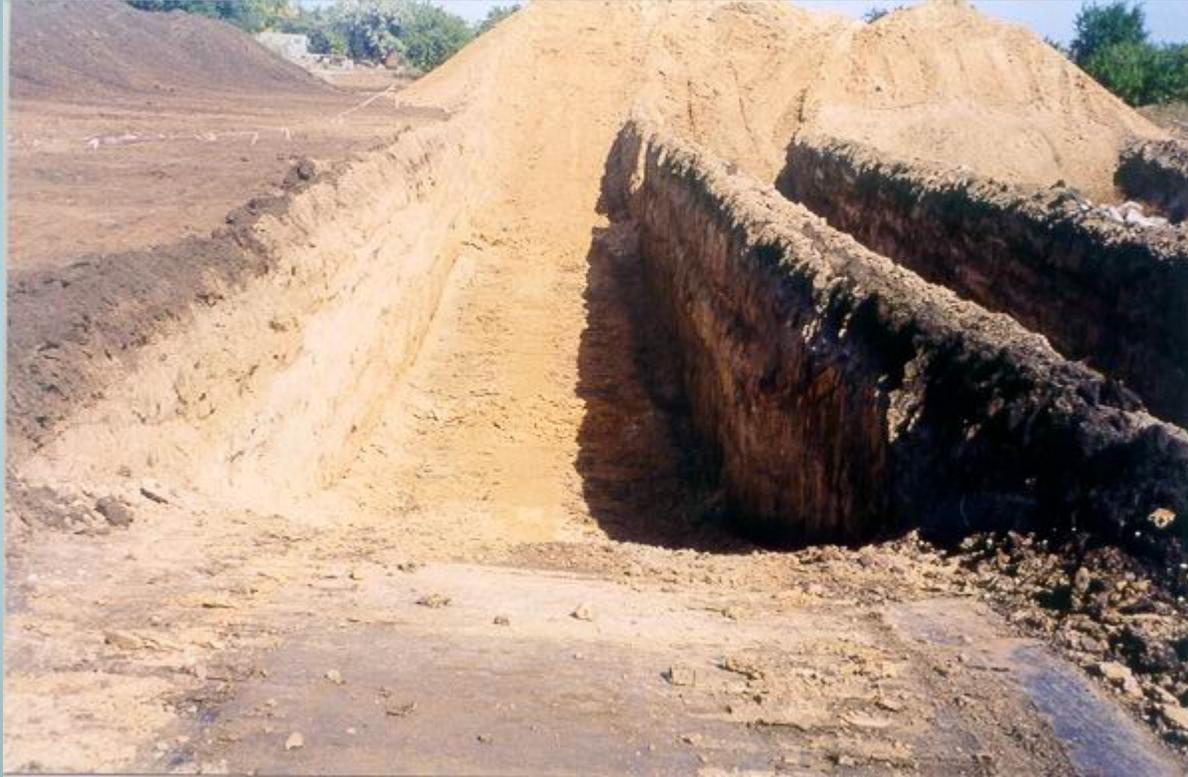
Debris and solid wastes burial

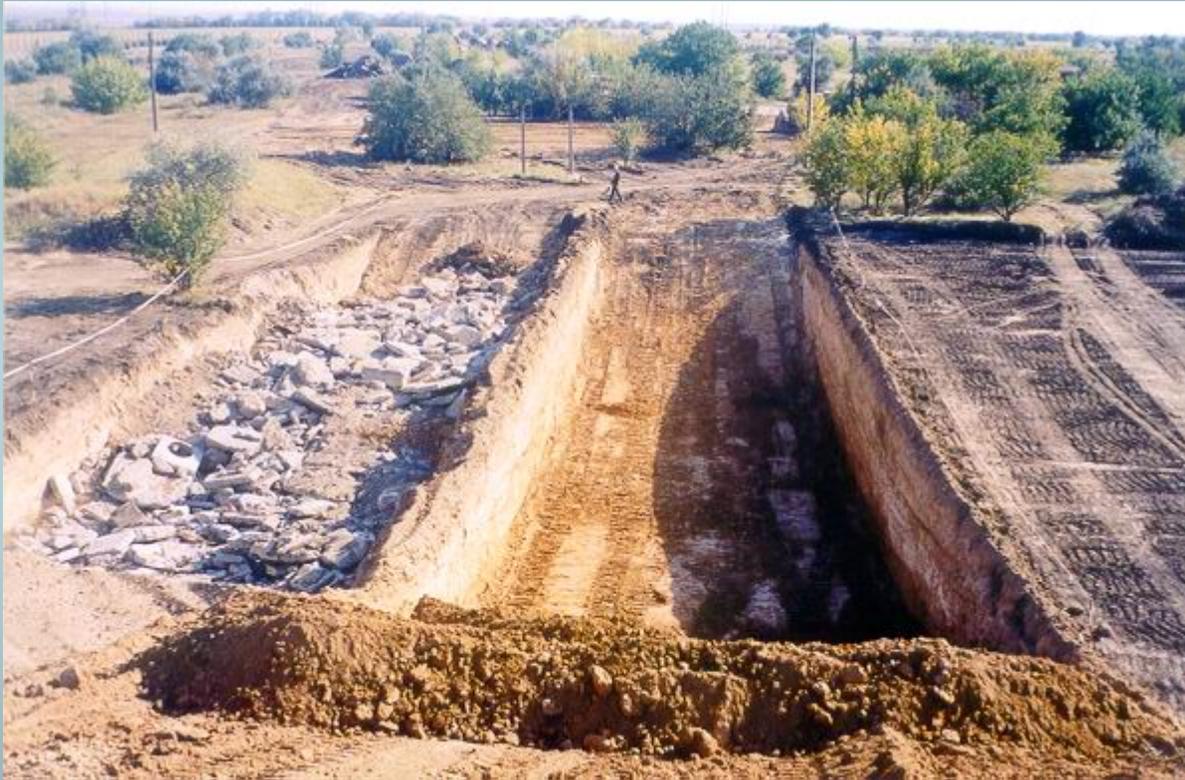
Debris and solid wastes burial

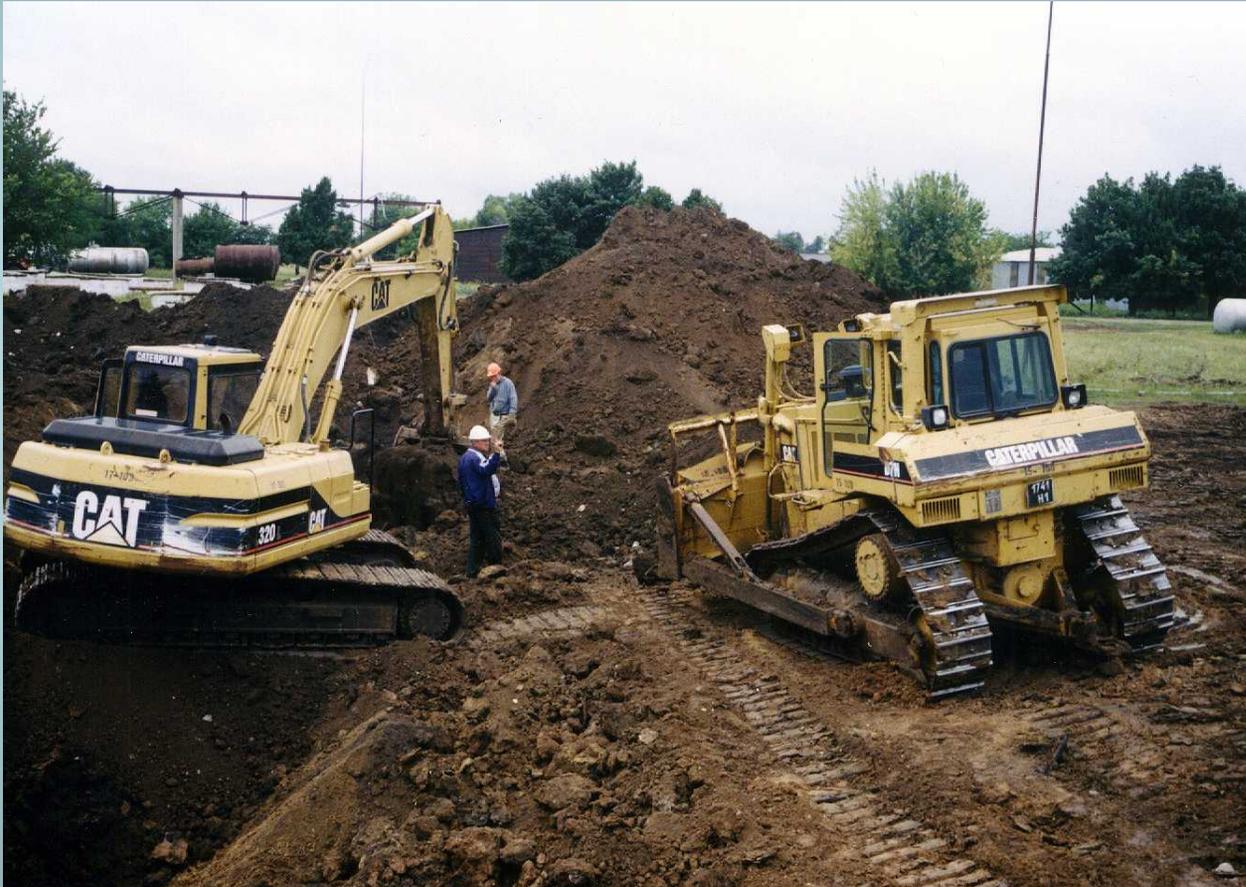
Removal and placement of contaminated soil

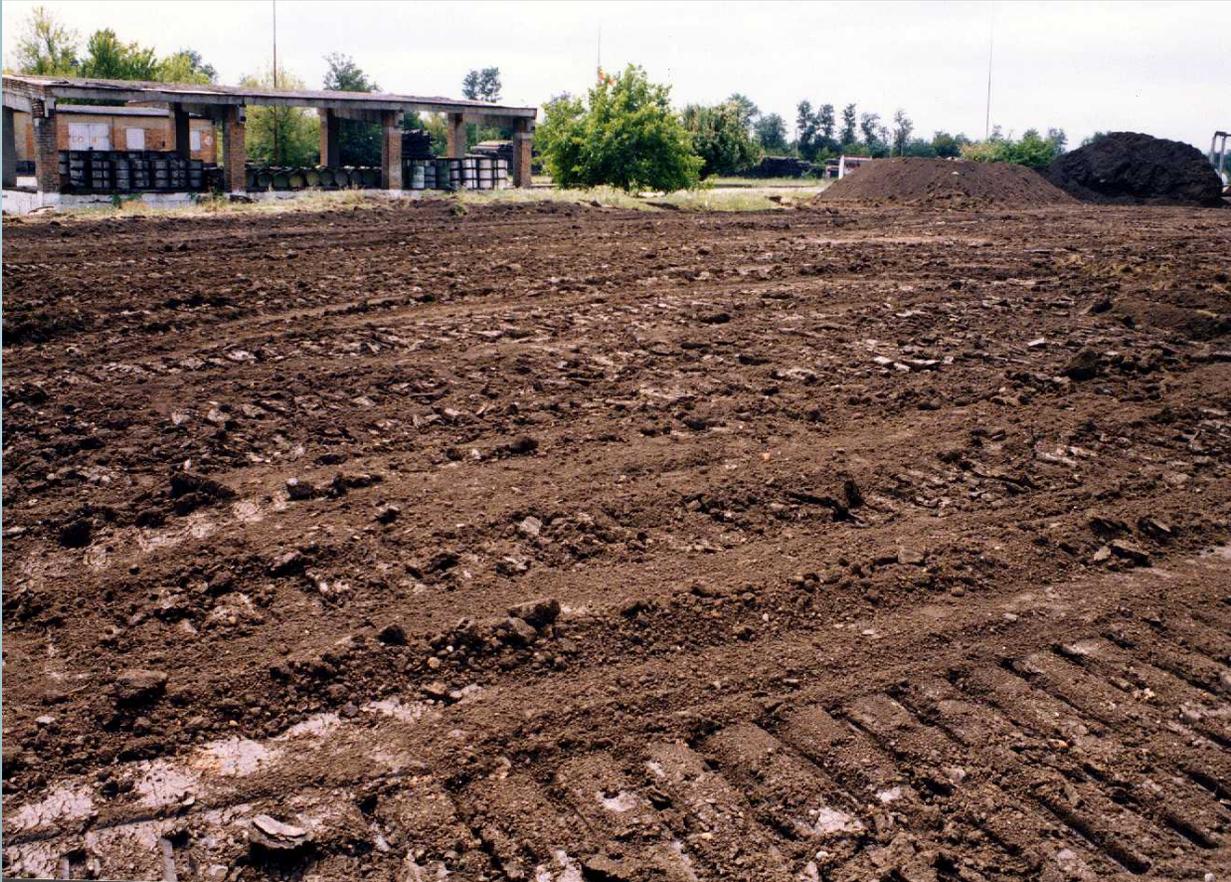
Site Restoration

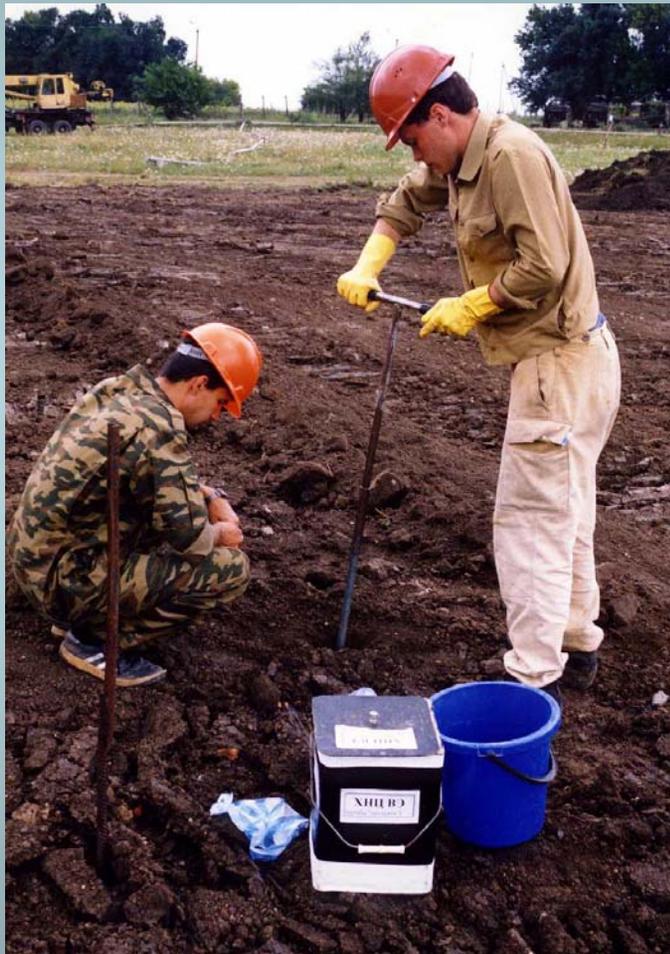
Site Restoration

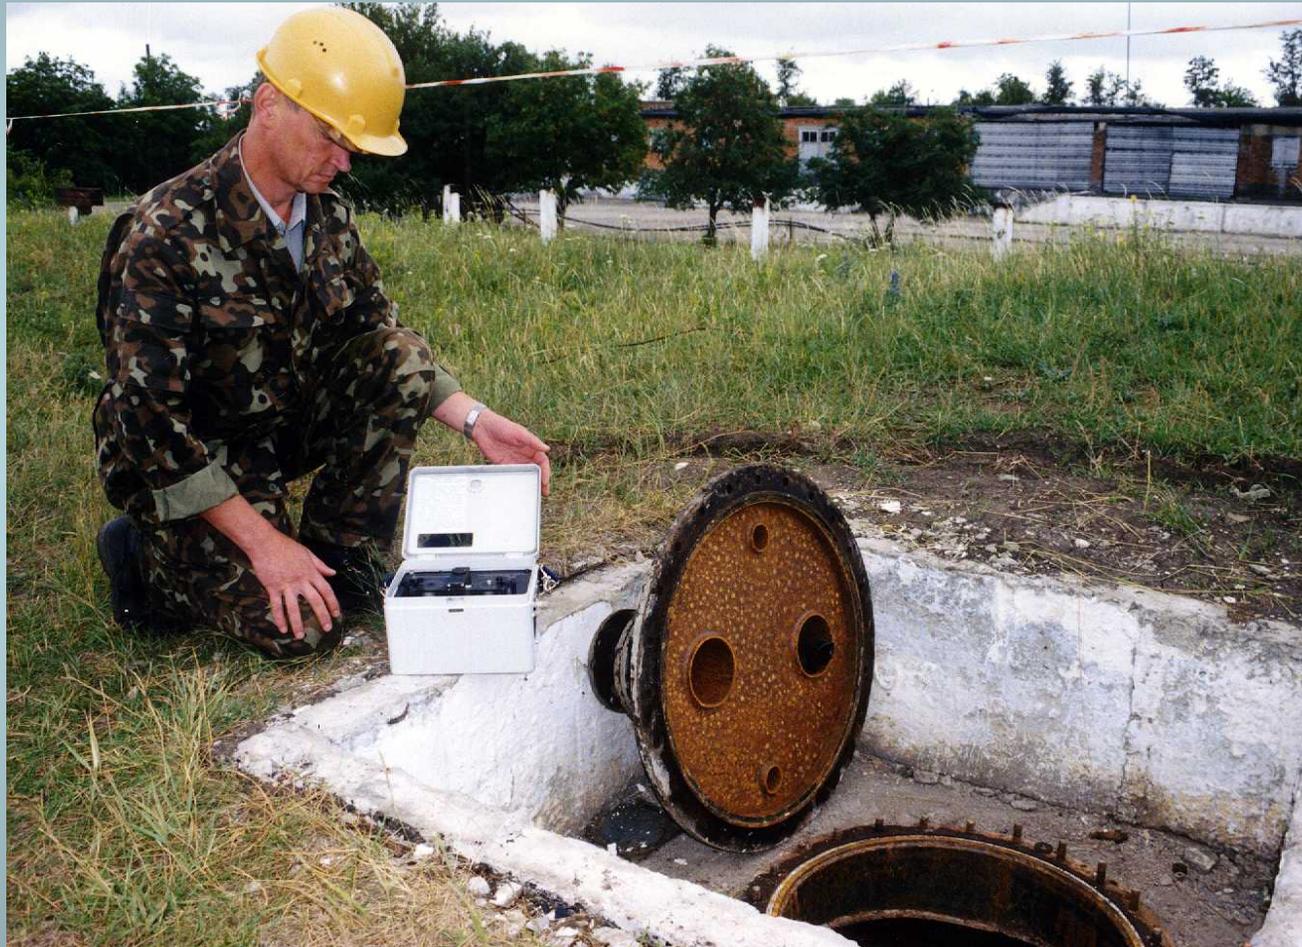
Air sampling at the R-60 Heptyl Tank Block

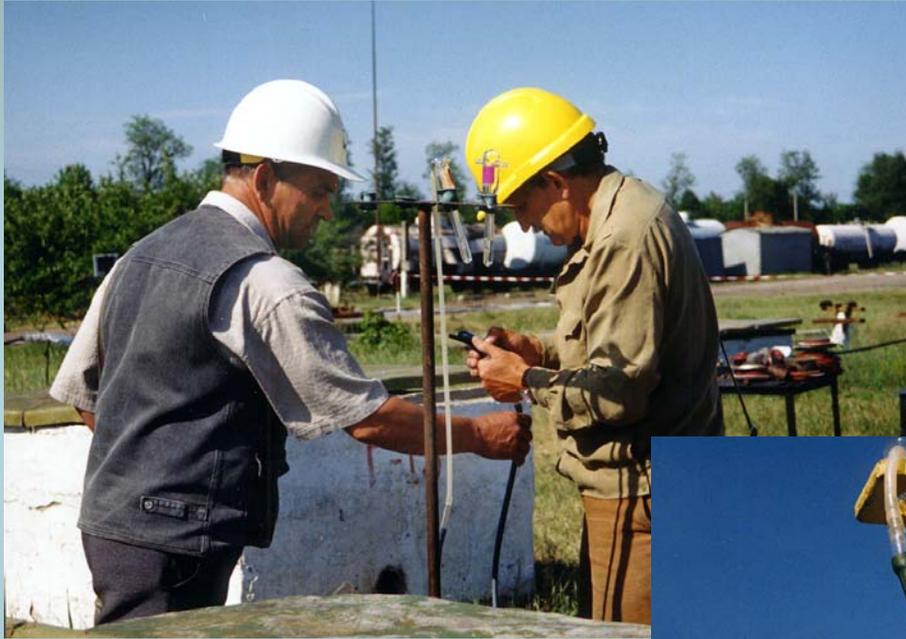
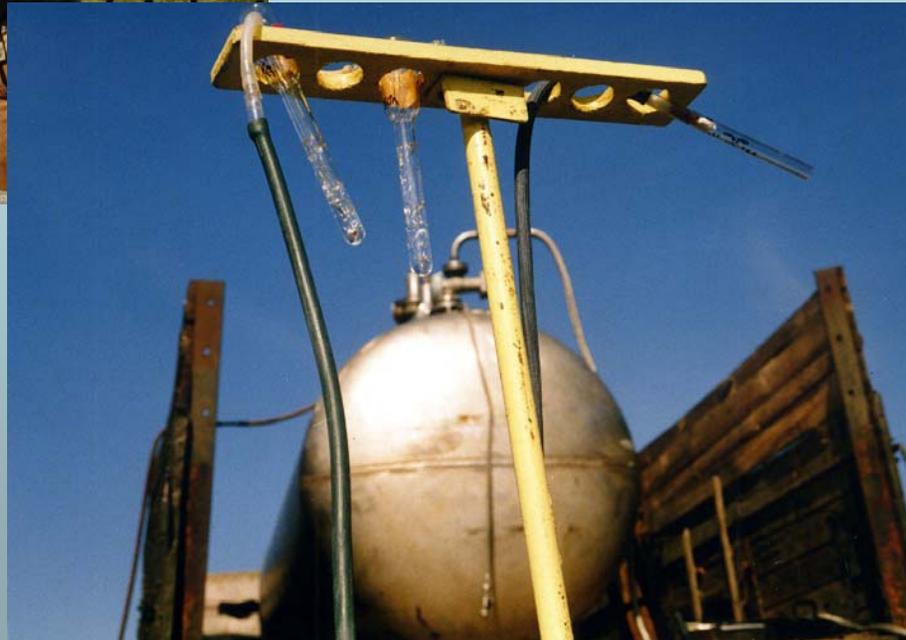
Air Monitoring Post  
Equipment

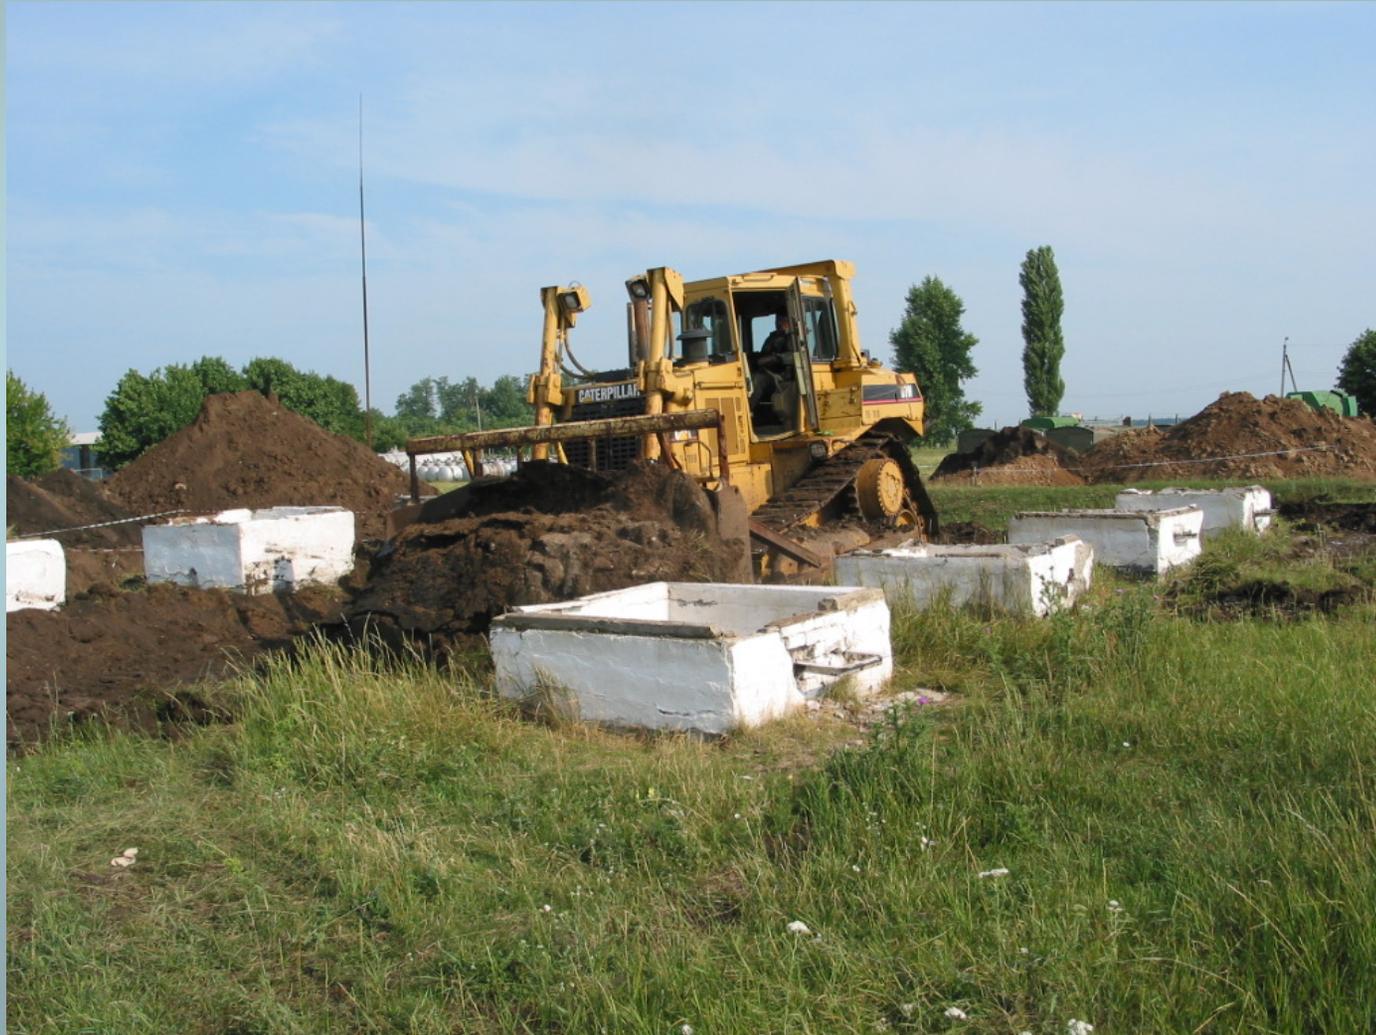
■ Prior to R-60 tank removal, soil covering the tanks was temporarily stockpiled beside the tank blocks in piles numbered one through six and then analyzed for UDMH and NDMA

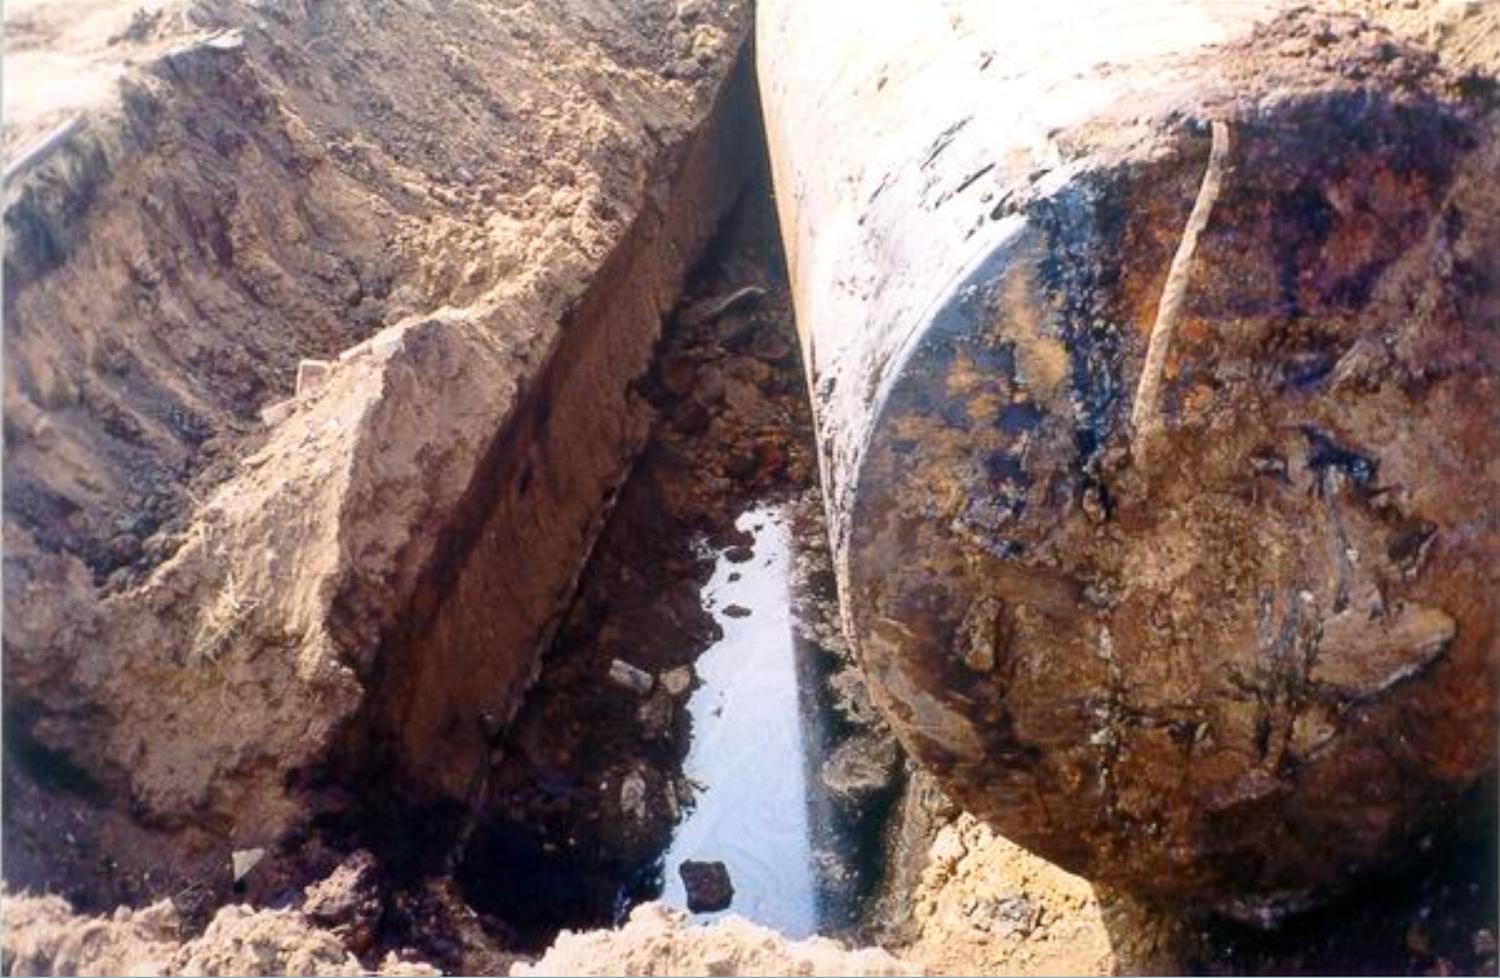
■ Two special cases were documented during the R-60 #G2 and #G4 tank removal process. At the bottom of the pans of these tanks, wet sand seemed to be heavily contaminated with spilled liquid with a strong Heptyl odor

Date	Tank pan #	Percentage of UDMH in liquid, %
16 July 2003	G2	2.76
18 July 2003	G4	42.9
<b>MAC Not Applicable for liquid test</b>

- Further technical inspection of the R-60 #G2 and #G4 tanks revealed that they had no holes. It is believed that these Heptyl spills resulted from improper practices at Liubashevka RFSS during the operational period
- In accordance with Design Documentation, Sump containment sand (6 m<sup>3</sup>) was neutralized by MOD with DTS-GK and placed in the contaminated soil temporary storage area.
- Tank pans were neutralized, dried, and cut into 1 x 1 m pieces

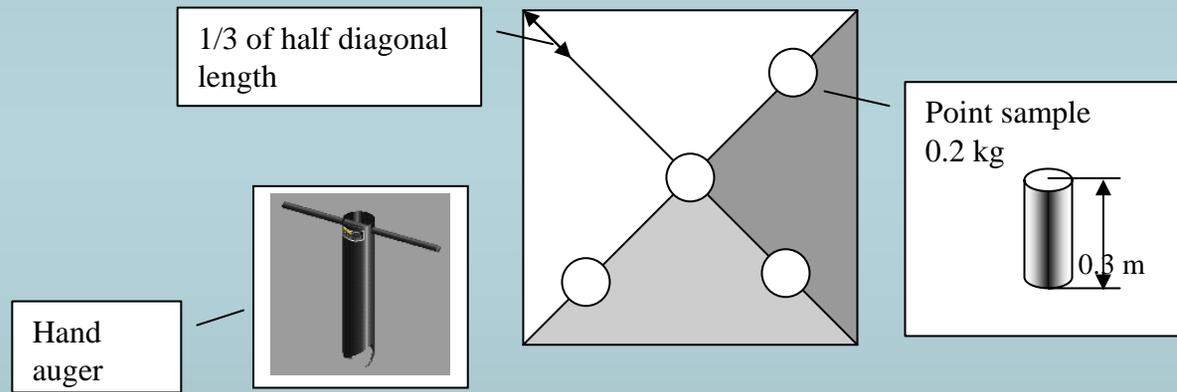
- The 1 kg combined samples, taken in topsoil and consisting of five 0.2-kg point samples each, were collected from each sampling square (10 x 10 m; 20 x 20 m; 40 x 50 m) using the “envelope sampling methodology”.
- Each point sample was taken using a hand auger from a depth 0 to 0.3 m.

“Envelope Sampling Methodology”

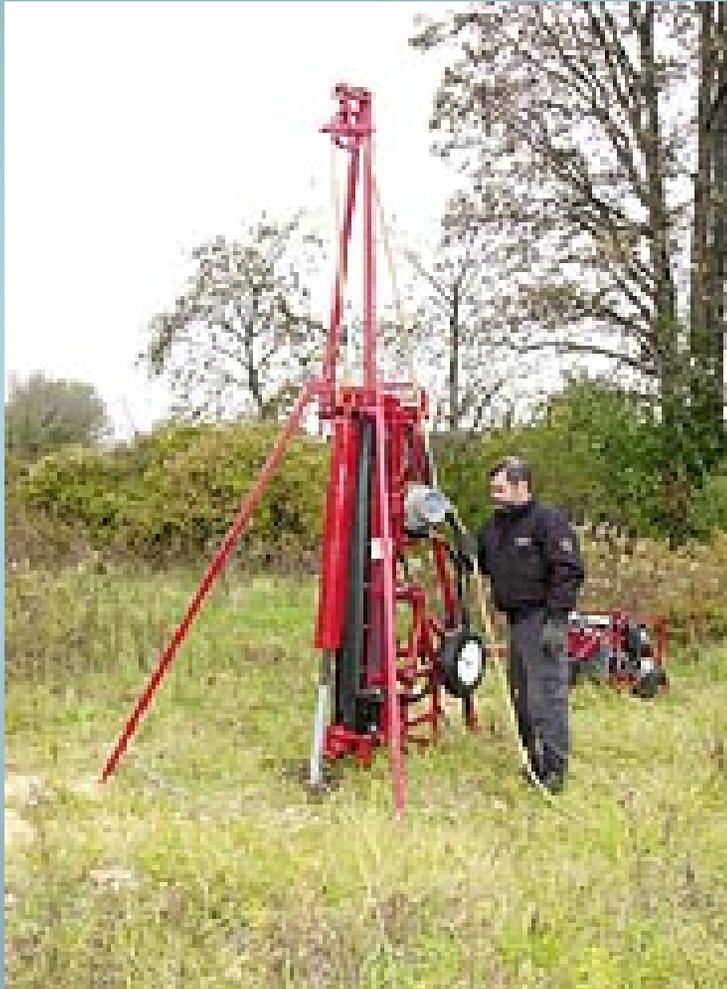
■ In order to assess the rate of vertical migration of contaminants, the soil samples were also collected from boreholes which were drilled with a “Big Beaver” portable earth drill up to 4.0 m depth each

Portable Earth Drill "Big Beaver"

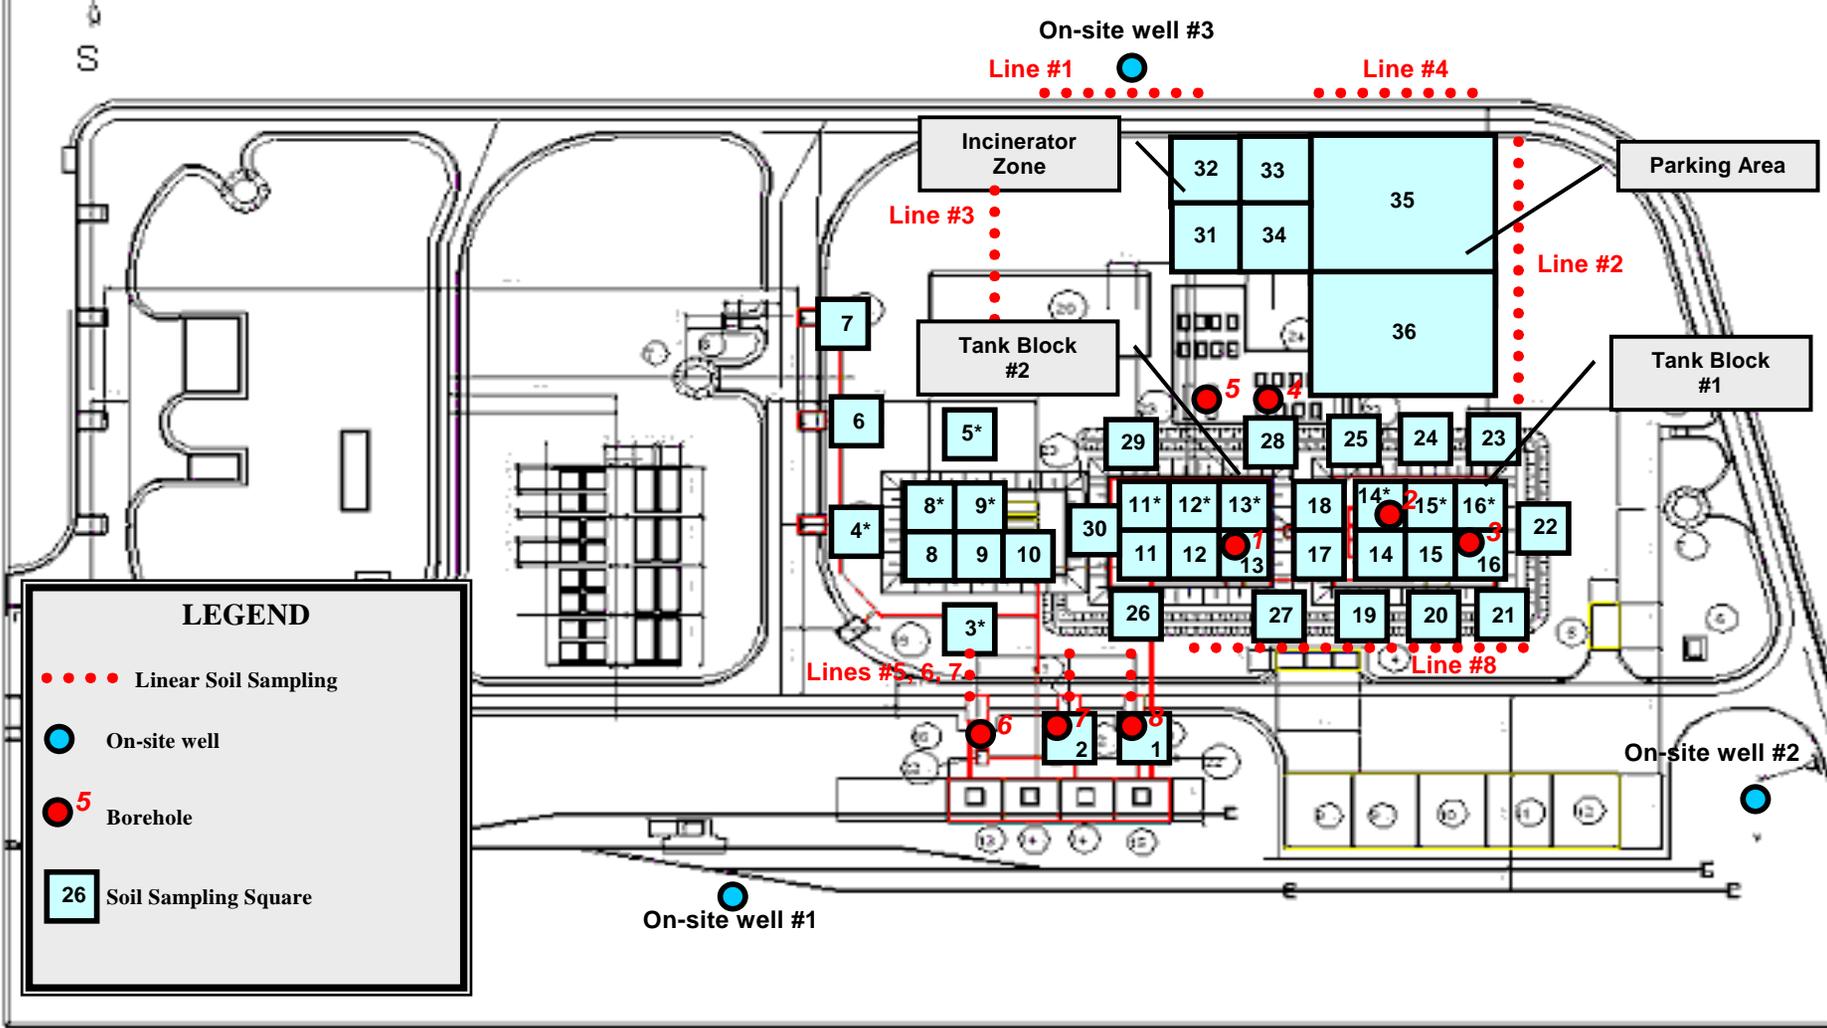
## Phase II Post-Dismantlement Environmental Survey

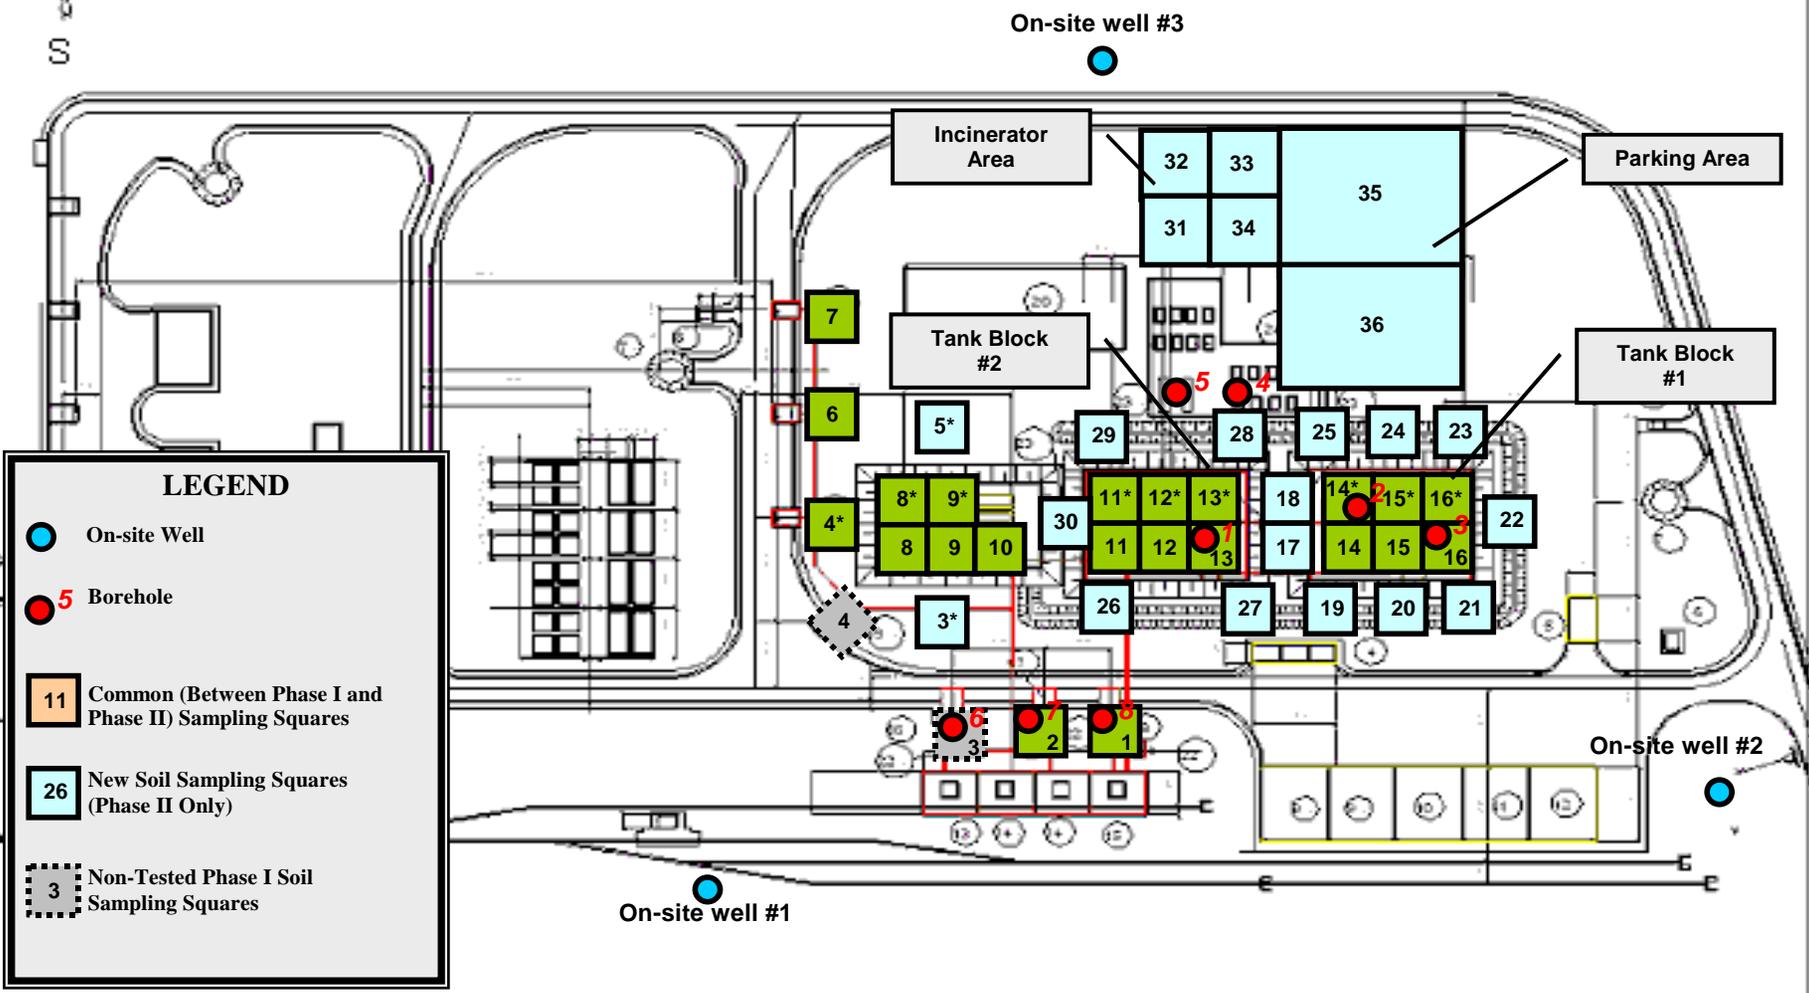
# Liubashevka RFSS Environmental Survey (Phase I and Phase II Comparison)
