Streamlined Remediation System Evaluation
Wash King Laundry Superfund Site
Pleasant Plains Township, Michigan

**WASH KING LAUNDRY SITE
PLEASANT PLAINS TOWNSHIP, LAKE COUNTY, MICHIGAN**

Report of the Streamlined Remediation System Evaluation
Conference Call Conducted for the Wash King Laundry Site
July 26, 2010

Revised Report
February 18, 2011

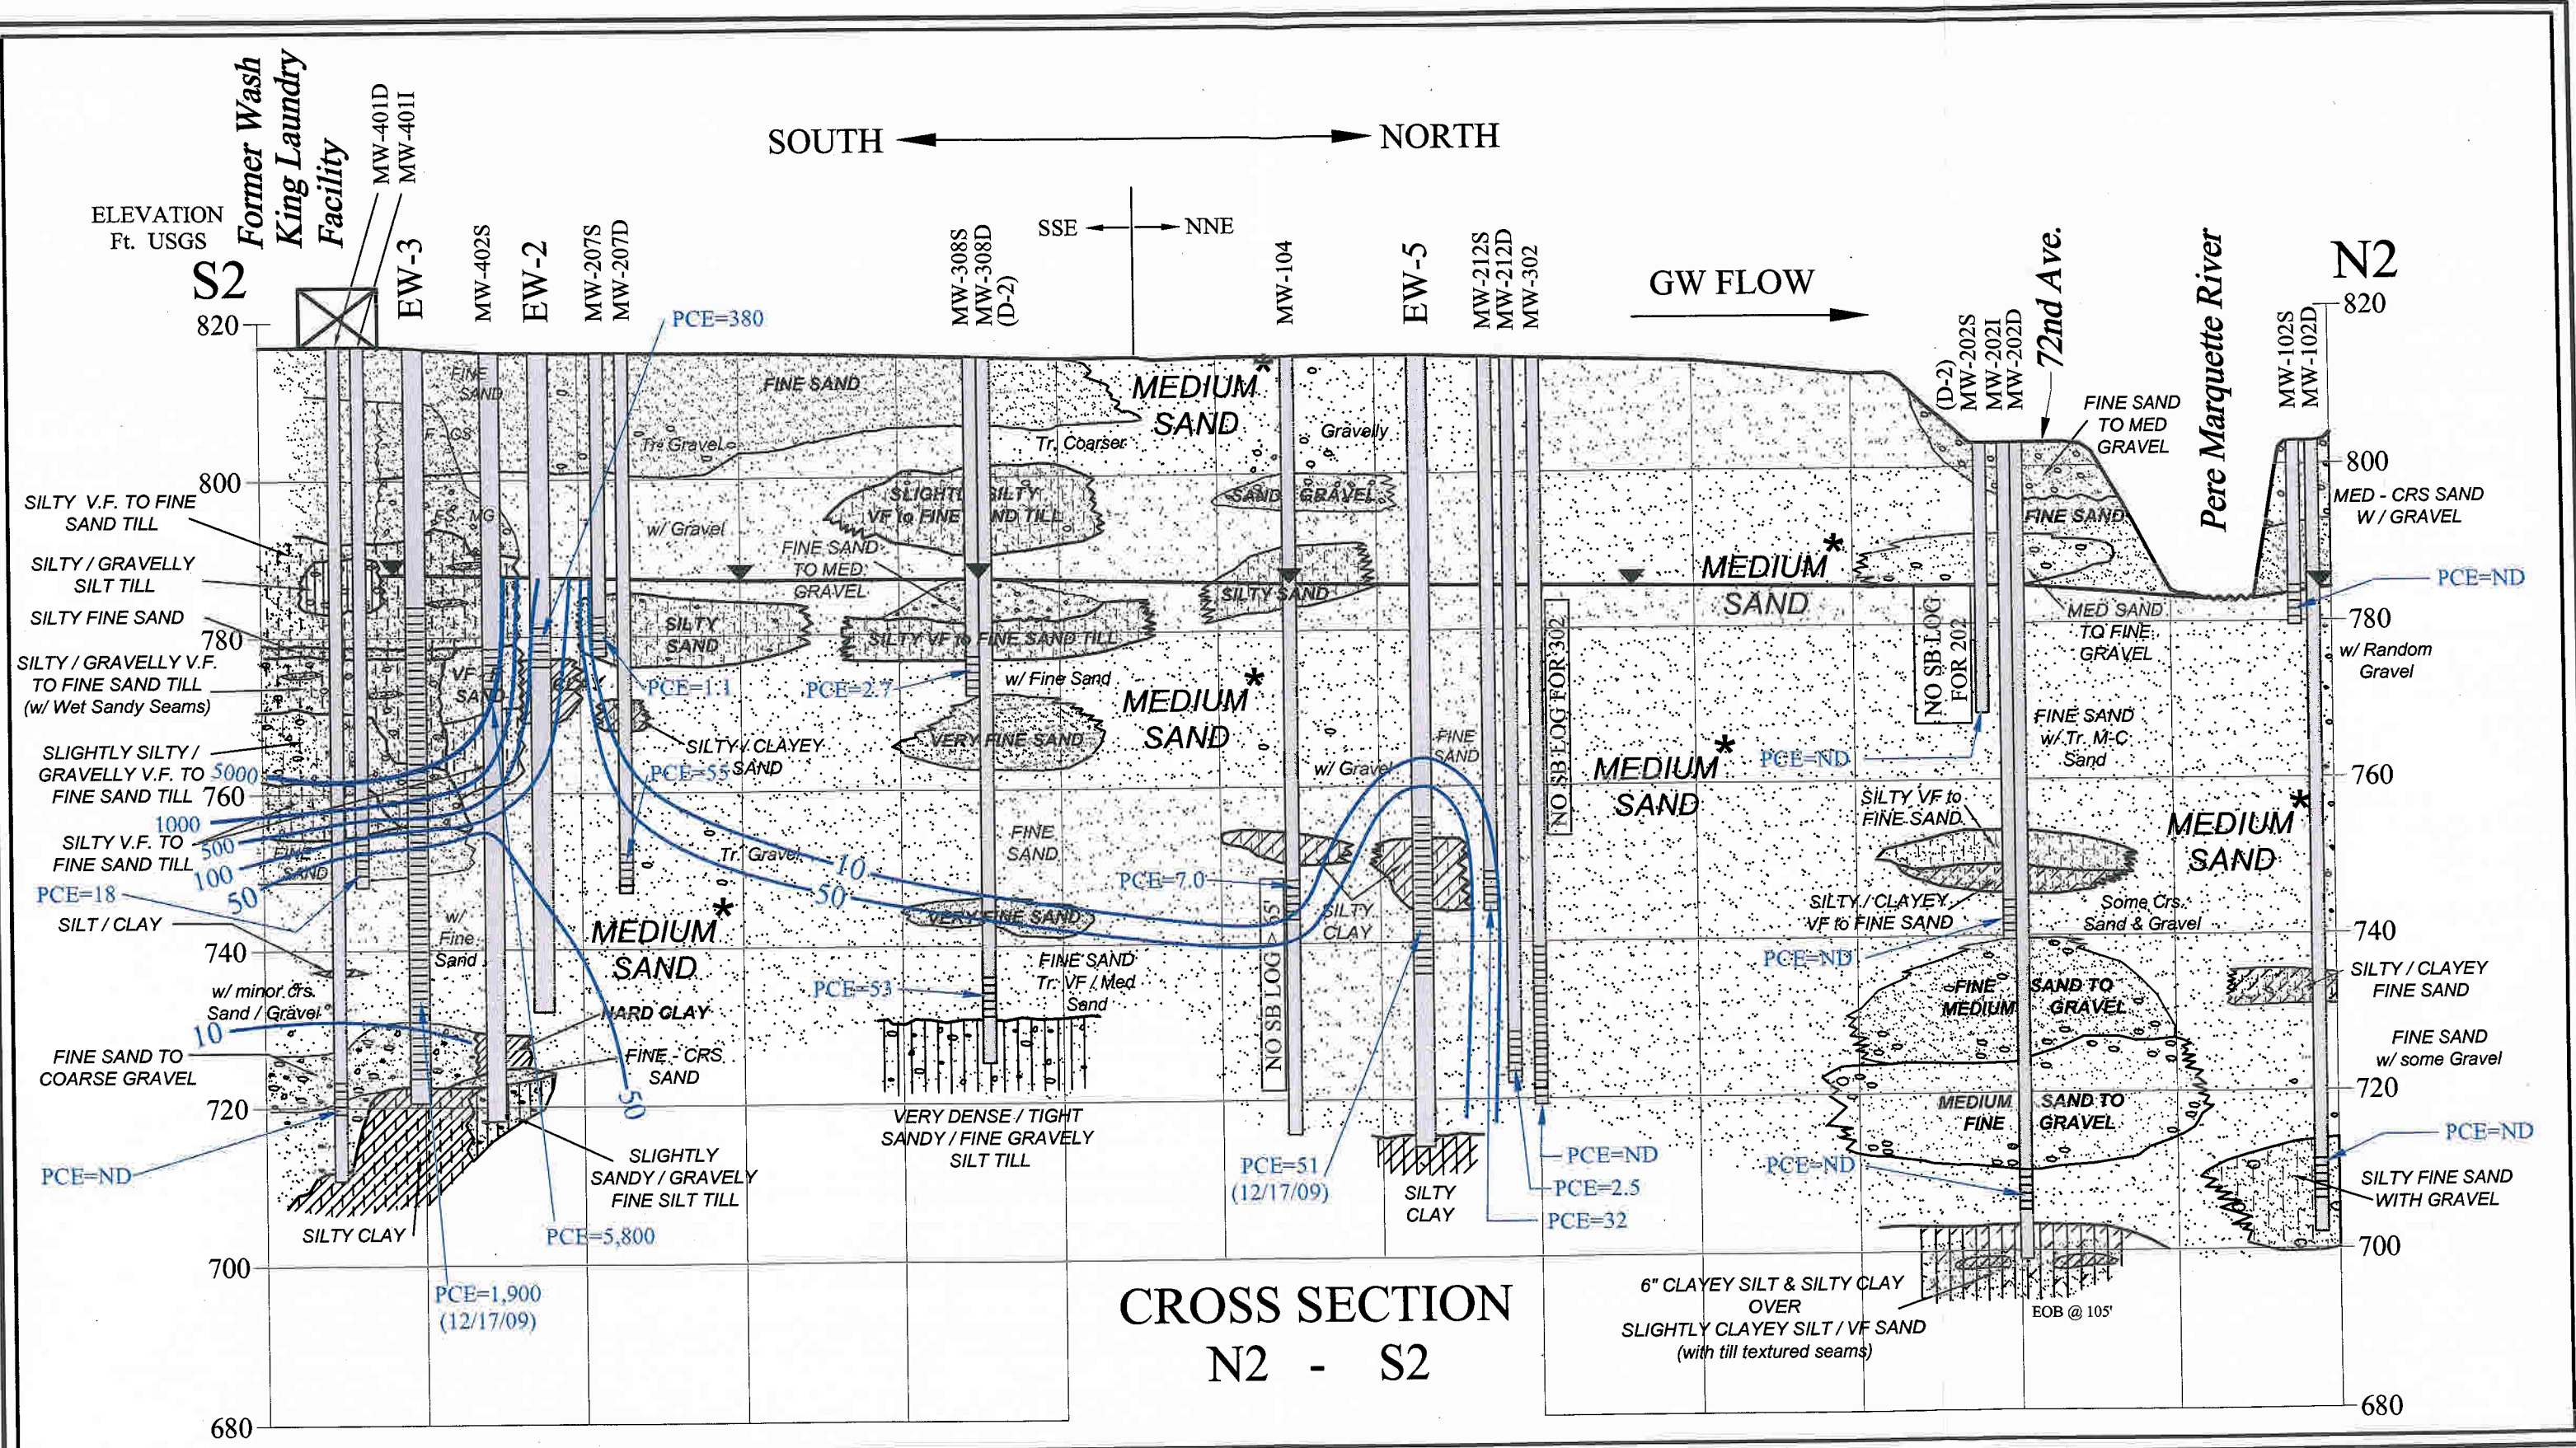
FIGURE 16 B

* Based on the cumulative historical soil boring logs, the predominant and/or average grain size description for the fluvial deposits is "Medium Sand". Lesser amounts of Silt, Fine and Coarse Sand, and Gravel were also described as being present at random depths and locations, as clarified in smaller print. Discrete low permeability layers (i.e. Clays, Silts, Very Fine Sands, or poorly sorted mixtures thereof [e.g. Fine-Grained Silts]), layers of Coarse Sand and Gravel, and in some cases Fine Sand, are mapped as distinct units.

SCALES:
 HORIZONTAL 1"=120'
 VERTICAL 1"=20'
