## **Appendix A**

### **The Standardized Precipitation Index at Hanford**

Pacific Northwest National Laboratory  
Richland, Washington

# **Prototype Hanford Barrier: Design, Enhanced Precipitation Test, and Controlled Burn Test**

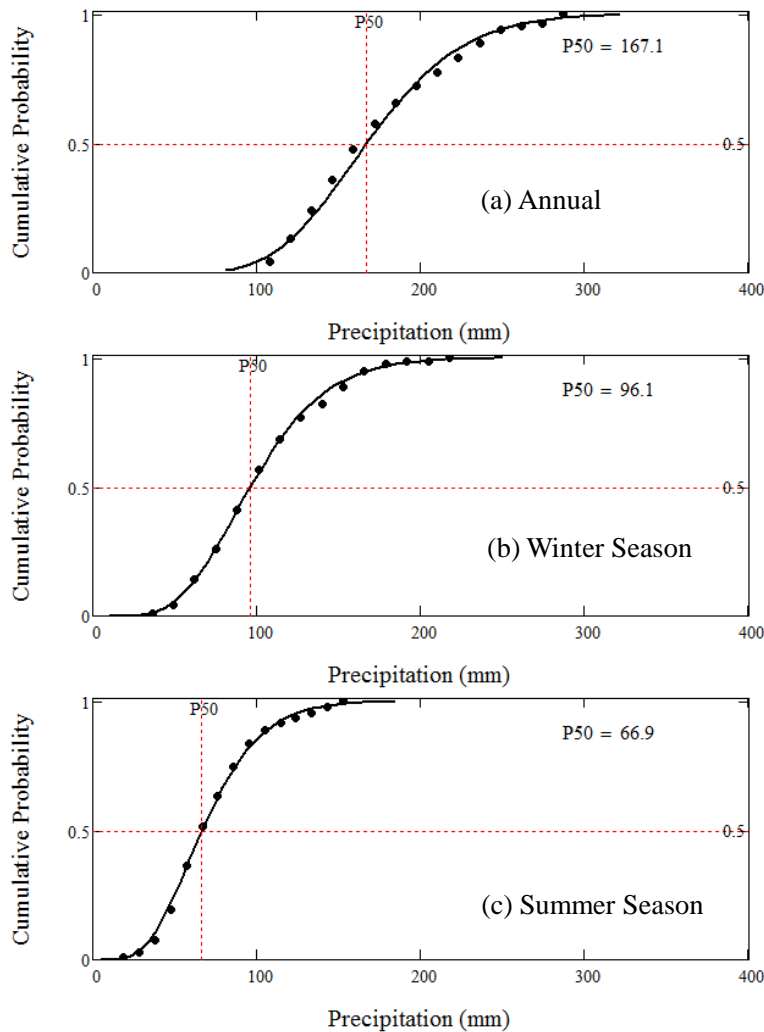
Figure A.2. The cumulative probability of precipitation. The symbols denote data and the curves the best fits of Eq. (A.4). The fitted parameters are summarized in Table A.3. P50 is the median precipitation.

Table A.4 gives the precipitation and SPI at different percentile level. For example, for the 99.9th percentile, there is only 0.1% chance (once in 1000 years) that the annual precipitation will be  $\geq 350.5$  mm or the winter precipitation  $\geq 253.0$  mm. It is noted that these estimated precipitations were estimated based on the 67-year precipitation record and hence are subjected to extrapolation uncertainty.

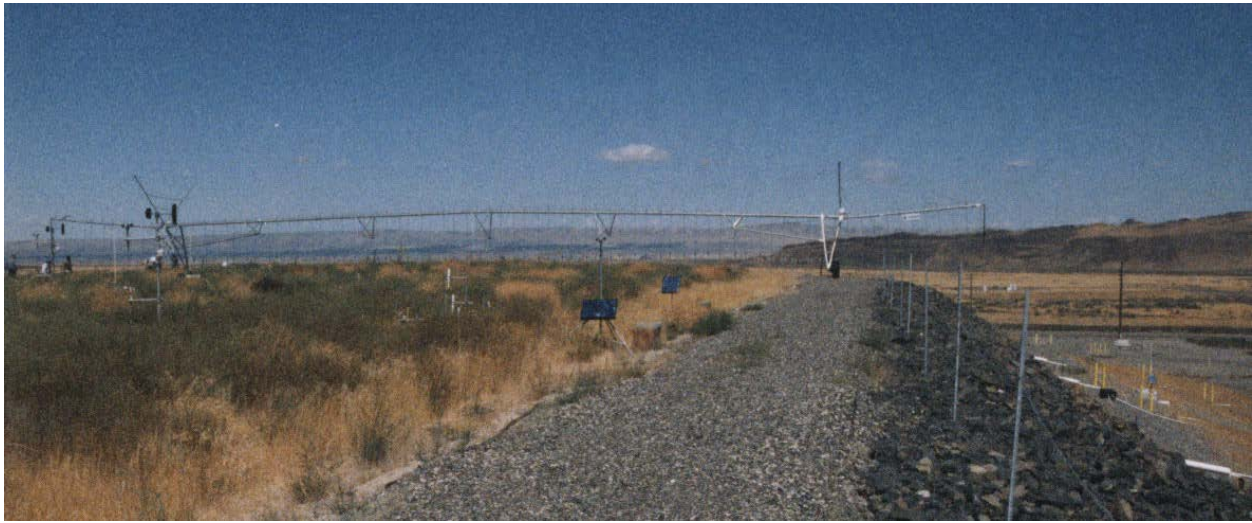
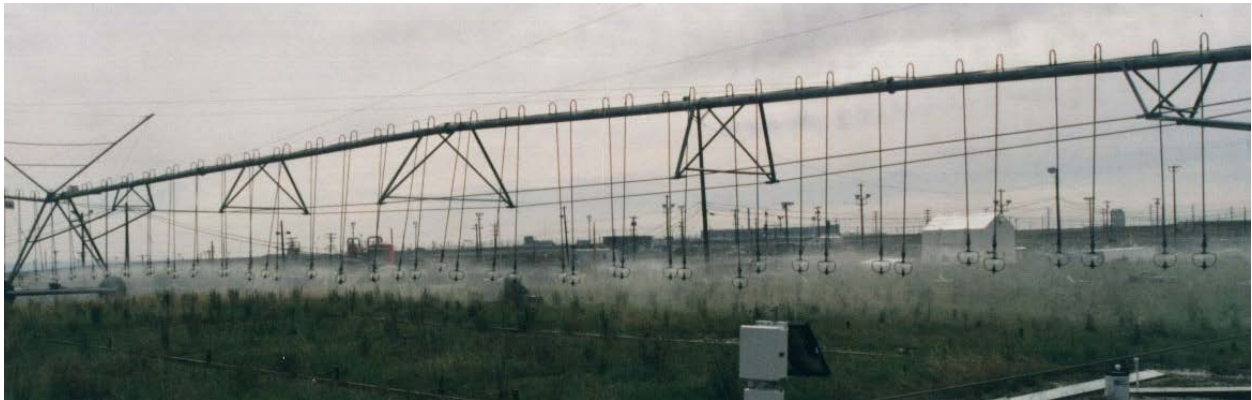
Figure B.8. The Lockwood linear-move sprinkler irrigation system. (a) The irrigation system spanned 43.9 m between road centers and had 10.4-m extension booms beyond the wheels to facilitate irrigation of the side slopes. (b) Water was delivered to outlets spaced 0.76 m apart along the distribution pipe. The Wobbler nozzles were within 0.91 m of the soil surface.

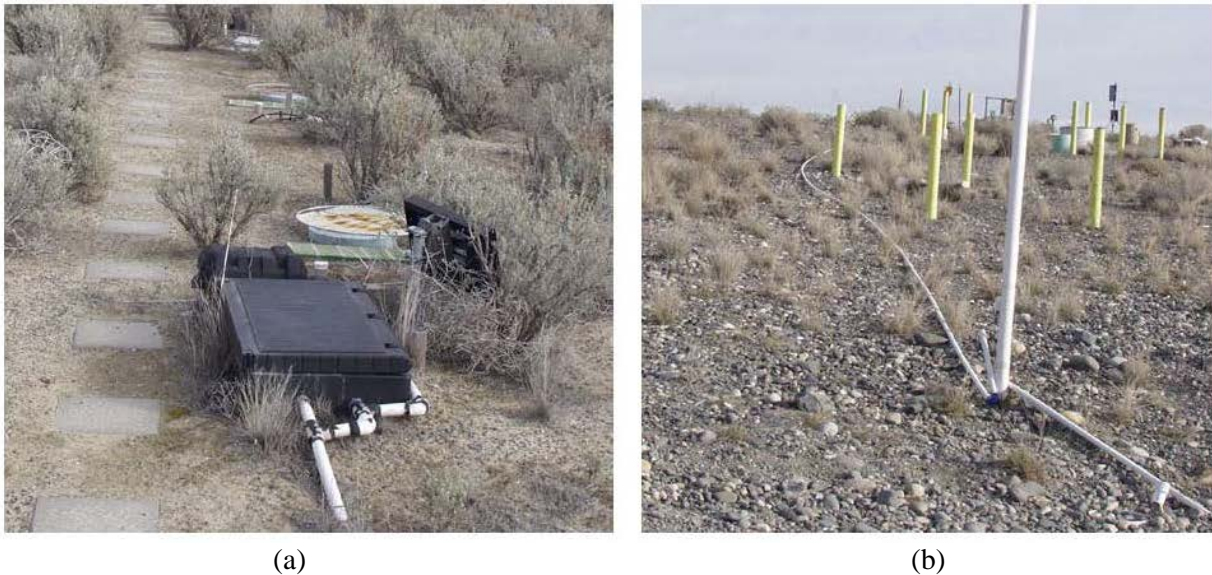
Figure B.10. Photographs of the barrier surface and gravel side slope showing examples of monitoring infrastructure, (a) instrument boxes containing dataloggers, and (b) conduits carrying communication cables for instruments, that needed protection during the controlled fire.

Preparing for the controlled fire included protecting monitoring systems, e.g., the polyethylene boxes housing the dataloggers (Figure B.10a) and the polyvinyl chloride conduit (Figure B.10b) for the anticipated temperature increases. To protect the monitoring system, instrument boxes were packed with fiberglass insulation, properly closed, and covered with fire blankets. Exposed conduit and cables were buried in trenches, where soil disturbance could be tolerated, or covered with an appropriate layer of dry soil or aluminum fire shelters. Six mini-rhizotrons, constructed of clear acrylic tube with outer PVC sleeves, were wrapped with a layer of fiberglass insulation and covered with an inverted galvanized pail.

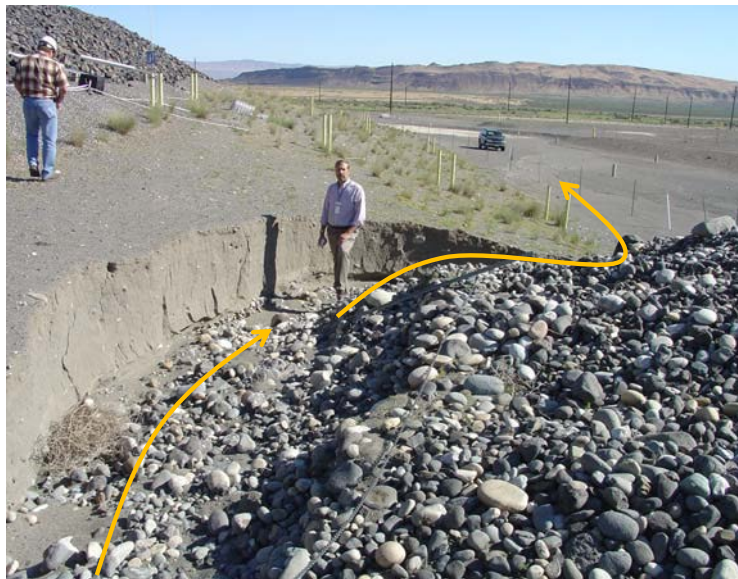
Figure B.11. North-facing photograph taken on June 16, 2004. The orange lines indicate the path and direction of the runoff.

After the completion of the PHB construction and revegetation in 1994, there was no significant maintenance of the PHB, other than instrumentation, except to fill a badger hole that was about 0.6-m deep with a 0.3-m diameter.<sup>1</sup> However, there was a major repair away from the southeast side of the PHB riprap side slope. In May 2004, after severe thunderstorms, runoff water from the elevated BY-BX Tank Farm surface (southeast to PHB) flowed down-gradient to the region between the tank farm and the PHB, eroding a channel about 1.1 m deep at the base of the east side of barrier side slope (Figure B.11). The channel extended into the sandy subgrade fill layer of the riprap toe slope. All repairs were completed in fiscal year 2005 (Figure B.12b).

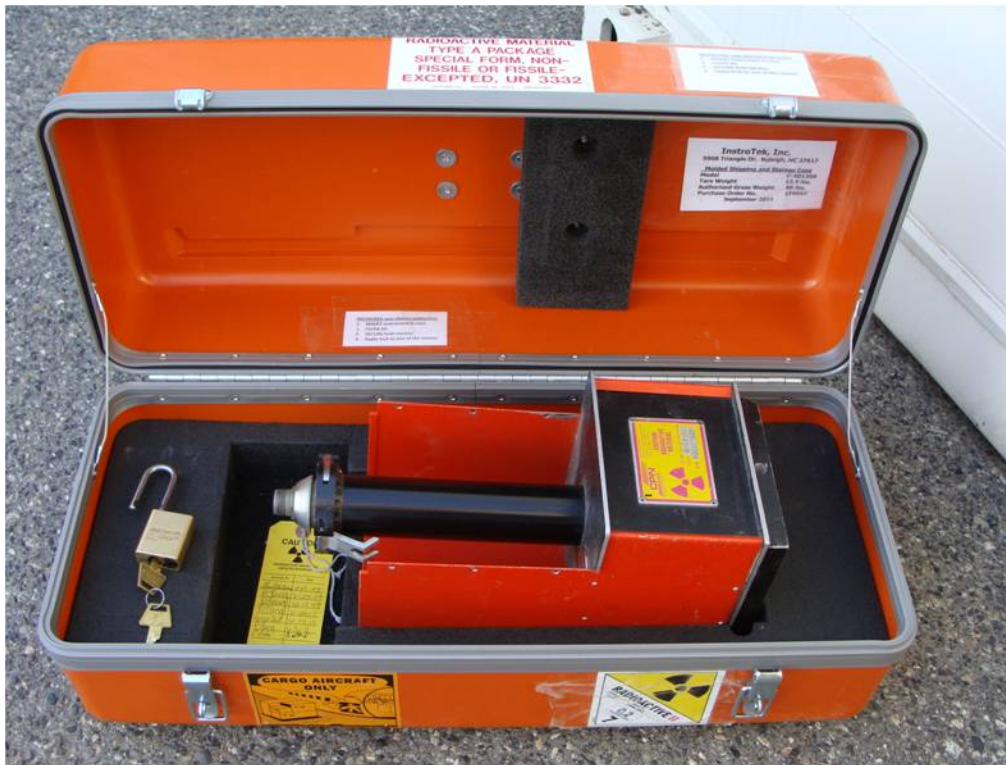
**Figure C.3.** A 503DR Hydroprobe for soil moisture logging.

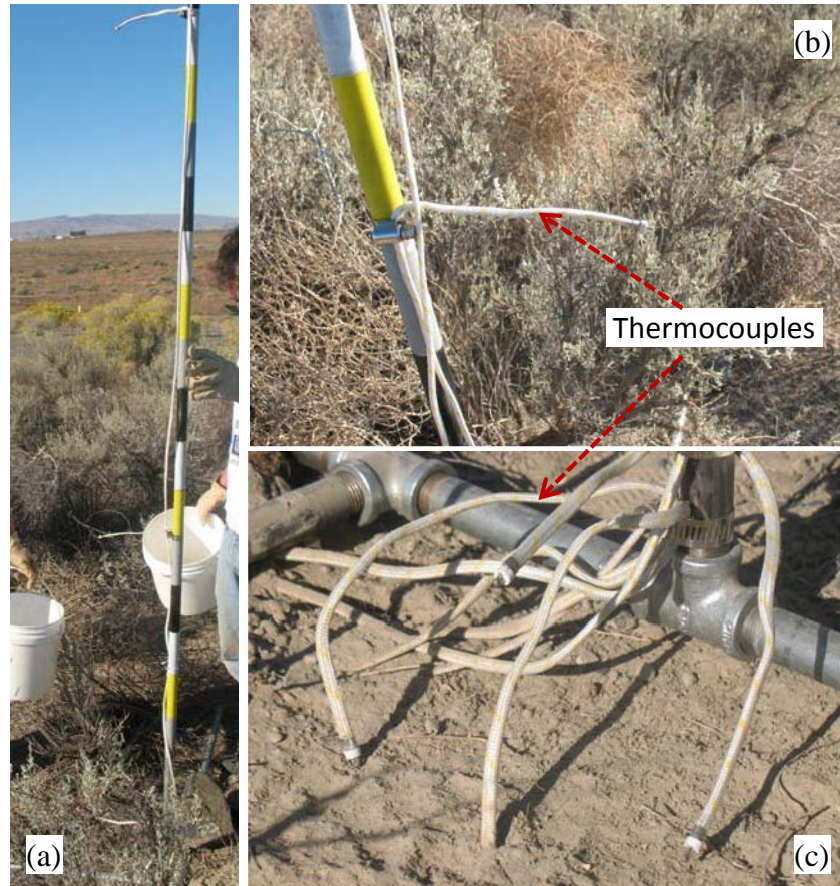
**Figure C.12.** Temperature monitoring system of the controlled fire. (a) A fire pole was used to measure flame characteristics and to secure thermocouples; (b) thermocouples were installed 1.5 cm deep, at the ground surface (0 cm), and at heights of 1, 10, and 30 cm; and (c) thermocouples were installed at heights of 100 and 200 cm.

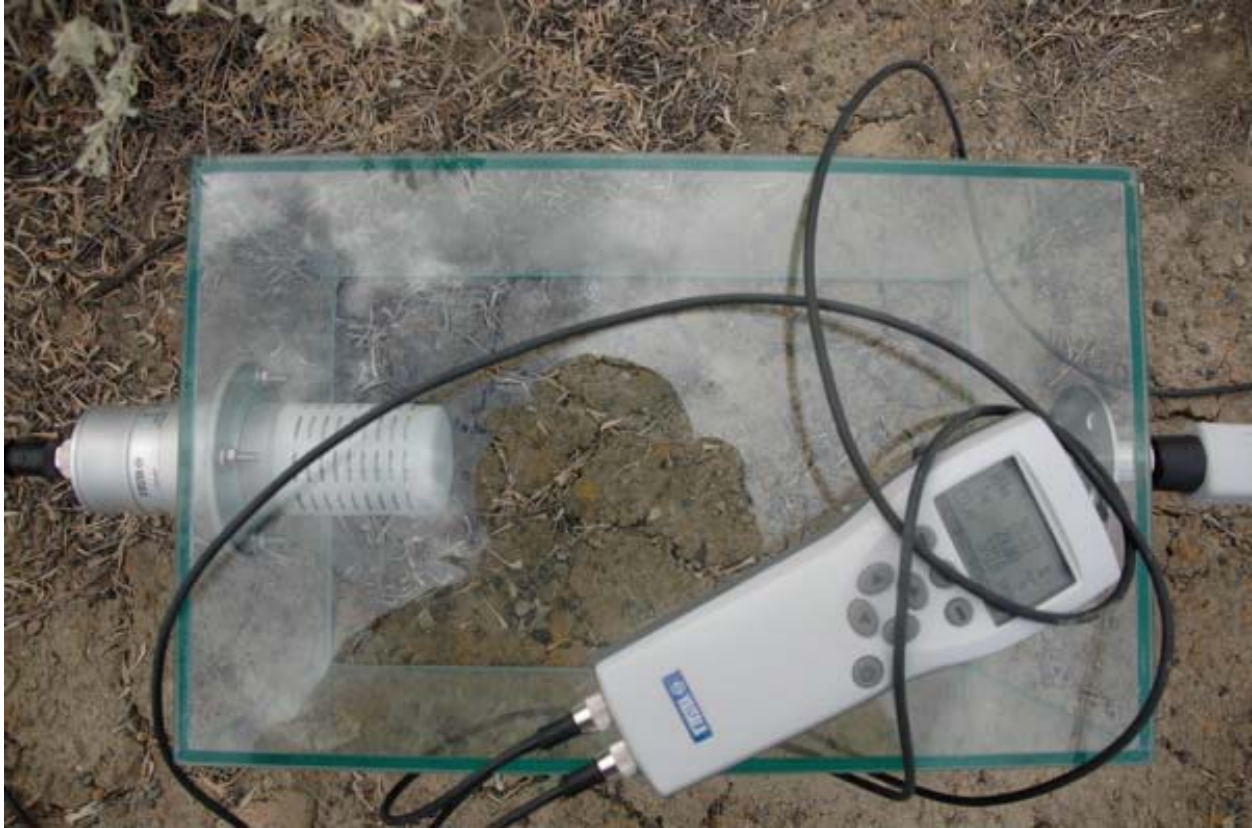
**Figure C.14.** Static diffusion chamber with sensors and readout device.

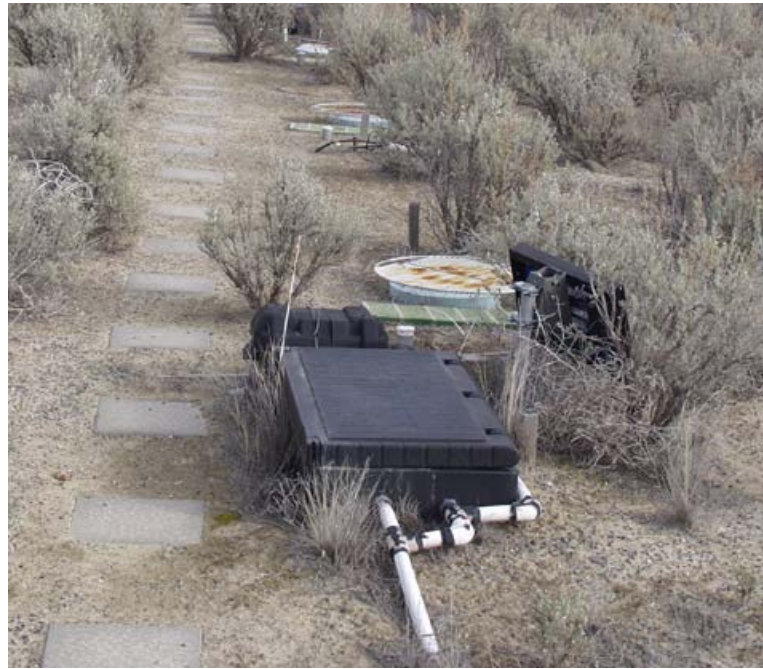
Figure C.15. The conduits for wires and enclosure for the dataloggers and barriers.

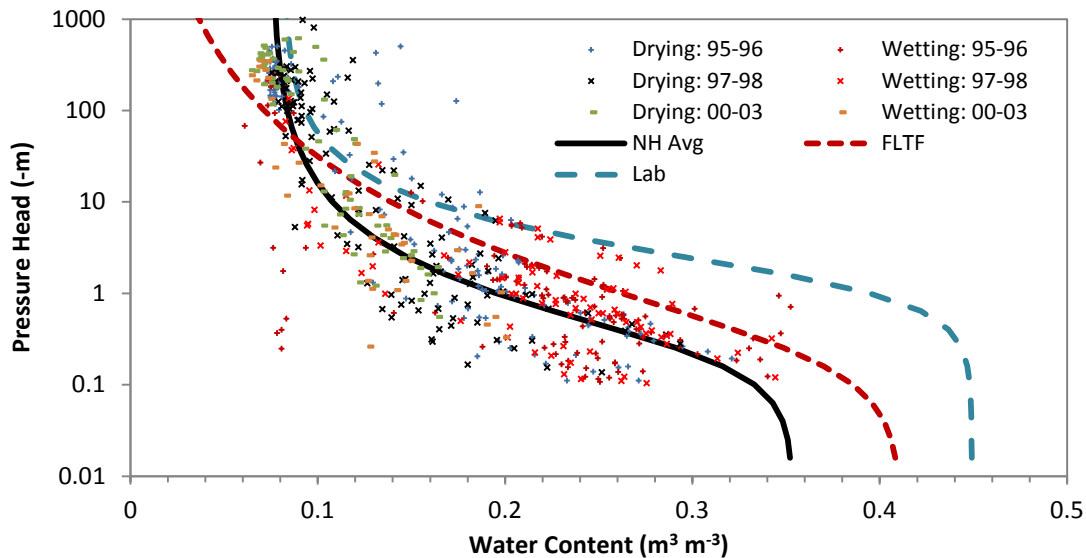
Figure E.4. Comparison of observed soil water retention at the 0.45-m depth and model predictions. There were 583 observations in the plot.

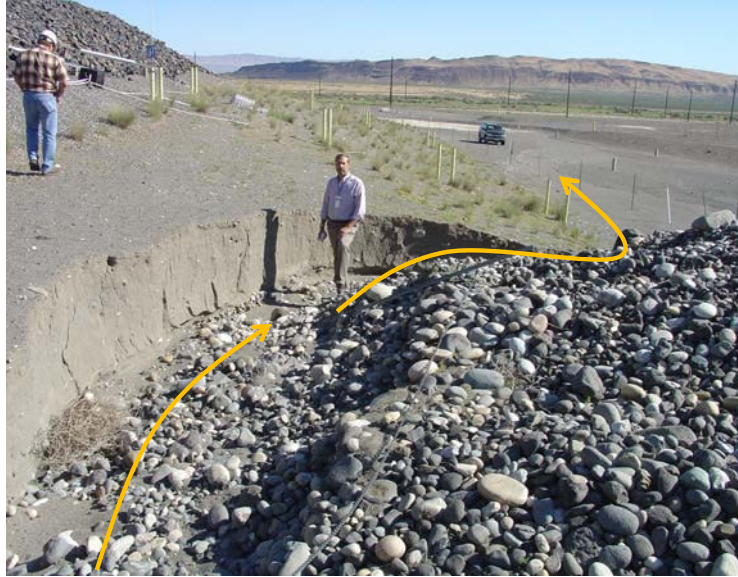
Figure I.9. North-facing photograph taken on June 16, 2004. The orange lines indicate the path and direction of the runoff water in May 2004 after severe thunderstorms.

After the completion of the PHB construction and revegetation in 1994, there was very little maintenance at the PHB, other than instrumentation, except the filling of an animal hole that was about 0.6 m deep with a 0.3 m diameter. In May 2004, after severe thunderstorms, runoff water from the elevated BY-BX Tank Farm surface (southeast to the PHB) flowed down-gradient to the region between the Tank Farm and the PHB, eroding a channel about 1.1 m deep at the base of the east side of barrier side slope (Figure I.9). The channel extended into the sandy structural fill layer below the riprap side slope. A repair was made in fiscal year 2005.

The occurrence of the flood indicates that the topology around the barrier, the resultant run-on/runoff, as well as the surrounding surface hydrology can play an important role to the integrity of the barrier and hence protecting the toe of the riprap side slope needs to be considered in the design. The current side slopes have constant gradients (10:1 in the west and 2:1 in the east), while natural analog indicate that a more stable slope usually has a convex shape in the upper portion and a concave shape near the toe (Schor and Gray 2007). The low elevation areas around the barrier will have high probability to be future runoff channels and hence proper protection (e.g., with gravels and vegetation) is needed for soil erosion.

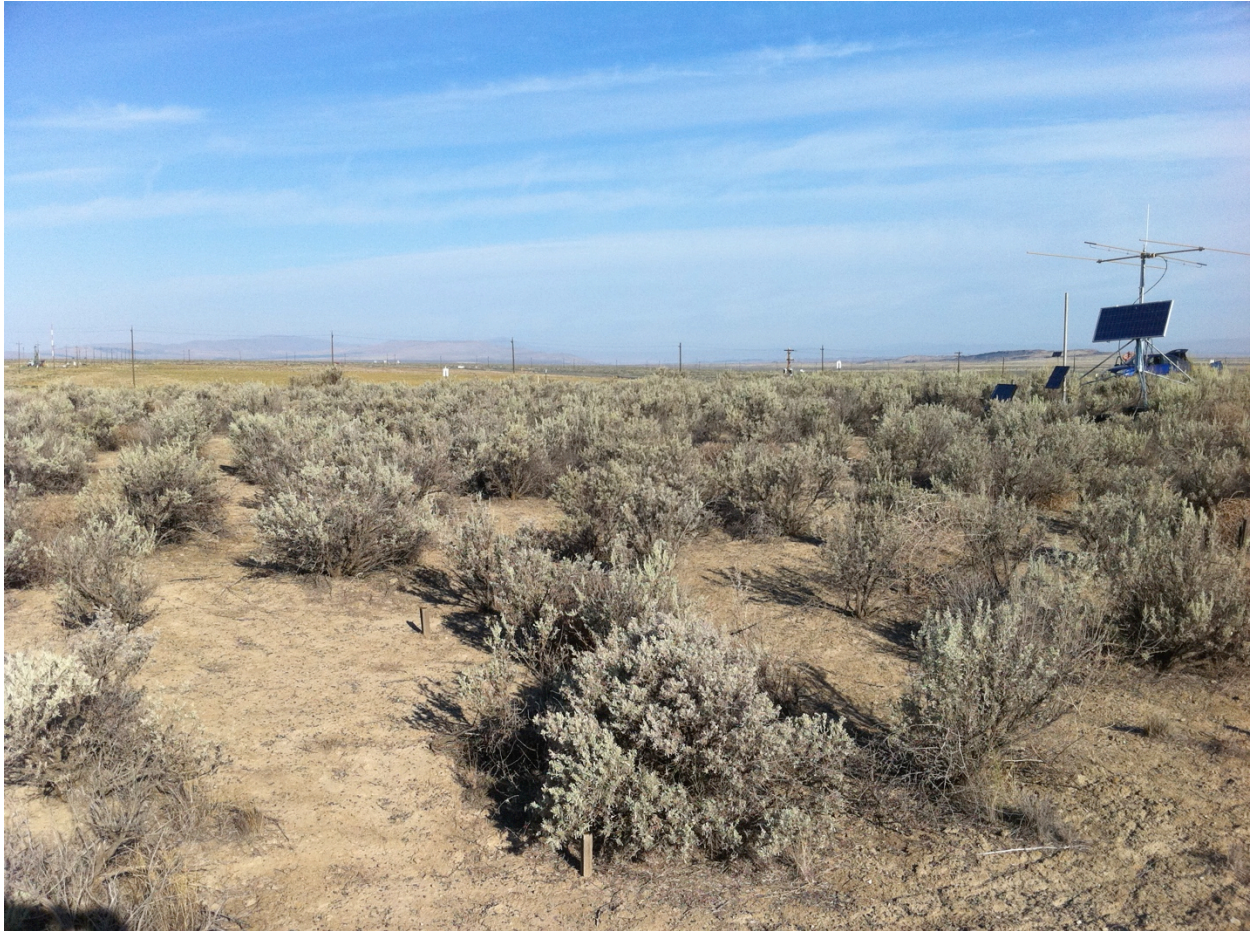
Figure J.7. Prototype Hanford Barrier cover dominated by *Artemisia tridentata* in 2010, 16 years after establishment on the unburned section of the surface.

Sagebrush dominates the unburned section of the Prototype Hanford Barrier (Fig. J.7).

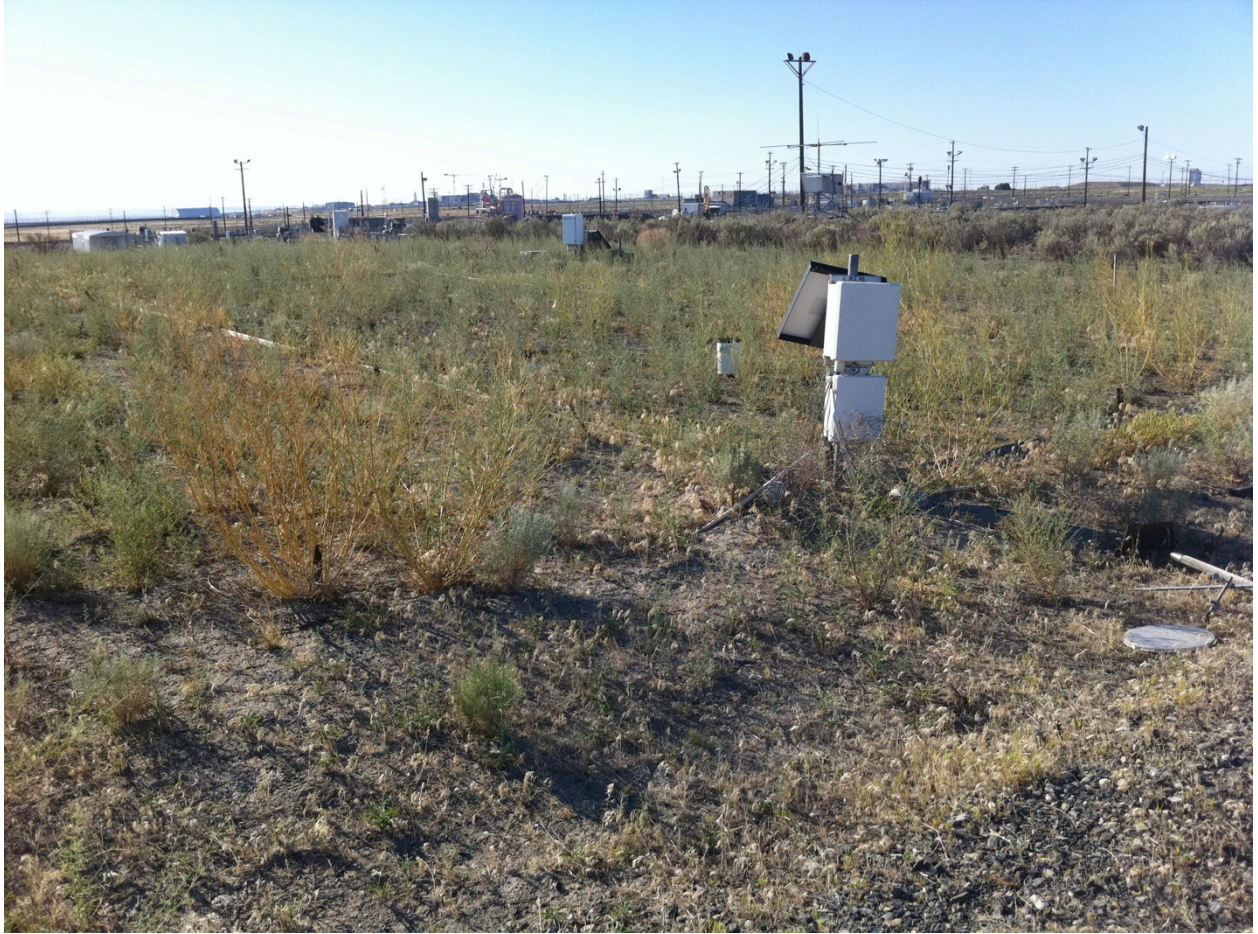
Figure J.8. Vegetation cover on the north section in 2010 dominated by biennial forb, *Machaeranthera canescens*.

After the prescribed fire on the north section of the barrier, the deep-rooted *A. tridentata* shrub was no longer dominant. *Machaeranthera canescens*, a biennial forb with roots growing to a depth of 1.55 m (Klepper et al. 1985), dominated in 2010 (Fig. J.8) and 2011 (Fig. J.9).

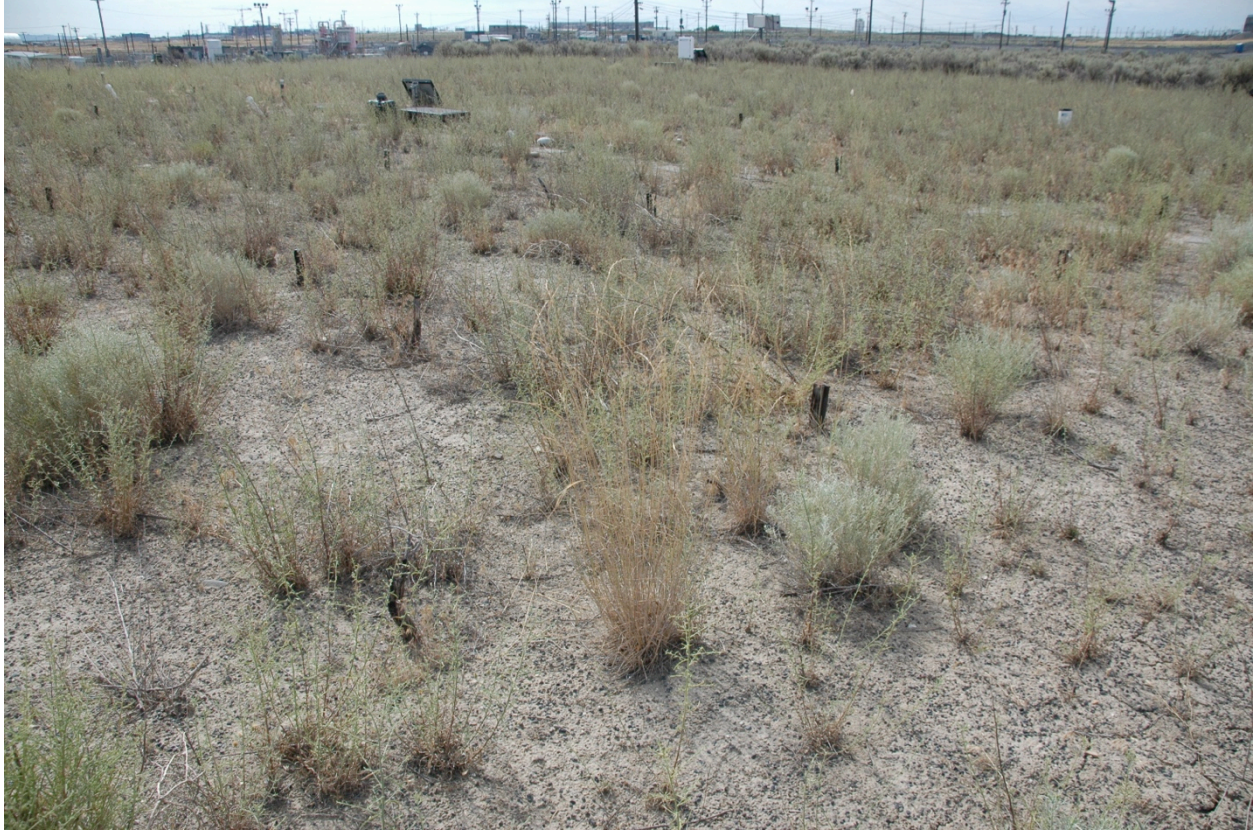
Figure J.9. Vegetation cover on the north section in 2011 dominated by biennial forb, *Machaeranthera canescens*.

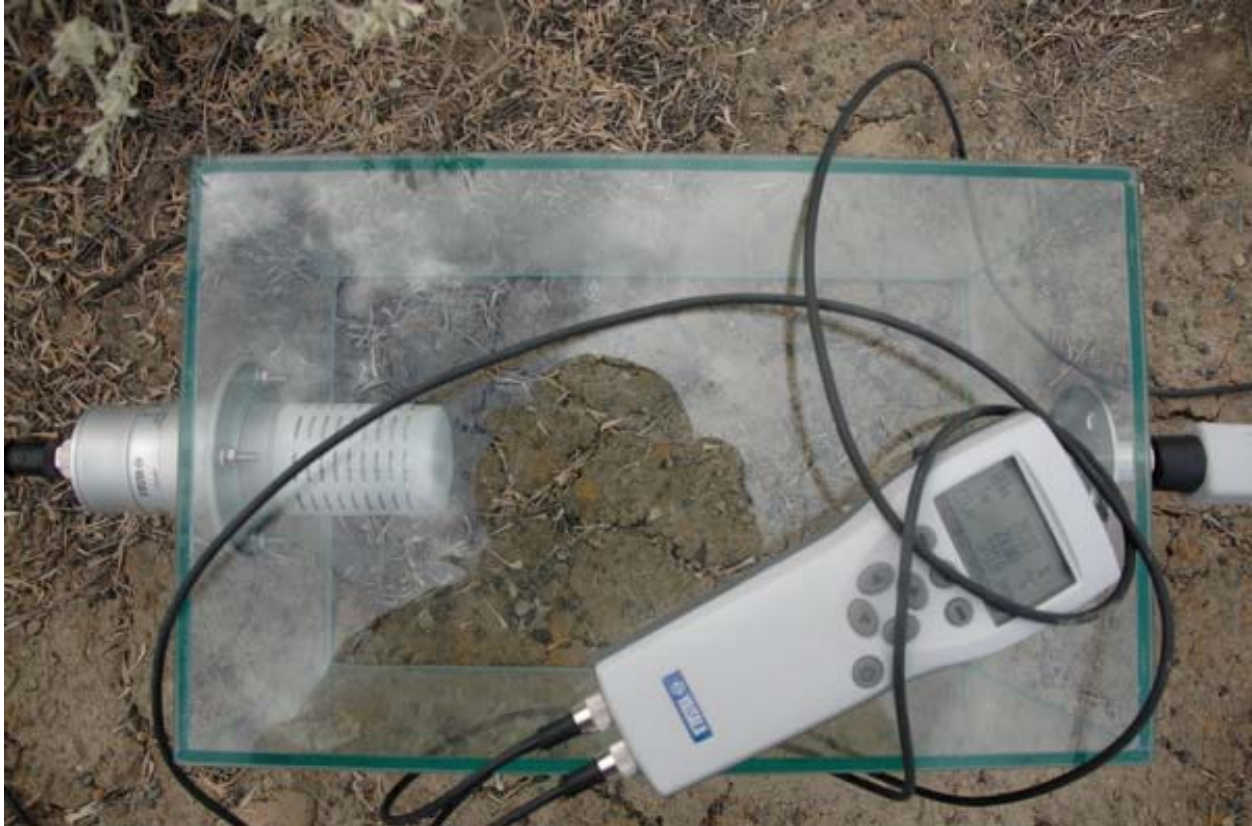
Figure K.1. Static Diffusion Chamber with Sensors and Readout Device

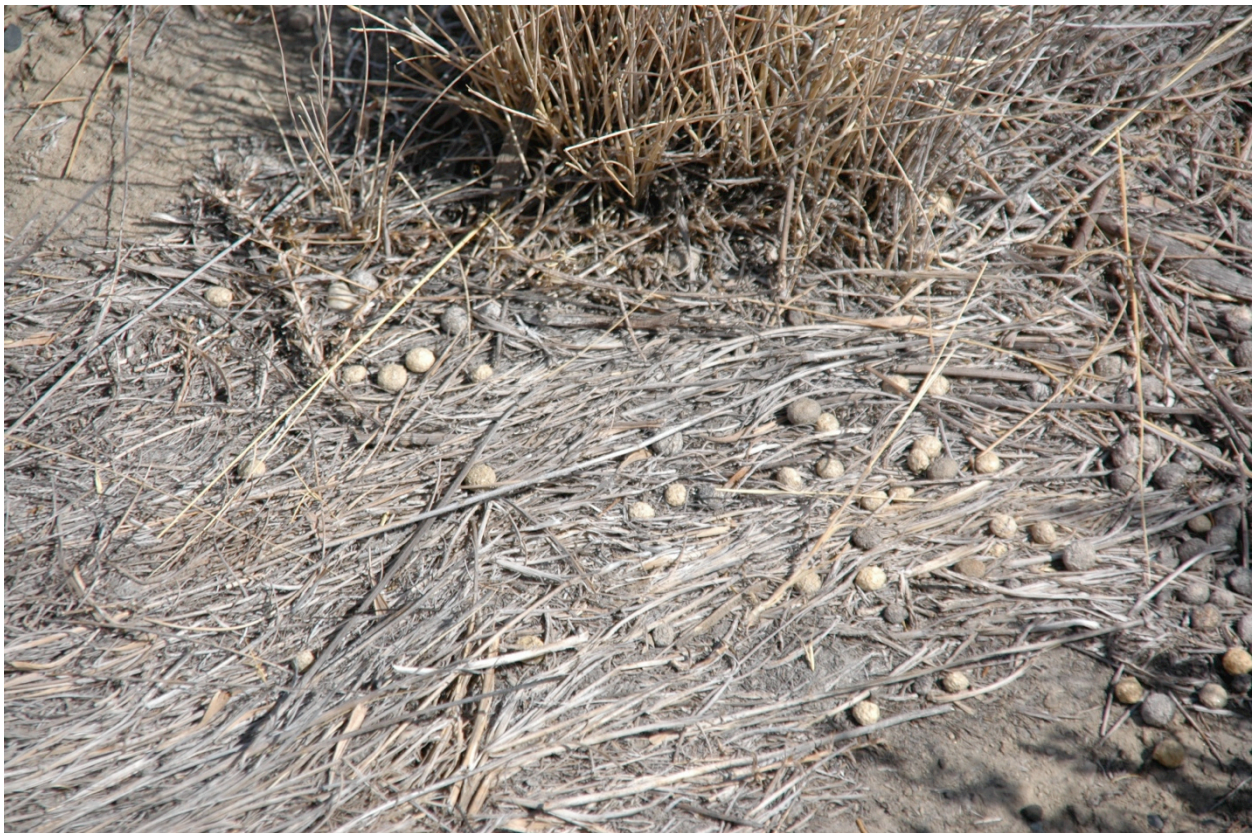
Figure L.1. Rabbit droppings in association with high grass cover in the northeast corner of the barrier surface.

In 2007, animal use of the surface was evident and widespread. Rabbit use, indicated by the presence of droppings, was most evident in the northeast corner of the north section of the barrier where grass cover is highest (Figure L.1). Numerous small (<2 cm diameter) holes were observed on the barrier surface. Larger holes were observed in 14 of 20 plots with a total of about 31 holes in the 20 plots (0.172 m<sup>-2</sup>). Based on the sample, 70% of the observation plots had animal burrows. These holes (Figures L.2 and L.4), dug by insects and small mammals, were distributed throughout the surface with little obvious pattern associated with disturbance, concrete, instruments, or other items on the surface. Eleven holes were measured and were 2 to 9 cm wide and up to 30 cm deep. Average hole diameter was  $3.9 \pm 0.8$  cm, area was  $13.8 \pm 5.5$  cm<sup>2</sup>, depth was  $12 \pm 2.6$  cm, and volume was  $164 \pm 75$  cm<sup>3</sup>. A few mounds were observed on the north edge of the barrier surface. No darkling beetles or other burrowing insects were noted on the surface except ants on the north edge of the barrier surface.

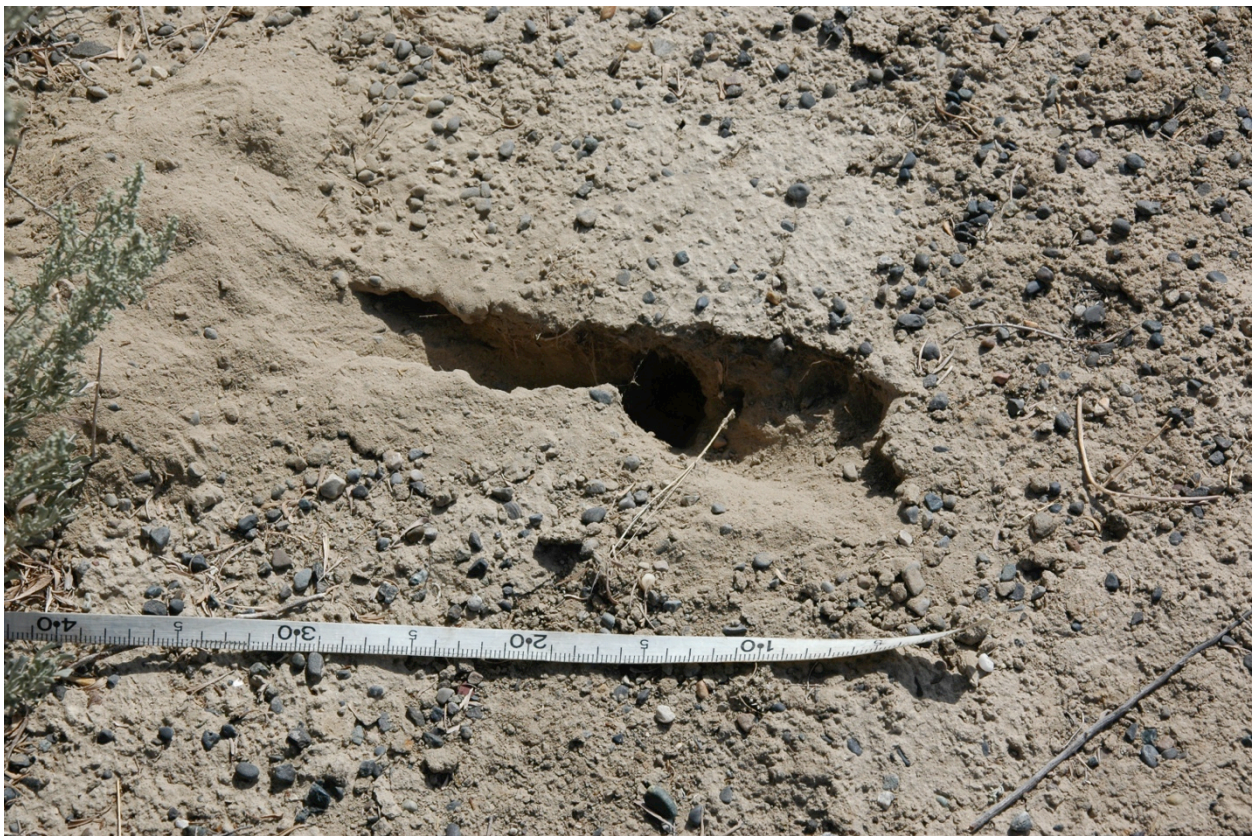
Figure L.2. Small Animal Hole on the Barrier Surface. Note recent digging activity in the upper left hand corner.

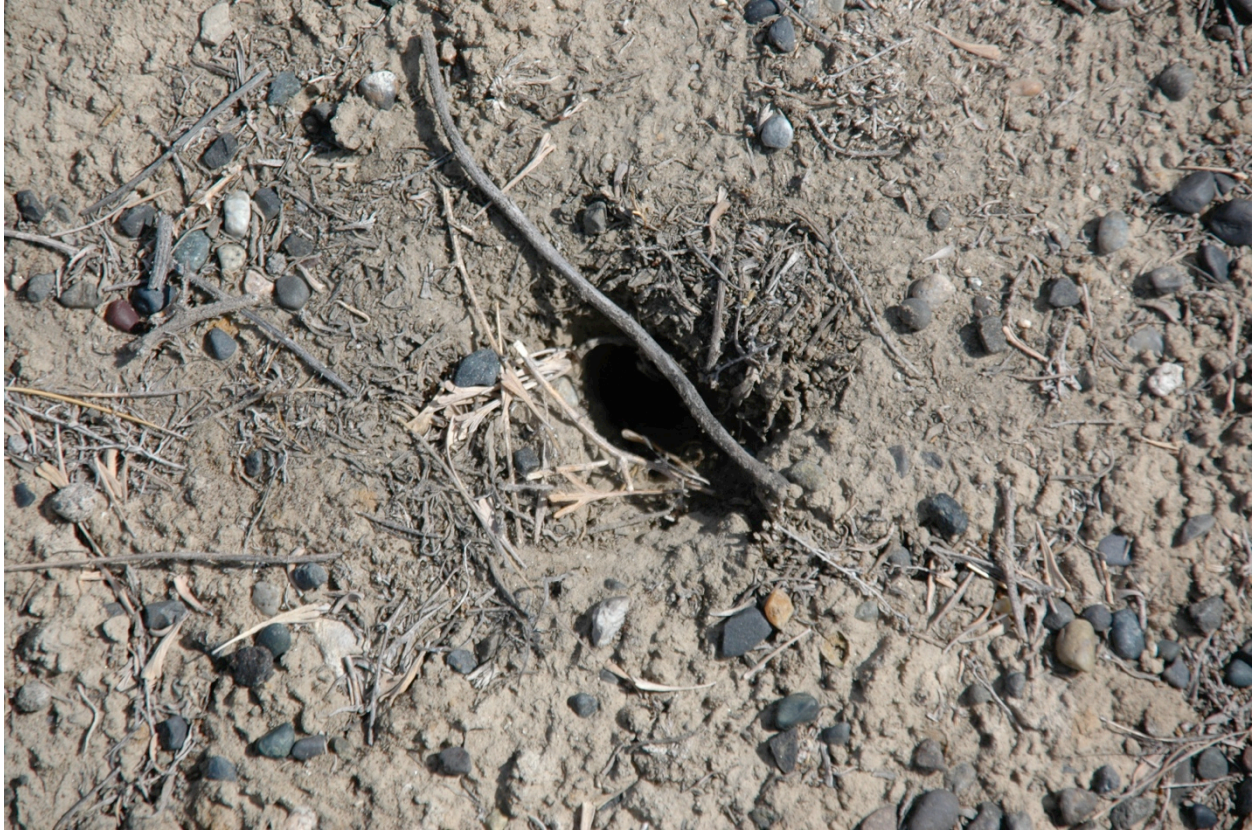
Figure L.4. Typical Animal Hole on the Surface of the Barrier.

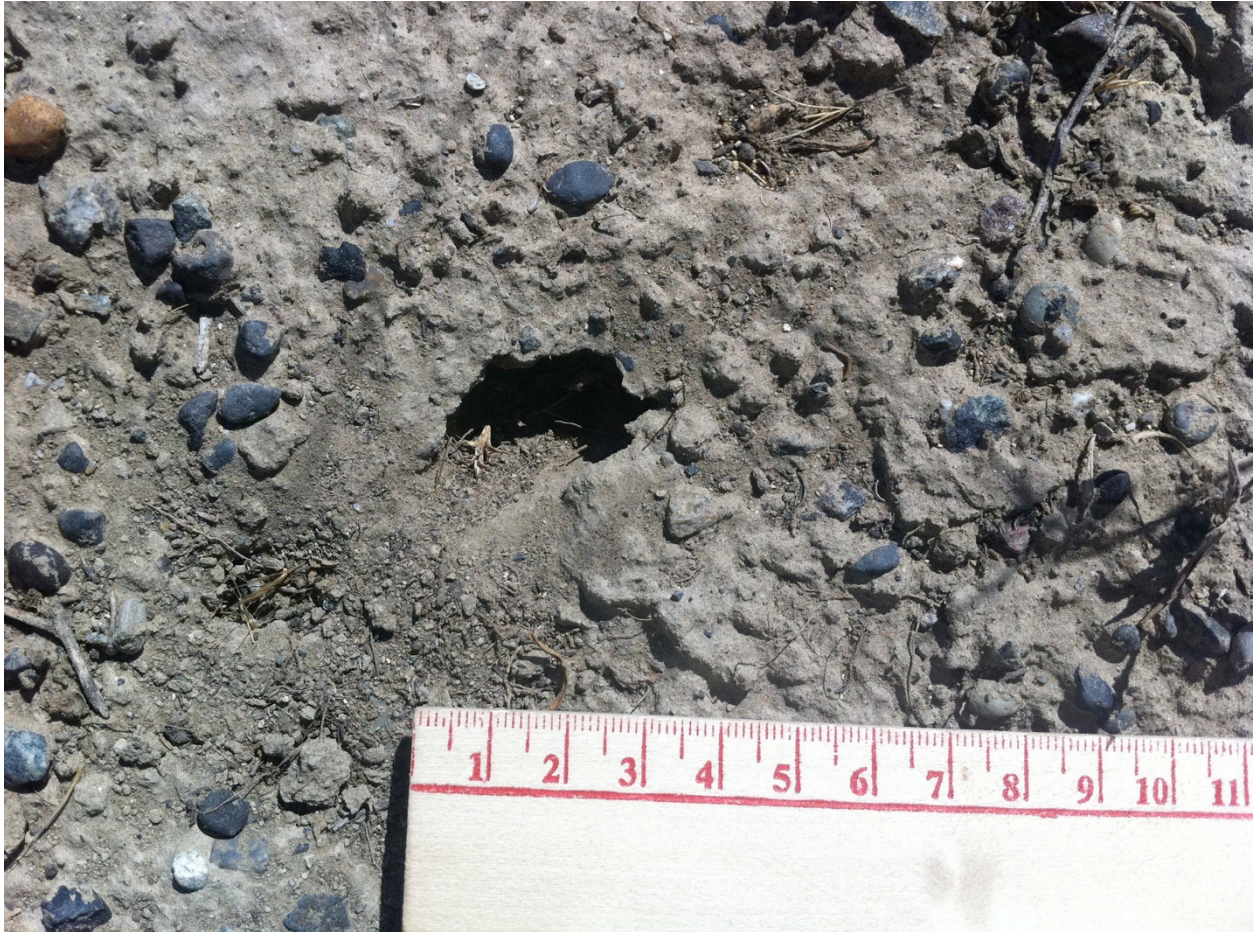
Figure L.5. Small Animal Hole on the Burned Section of the Barrier Surface.

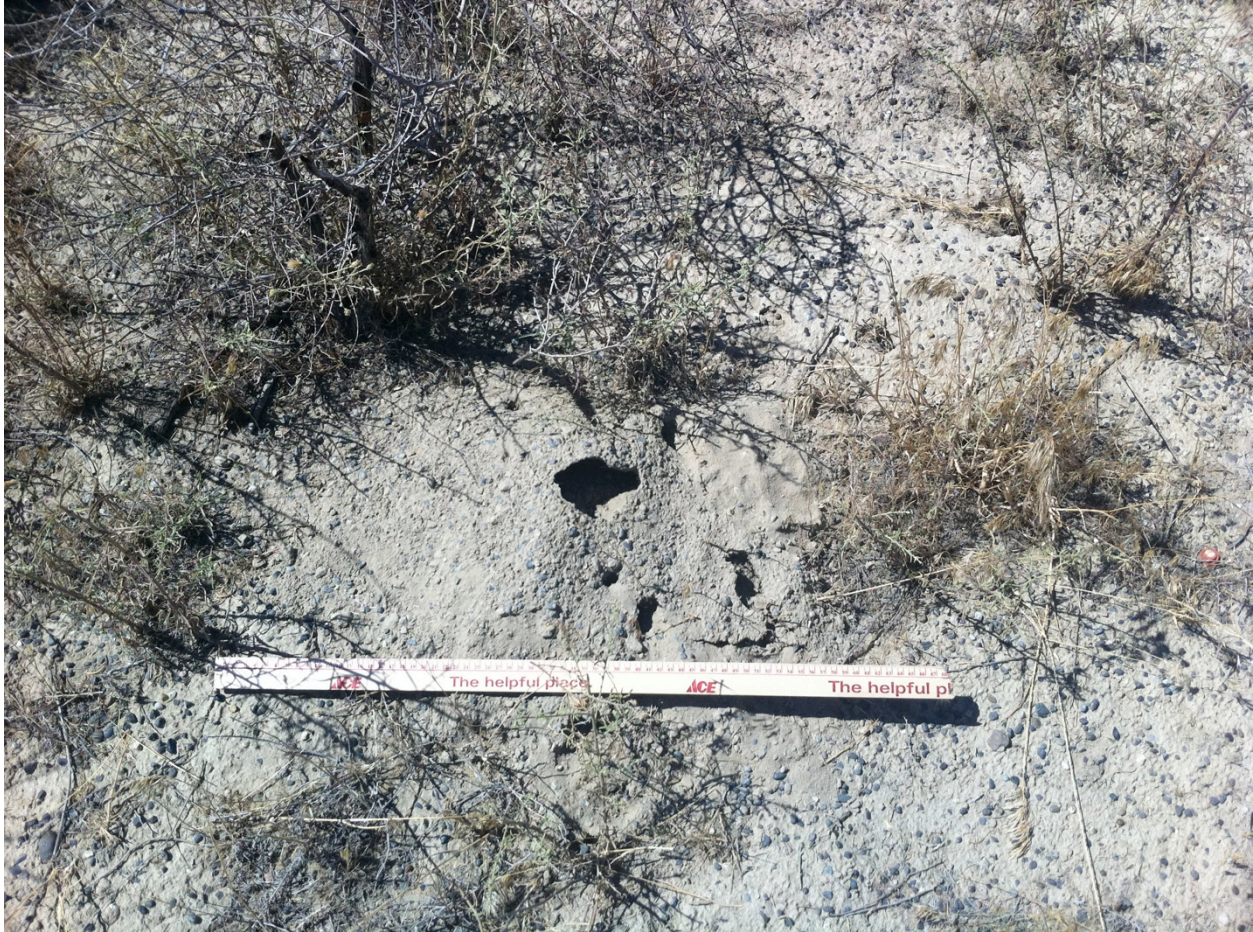
Figure L.6. Large Animal Hole with Five Nearby Holes on the Burned Section of the Barrier Surface.

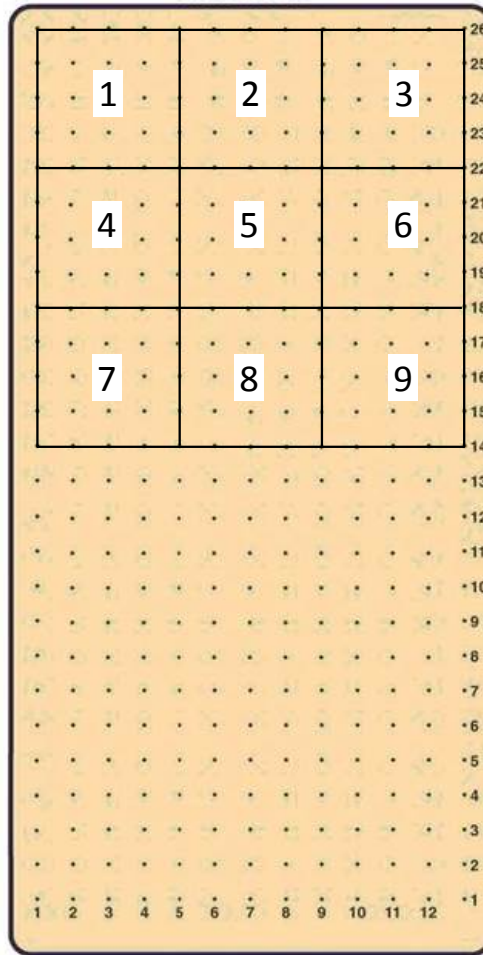
Figure M.1. Schematic plan view of the barrier's surface showing the  $3 \times 3$  m grid and the nine (1 through 9)  $12 \times 12$  m plots to be used for comparing effects of fuel loads on fire intensity.

Responses to the fire potentially vary according to the intensity of the fire, and the site was configured and instrumented to permit monitoring. The simulated fire was limited to the north section of the barrier, which was divided into nine 12-m x 12-m plots (Figure M.1). Nine flame-height poles fitted with thermocouples (Figure M.2) were installed at the center of each plot for visual observation of flame height and to quantify fire intensity during the fire. Flame height was used to estimate radiation intensity of flames, which is directly related the rate of spread of a fire (Johnson and Miyanash 2001). Two theoretical definitions of flame height are (1) the height where flames reach the maximum temperature and (2) the vertical distance from the flame base or ground to the time-averaged yellow flame tip (Johnson and Miyanash 2001). During the fire, the scorch height was measured by recording the elevation of the scorch marks on flame-height rods mounted within each plot. Flame height poles were constructed of galvanized pipe and painted alternating colors to permit easy determination of scorch height. The poles were painted in 10-cm sections from 57 cm to a height of 297 cm above ground. Each unit was self-supporting, allowing installation without the need to core into the barrier surface.

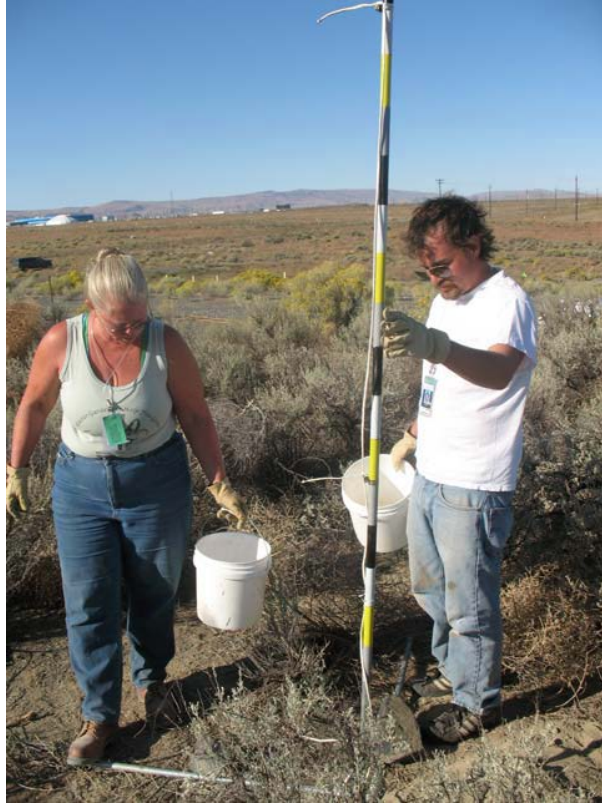
Figure M.2. Photograph of fire pole used to measure flame characteristics and to secure thermocouples (After Figure 2.7 of Ward et al. 2009a).

The degree of fire intensity was scored on a scale of 1 to 5, with little or no effect (bright white) assigned a value of 1 and the darkest carbonized areas assigned a value of 5. White painted strips were examined every 40 cm for seven assessments on each pole. Values were averaged on each pole, and the pole average was used to create a fire intensity map. To verify flame heights inferred from ocular observation and to track soil temperatures, Type-K thermocouples (ThermoWorks, Lindon, UT) were installed on the flame height rods at 1.5 cm (0.6 in.) below the soil surface and at 0 cm (Figure M.3a). In addition, thermocouples were installed at five additional heights above the surface (Figure M.3b): 1 cm (0.4 in.), 10 cm (4 in.), 30 cm (12 in.), 100 cm (39.4 in.), and 200 cm (78.7 in.). A thermocouple wire can be seen mounted at a right angle to the pole at a height of 2 m (Figure M.3b). Each of the 63 thermocouples was attached to a HOBO data-logger (Onset, Bourne, MA) to record temperatures. Temperatures were measured once per second starting 3 hours before the fire until about 9 hours after the fire. The resulting data were used to map the relative intensity of the fire across the burned surface.

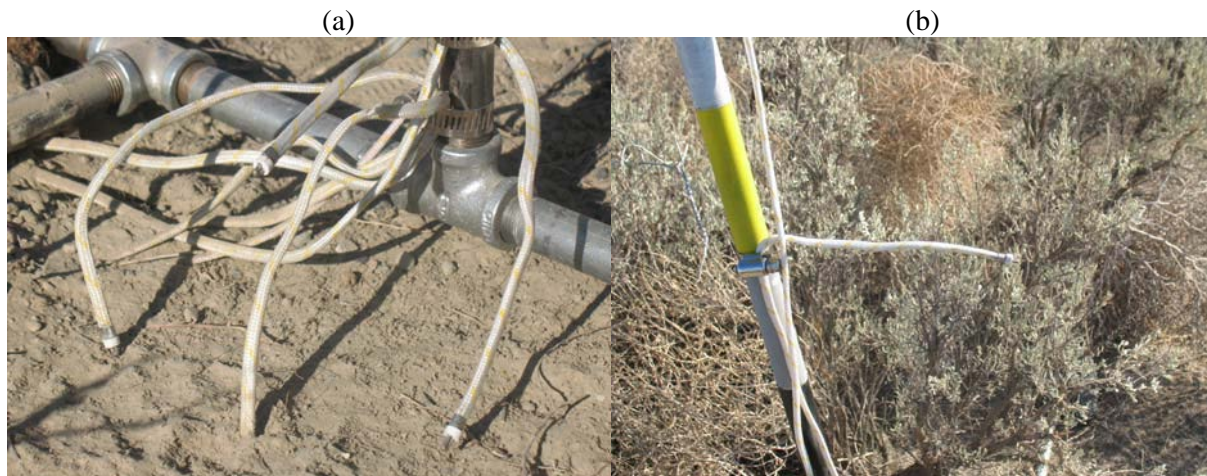
Figure M.3. Thermocouples for measuring soil and air temperature installed on flame height scaffold: (a) thermocouples were installed 1.5 cm deep, at the surface (0 cm), 1 cm, 10 cm, and 30 cm, and (b), aboveground thermocouples were installed at 100 cm and 200 cm (After Figure 2.8 of Ward et al. 2009a).

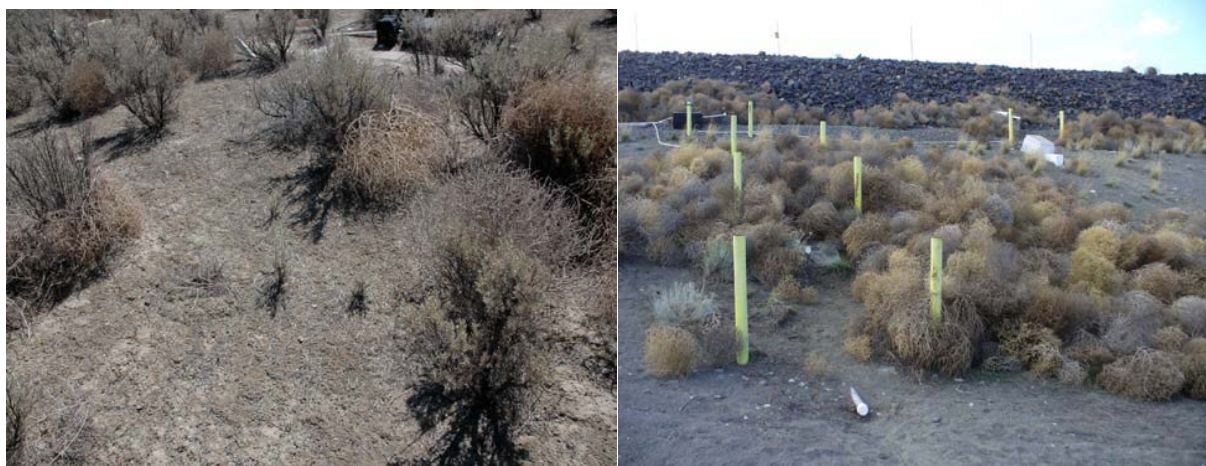
Figure M.4. Photographs of the PHB surface: (a) sparse vegetation on the surface suggesting need for increased fuel load to emulate realistic conditions. Some *Salsola kali* (tumbleweed) was already lodged among sagebrush plants, and (b) the riprap side slope of the barrier shows an accumulation of tumbleweed. Dead sagebrush and tumbleweed were imported to the barrier surface to increase the fuel load. (After Figure 2.9 of Ward et al. 2009a).

al. 2005). Thus, pre-burn site characterization included assessing the available fuel load. As shown in Figure M.4, significant differences in plant density and fuel load were observed on the surface.
