## **Appendix A**

### **The Standardized Precipitation Index at Hanford**

Pacific Northwest National Laboratory  
Richland, Washington

# **Prototype Hanford Barrier: Design, Enhanced Precipitation Test, and Controlled Burn Test**

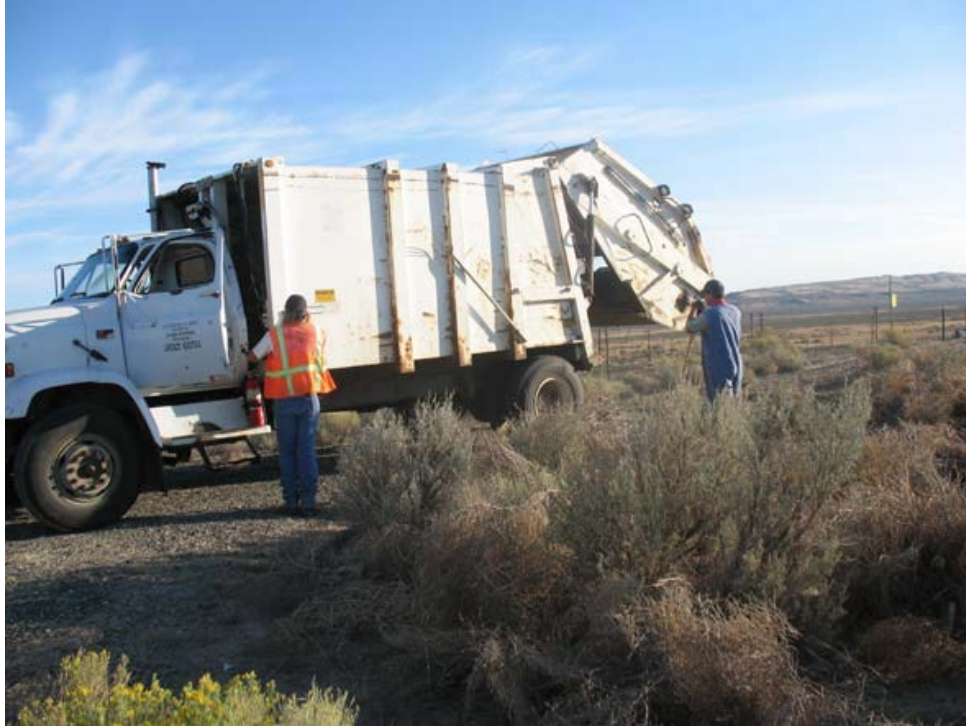
Figure M.5. Unloading of tumbleweed brought to the barrier to increase fuel load. Over 2 tonnes of tumbleweed was added to the surface. (After Figure 2.10 of Ward et al. 2009a)

Shrub biomass that could serve as fuel was determined by measuring the canopy characteristics, including height, greatest width, and greatest diameter at right angles to the greatest width on the shrubs. Measurements were taken on 18 individual shrubs off the barrier surface that spanned the range of shrub sizes on the barrier surface. These shrubs were then harvested, weighed, dried, and weighed again to the fuel moisture content. Canopy characteristics were then measured on 81 individual *A. tridentata* shrubs on the barrier surface to estimate shrub fuel density. The biomass of other fuel components on the surface was also estimated. Some areas of the barrier surface were quite sparse in vegetative cover and required an increase in biomass to reach representative fire intensities and severities (e.g., Figure M.4a). Other fuel components included *Salsola kali* (tumbleweed). Tumbleweed was already lodged among the *A. tridentata* shrubs on the surface, and more were brought in to confirm a complete burn of the surface. Although some tumbleweed was found near the barrier, it was still necessary to import tumbleweed from other areas. A truck was used to collect and transport tumbleweed across the Hanford Site to the barrier (Figure M.5).

Over 2 tonnes of clean tumbleweeds were brought to the barrier from around the 200 East Area. Tumbleweeds were dumped onto the gravel road to the north of the barrier and distributed from there. Subsamples of the imported fuel were weighed and dried to determine the moisture content. The dry tumbleweeds were spread across the surface of the barrier by hand (Figure M.6) to achieve the randomly assigned fuel loads. Two fuel loads of approximately 10.5 and 12.8 tonnes/ha were assigned to the nine  $12 \times 12$  m plots.

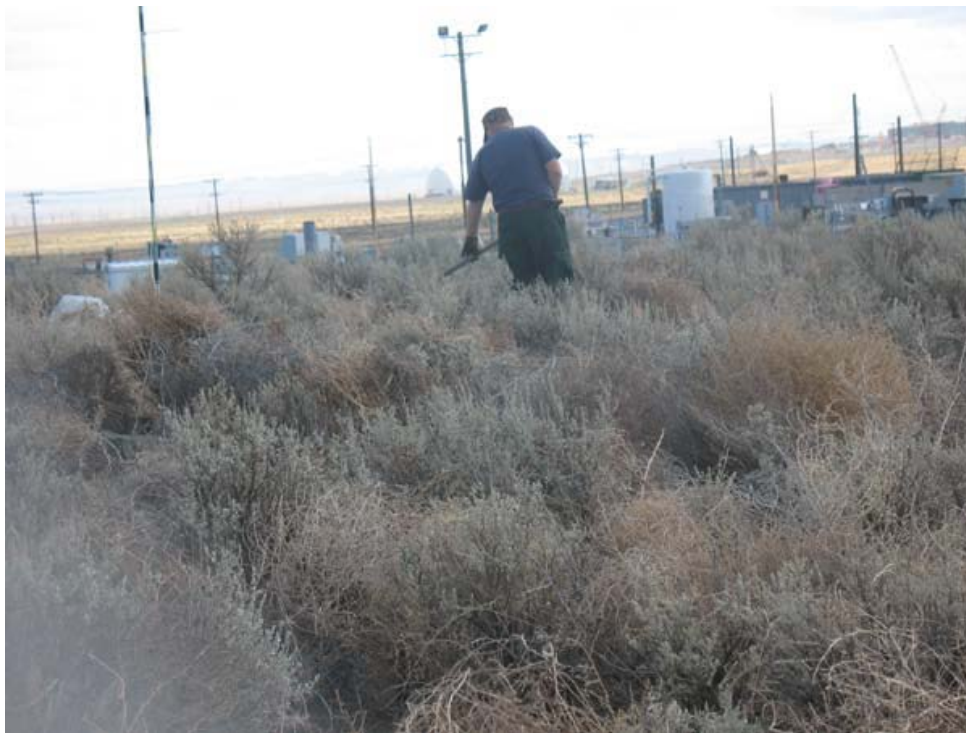
Figure M.6. Redistribution of imported tumbleweed across the barrier to achieve different fuel loads for the controlled burn. Captain Jerry Keeling of the Hanford Fire Patrol is shown redistributing tumbleweed with a rake. (After Figure 2.11 of Ward et al. 2009a).

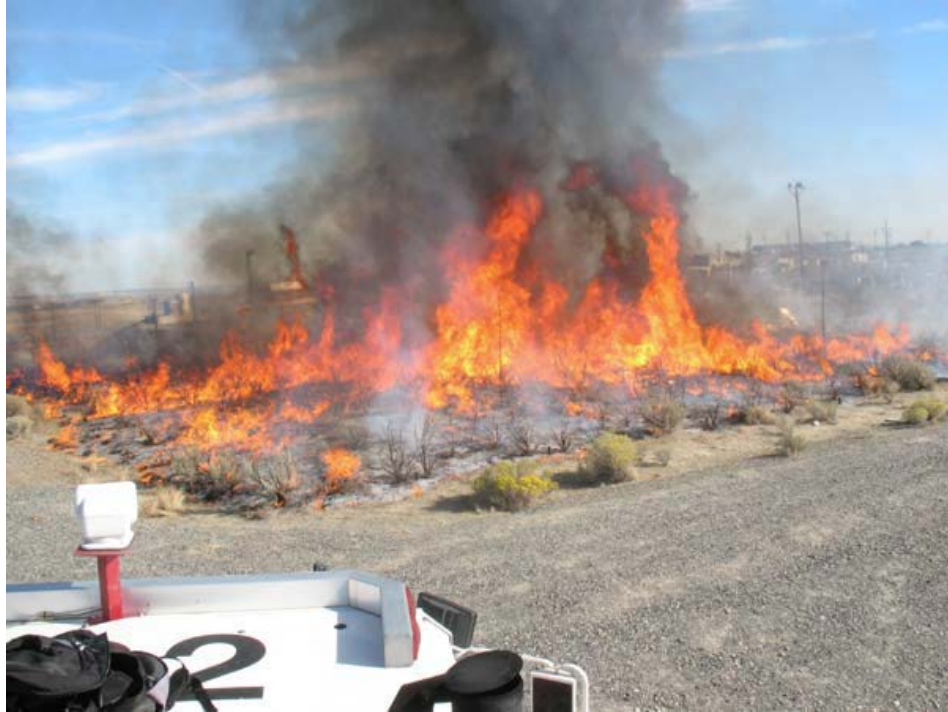
Figure M.9. A View of the fire from southwestern edge of the plot about 4 minutes after ignition. the photograph was taken from atop of the Hanford Fire Department bush rig. (After Figure 3.16 of Ward et al. 2009a).

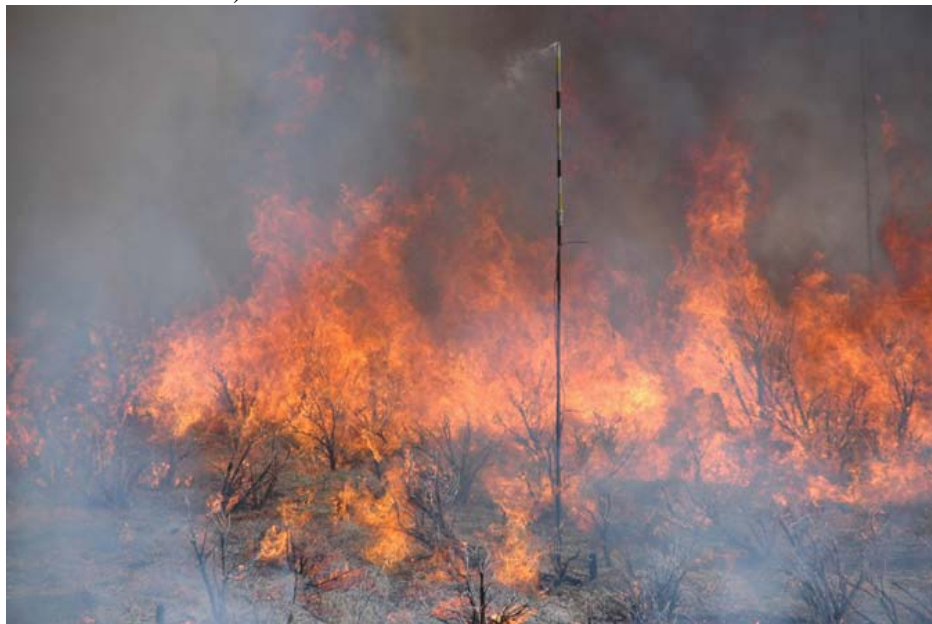
Figure M.10. Painted fire pole in foreground showing a thermocouple mounted perpendicular to the pole at a height of 2 m (After Figure 3.17 of Ward et al. 2009a).

Fire intensity was verified by soil and air temperature measurements. The time-course of temperature before, during, and after the fire was recorded and examples of these data are shown in Figure M.11. These two temperature time-courses were taken from one tower at the hottest part of the barrier surface. Temperatures ranged from 250°C (482°F) at 1.5 cm (0.6 in.) below the surface to over 700°C (1292°F) at 1 m (3.3 ft) above the surface (Figure M.12). Air temperature rose much higher than the soil temperature. This can be expected because of the large amount of fuel on the surface and the flame heights. In addition, the thermal conductivity of soil is strongly dependent on moisture, with dry soils being very poor thermal conductors. With little soil organic matter, the only other possible source of fuel in the subsurface would have been live roots, and as a result, there would have been little transmission of heat in the subsurface.

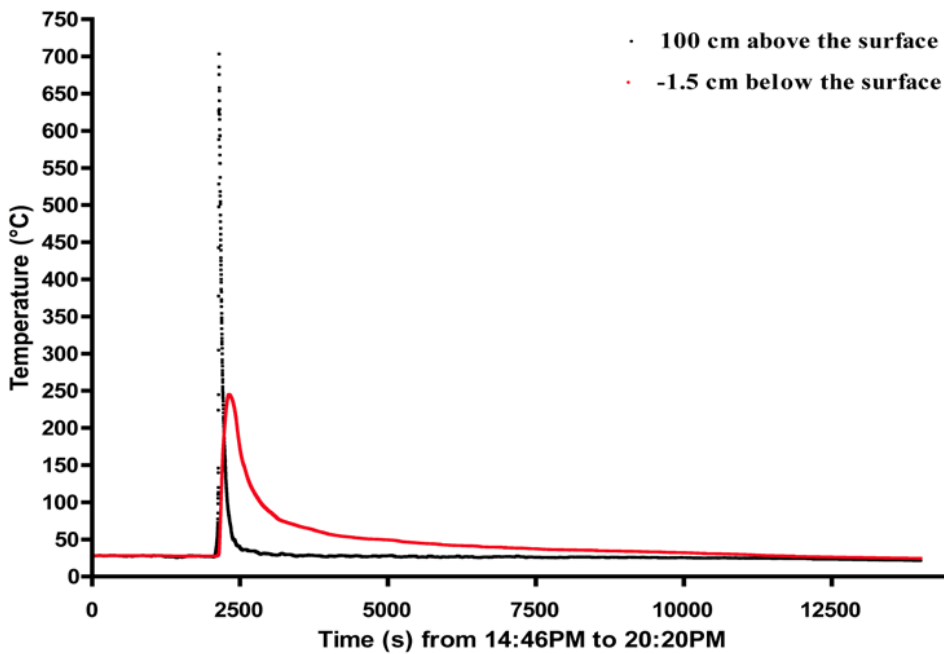
Figure M.12. Temperature in the air and soil before, during, and after the fire (After Figure 3.19 of Ward et al. 2009a).

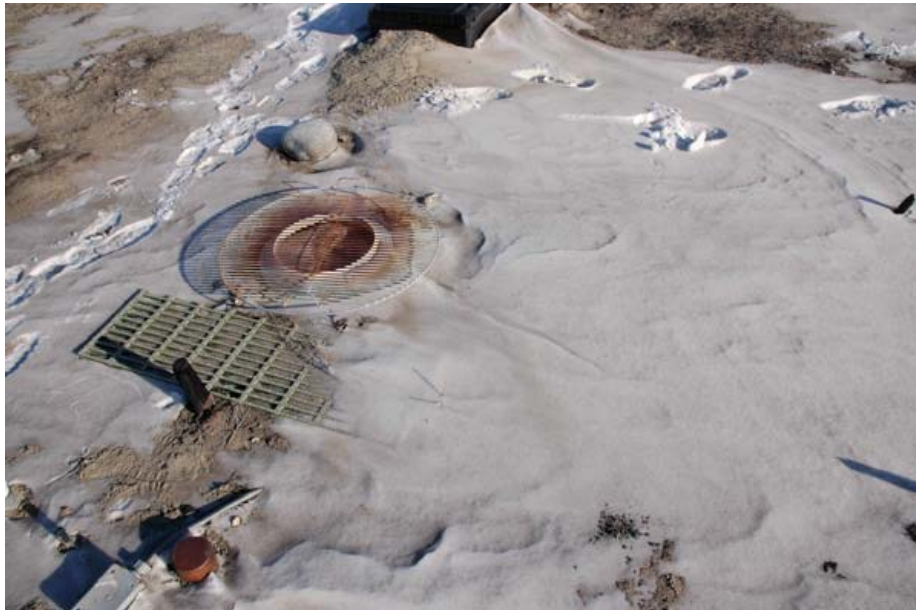
Figure M.16. Soil deposition patterns on a snow-covered surface on December 16, 2008 (After Figure 3.28 of Ward et al. 2009a).

is circumstantial evidence that some soil may have been transported across the surface since the fire. Evidence of soil migration was observed after a snowfall on December 16, 2008. Soil dust was evident on the snow surface owing to its contrast with the bright snow found in footprints that were shielded from the deposition (Figure M.15) but the source of the dust uncertainty. The average change in measurement with one standard deviation was  $1.3 \pm 7.1$  cm in 2009 and  $0.6 \pm 7.5$  cm in 2010. The large uncertainty in the measurements suggests the measurements with erosion pins were inconclusive on inflation and deflation (Figure M.16). Based on the surveys of ground surface elevation using a real-time-kinematic global positioning system at the 338 locations on September 1, 2008 and July 29, 2009, the average change in elevation with one standard deviation was  $-0.3 \pm 2.2$  cm in 2009 and  $-3.6 \pm 1.7$  cm in 2010, which are inconsistent with the observation using the erosion pins, indicating no detectable change in ground surface elevation.

These changes may be due to localized redistribution of soil from the burned area (Figure M.16). During the period of monitoring for the treatability test, very little erosion was observed. The only measurable loss of soil by wind occurred during the first 3 months when the surface was bare, with estimates ranging from 7.4 to 744 mg/m<sup>2</sup> (DOE-RL 1999). After the fire there were losses of up to 0.8% of the depth of surface soils (1.6 cm out of 200 cm). Areas with lower temperatures and fuels had gains of up to 1% of the depth of the surface soils. Surface inflation and deflation may be coarsely associated with fire temperatures. Fires are associated with increased wind erosion (Vermeire et al. 2005), and Ravi et al. (2006) did observe that fire-induced water repellency enhances erodibility. It is possible that soil losses were associated with higher fire temperatures compared to areas with lower soil losses or gains. This has not been assessed. It is not likely that significant amounts of soil will be lost from the surface after fires. It is also possible, but not measured at the barrier, that soils will deposit on the surface when vegetation cover is high given that the drier portions of the Columbia Basin are subject to wind erosion of soils (Feng et al. 2011).

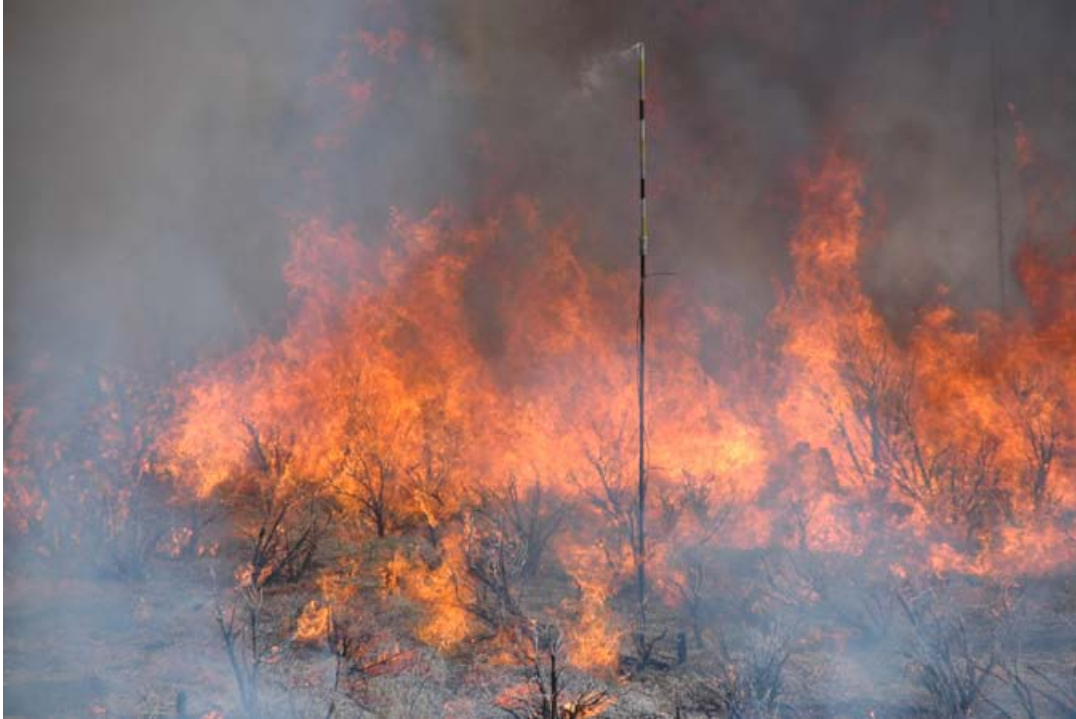
Figure N.1. Painted fire pole in foreground showing thermocouple mounted perpendicular to the pole at a height of 2 m.

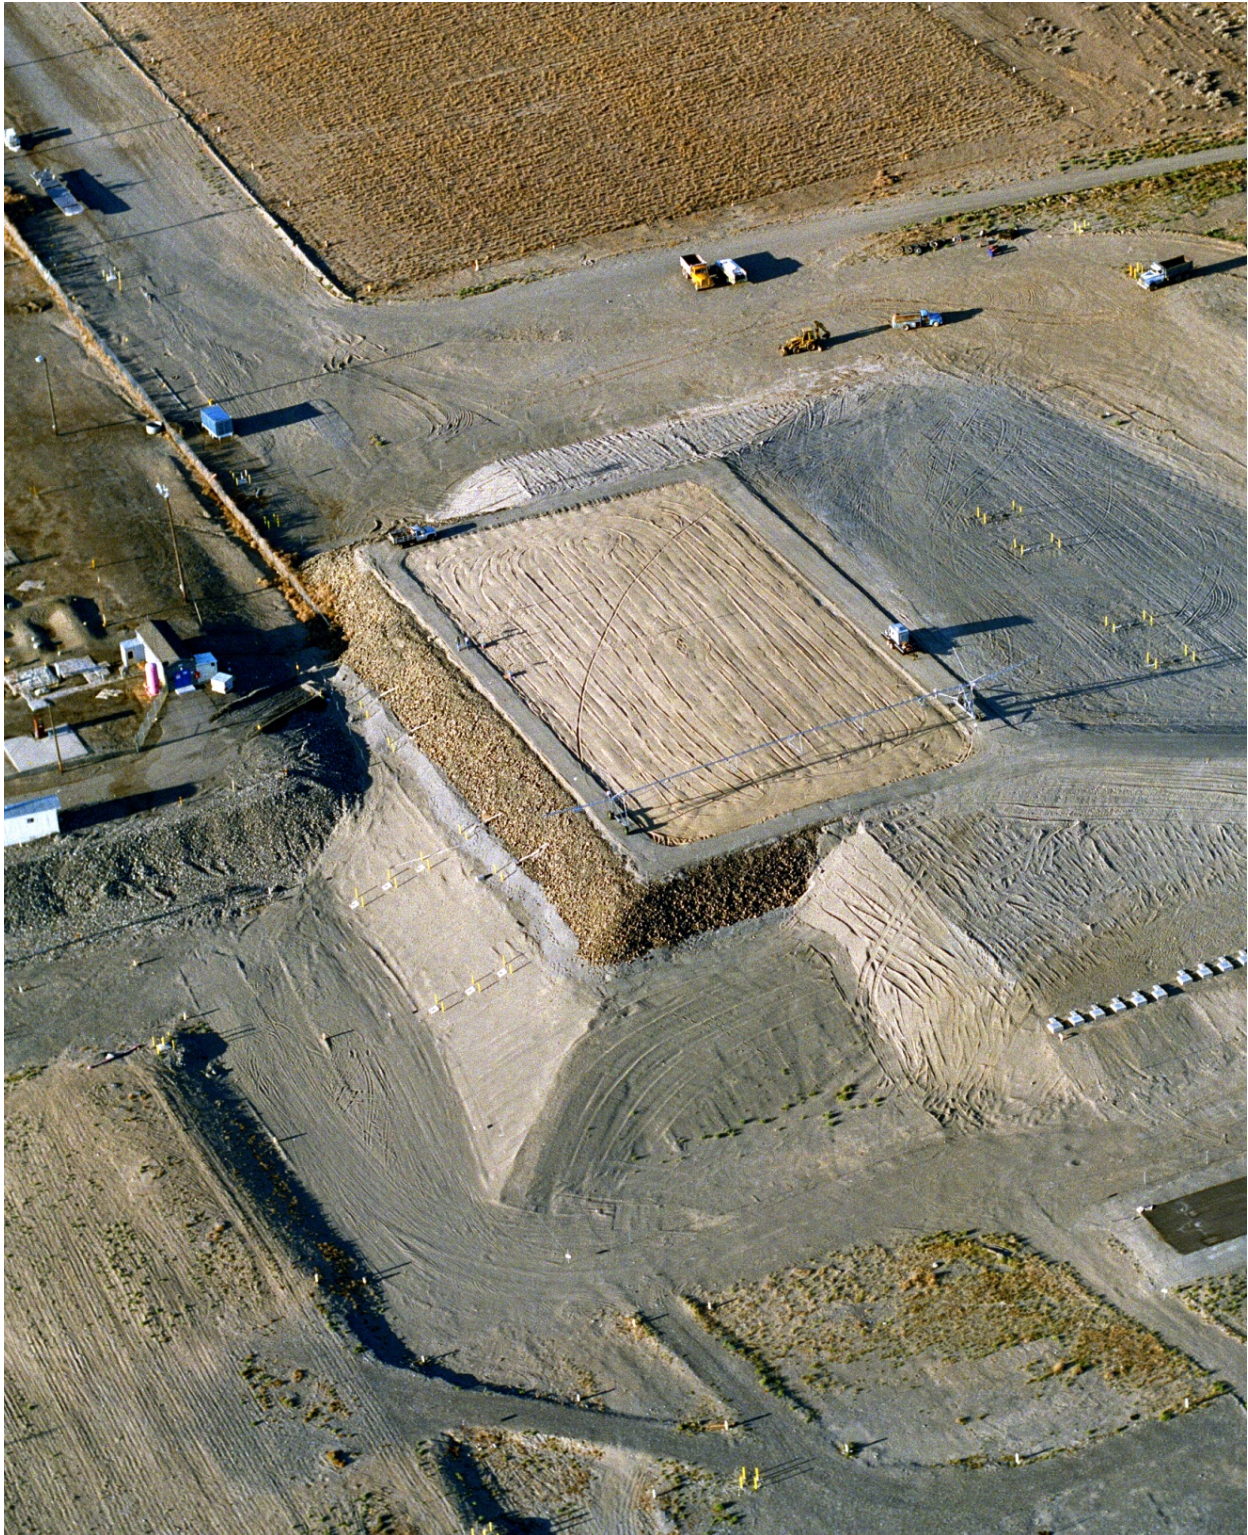
**Figure O.1.** The Prototype Hanford Barrier on August 9, 1994 (southwest-facing view). The two side-slope configurations and drainage monitoring system are to the north.

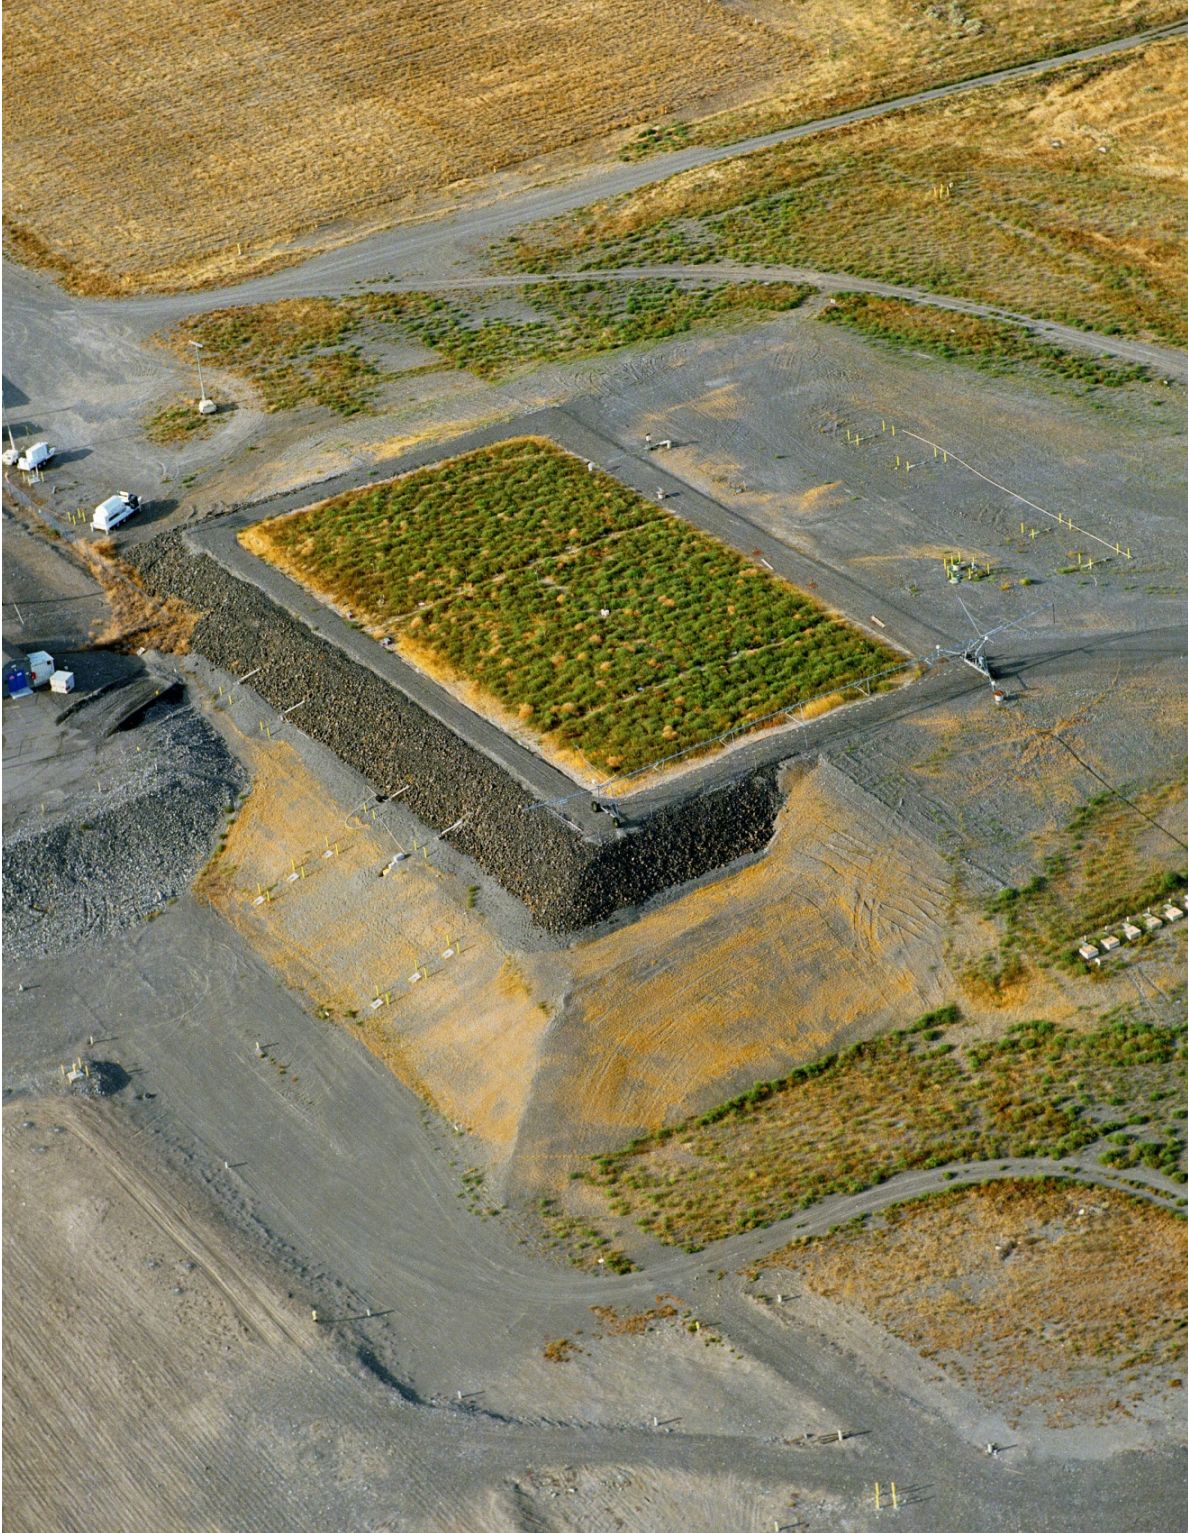
**Figure O.2.** The Prototype Hanford Barrier on August 9, 1995 (southwest-facing view). The green vegetation seen in the photo is non-native Russian thistle (tumbleweeds), not the planted native sagebrush and rabbitbrush, which were still seedlings and were much smaller than the Russian thistle, and cannot be seen in the image. The Russian thistle might come with the imported silt loam.

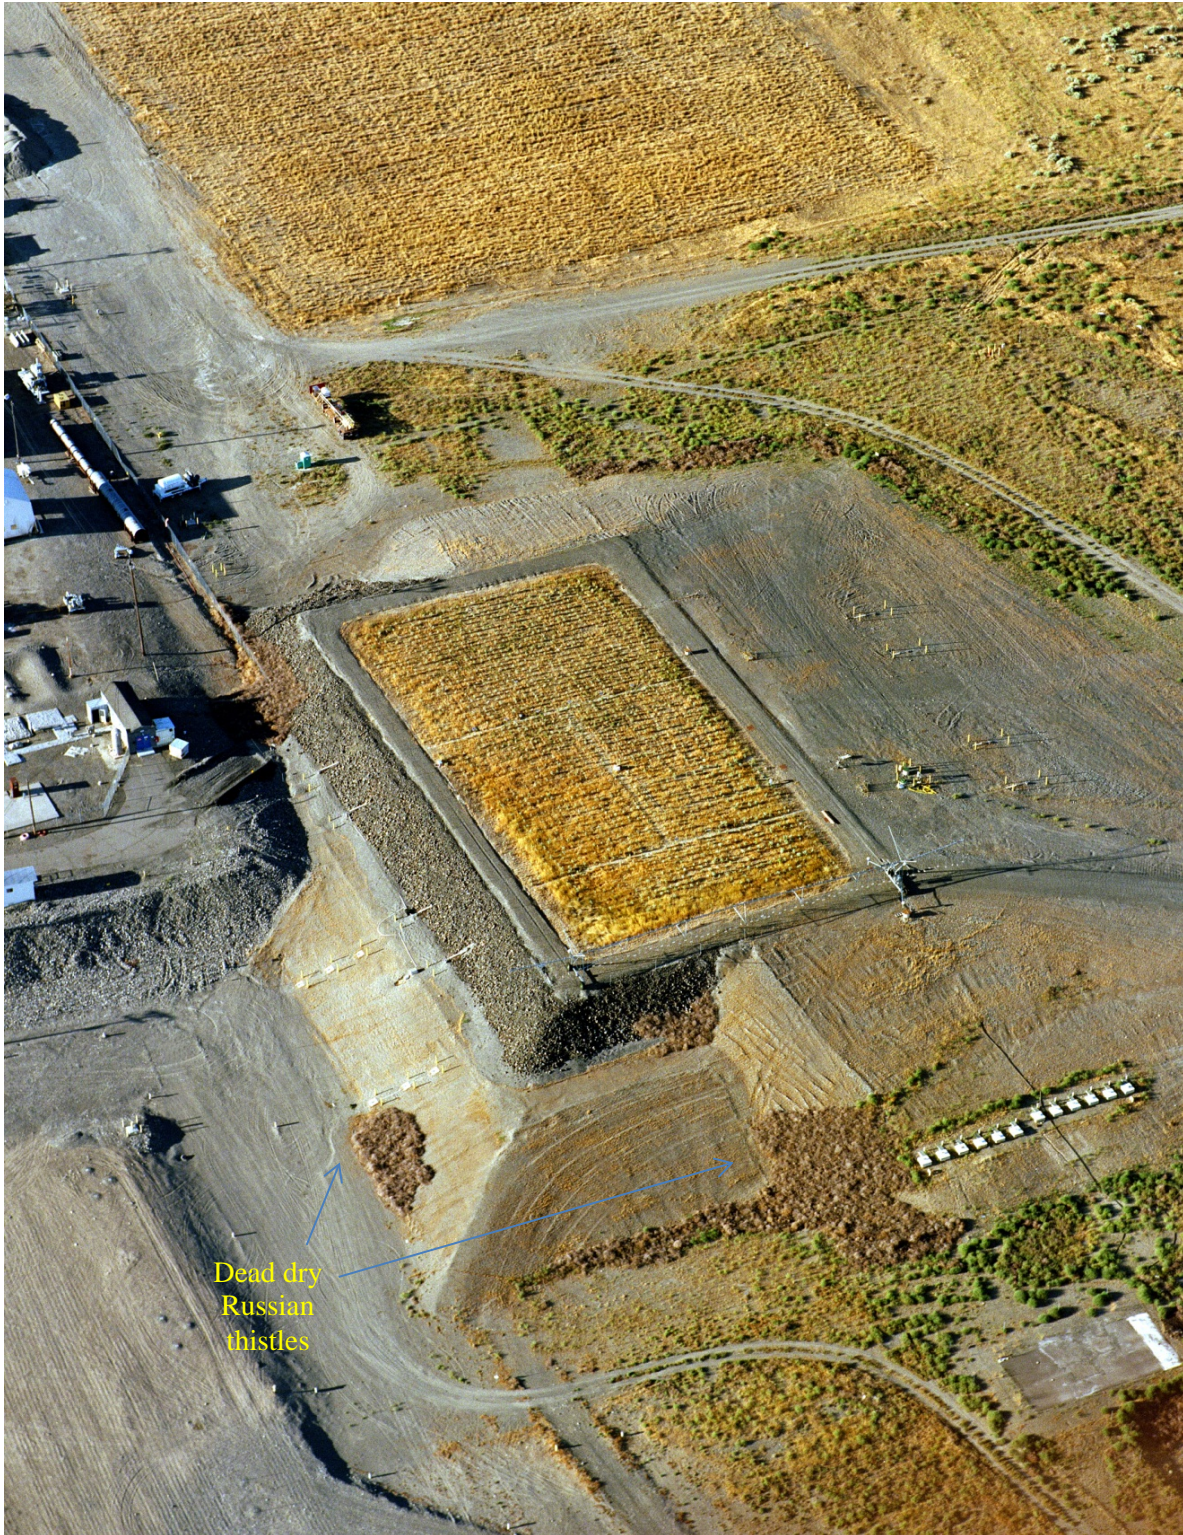
**Figure O.3.** The Prototype Hanford Barrier on September 14, 1996 (southwest-facing view). The Russian thistle (tumbleweeds) had died and been blown off the barrier surface by wind.

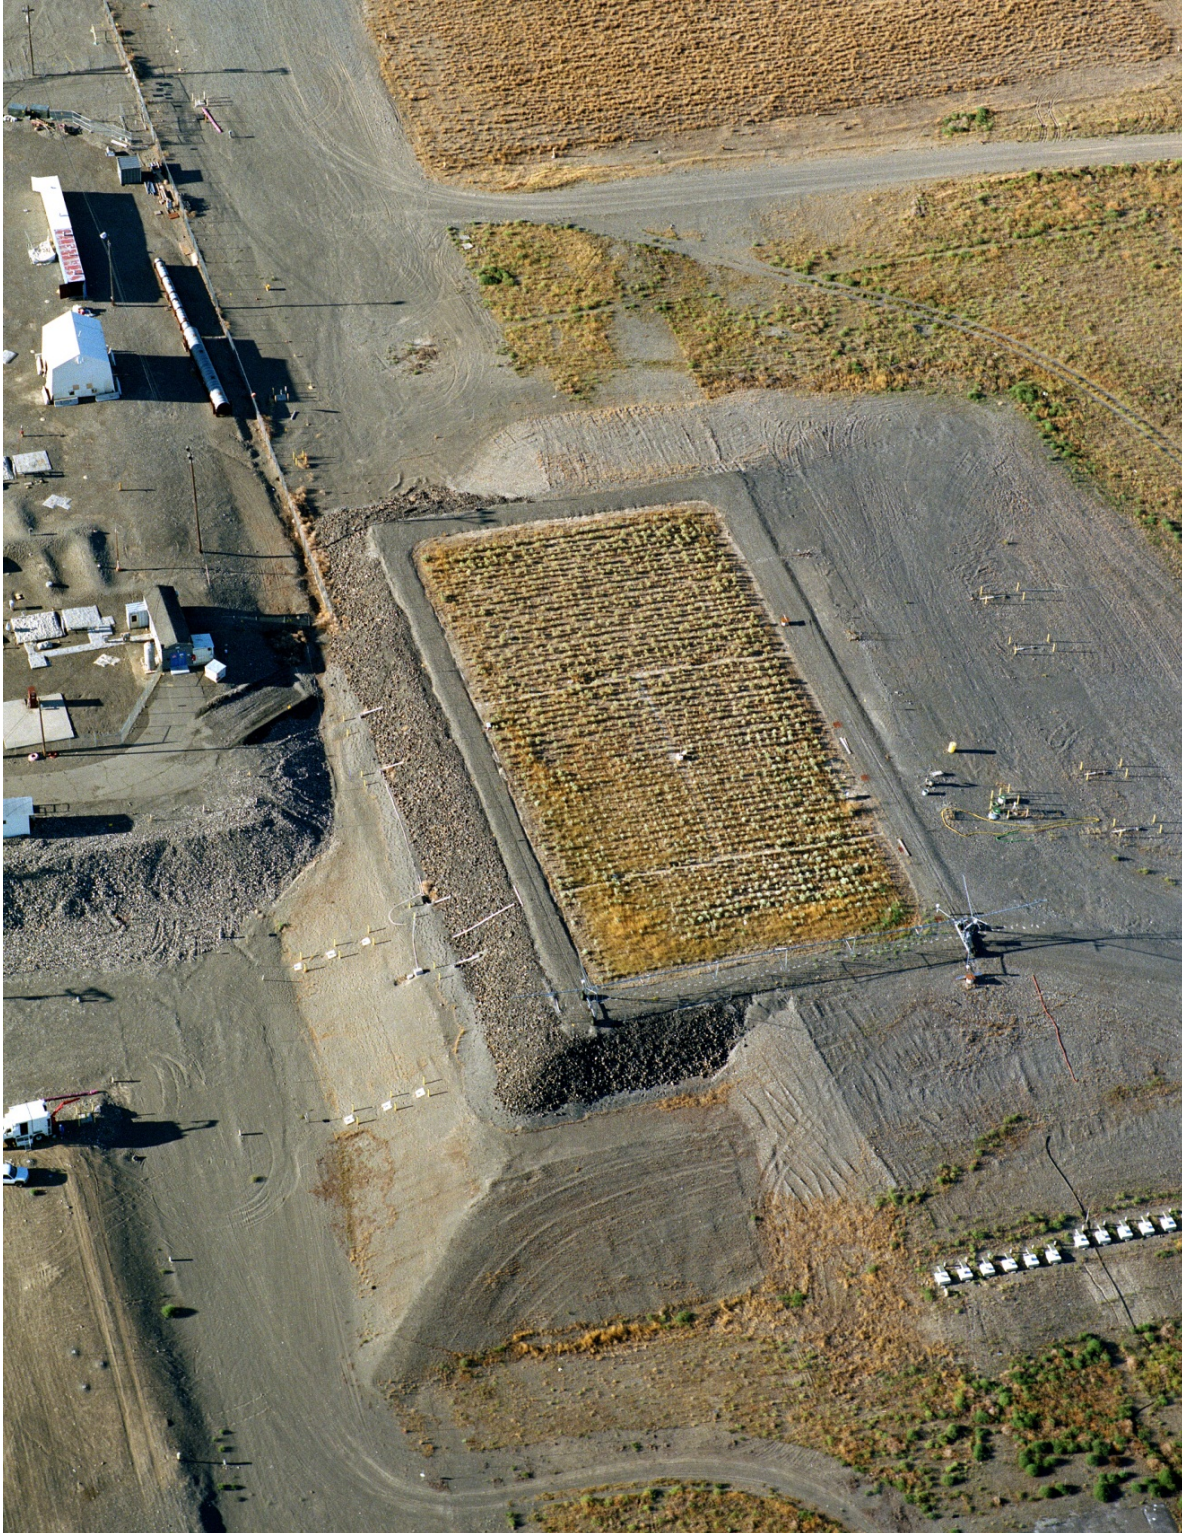
**Figure O.4.** The Prototype Hanford Barrier on September 18, 1997 (southwest-facing view). The planted native species (sagebrush and rabbitbrush) were developing in rows.

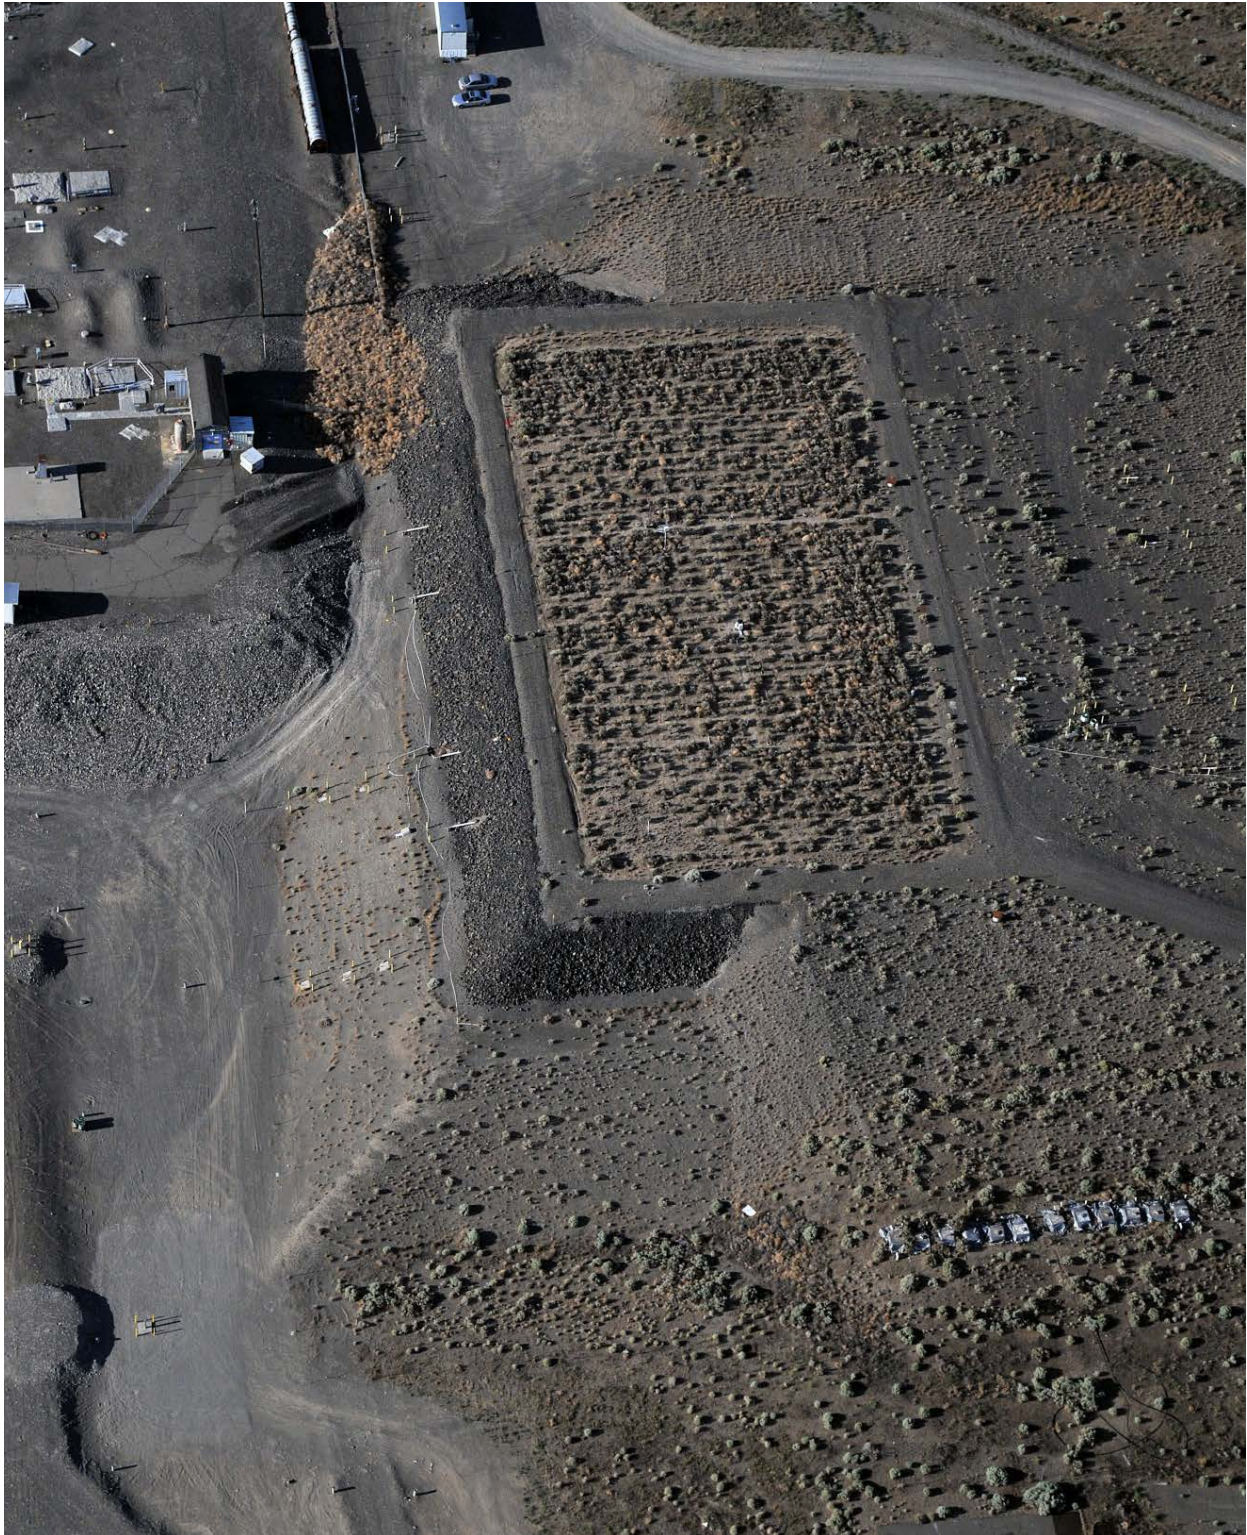
**Figure O.9.** The Prototype Hanford Barrier on September 20, 2008, 1 week prior to the controlled burn (south-facing view).

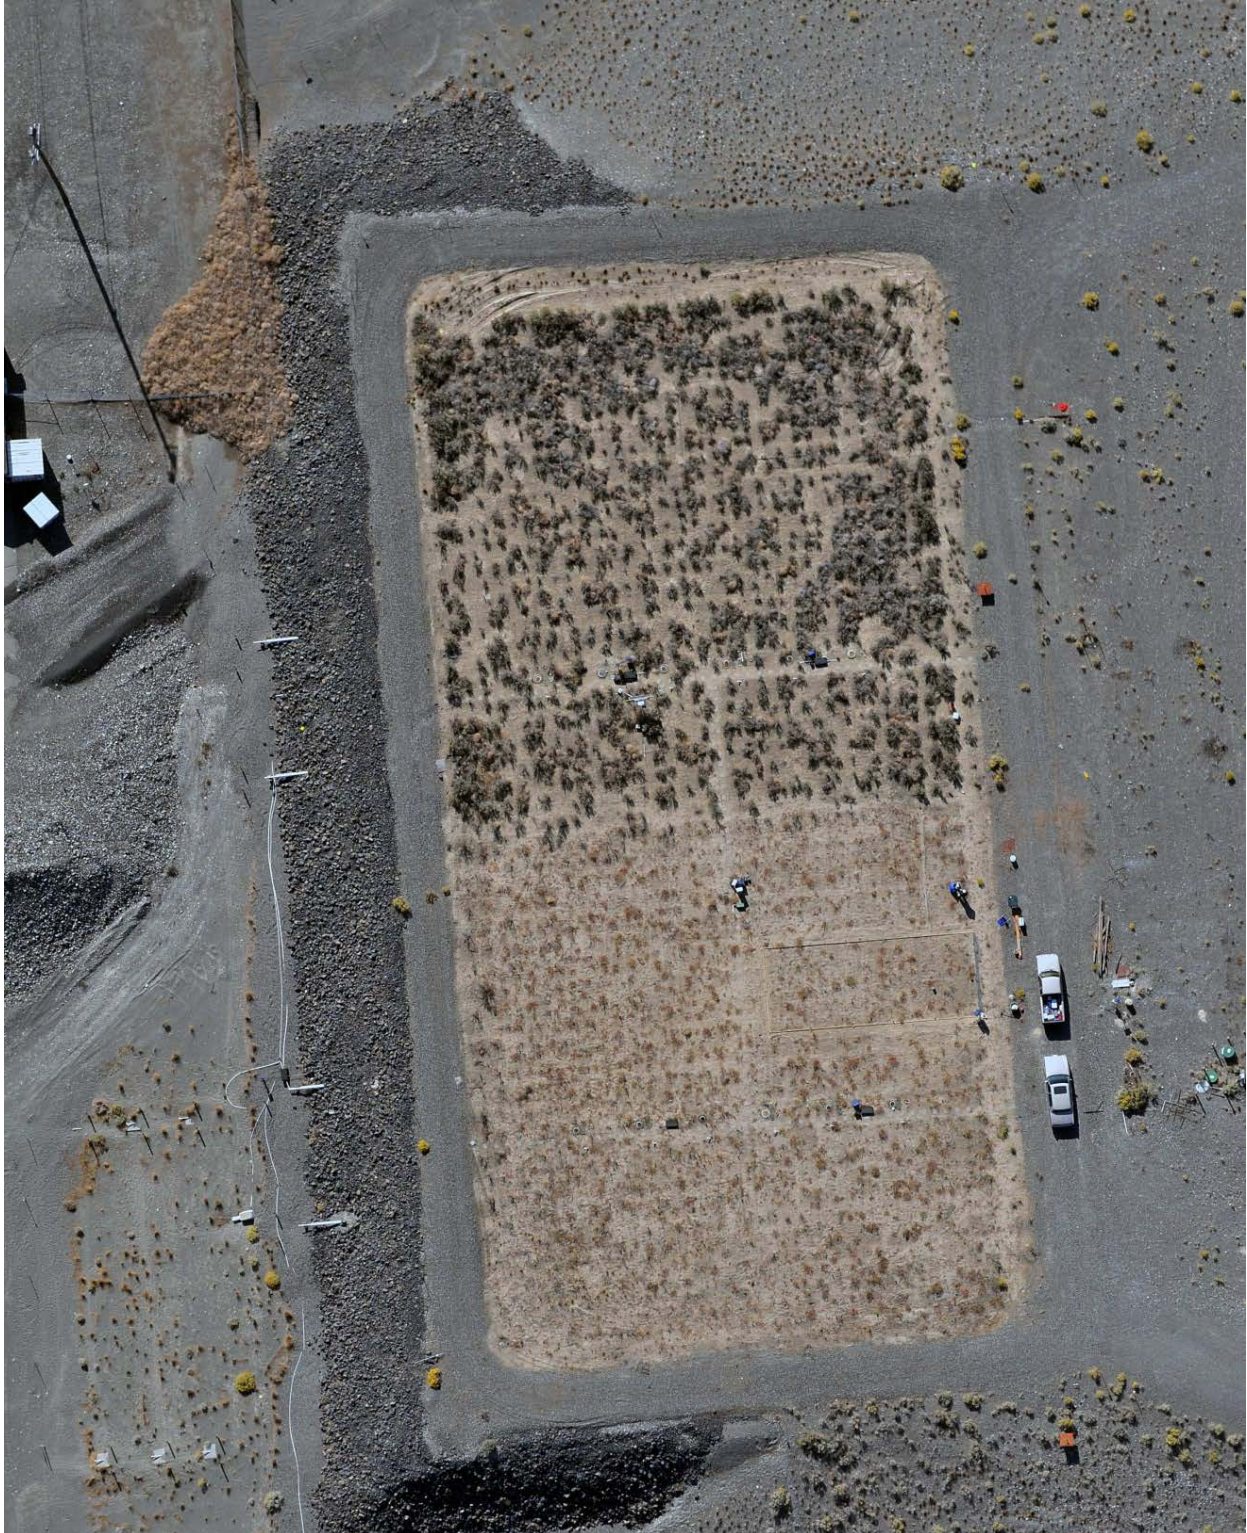
**Figure O.10.** The Prototype Hanford Barrier on September 30, 2009, 1 year after the controlled burn (south-facing view). The north half was still mostly free of vegetation.
