FIVE-YEAR REVIEW REPORT

**St. Louis River Superfund Site
Duluth
St. Louis County, Minnesota**

**U.S. Steel Site - EPA OU 02
St. Louis River/Interlake/Duluth Tar Site, Tar Seep OU – EPA OU.01
St. Louis River/Interlake/Duluth Tar Site, Soil OU – EPA OU 03**

**U.S. Army Corps of Engineers
Omaha District**

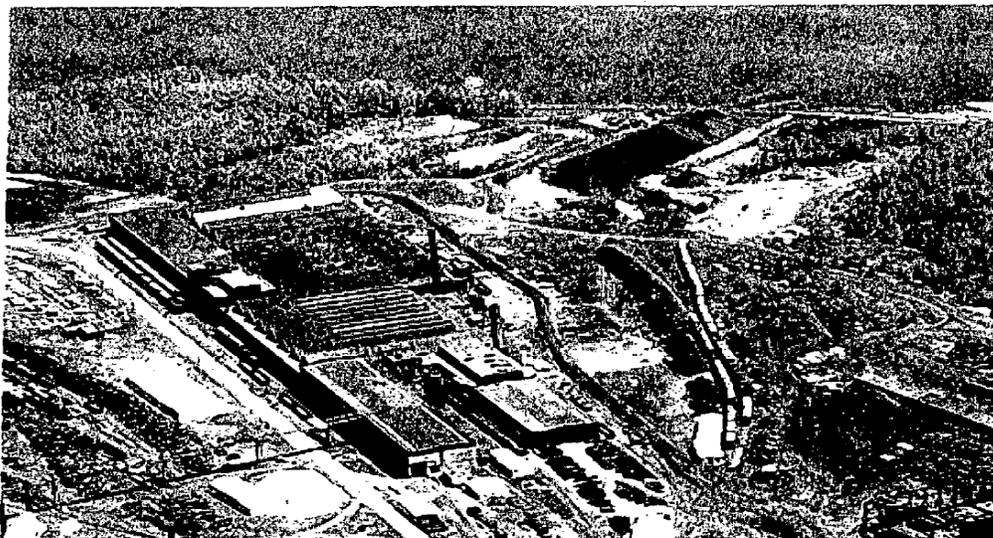
The Wire Mill Pond served as receiving pond for stormwater and wastewater from the “cold” side of the integrated steel mill; including the wire mill, and the merchant mill. Operations performed in these mills included hot and cold rolling, pickling, and galvanizing. The cold side of the Duluth Works ceased operation in 1973, except for the wire mill that continued to operate under a lease agreement. Tenants used the wire mill and discharged noncontact cooling water to the pond from 1973 until approximately 1986, when the operation of the wire mill was discontinued. During operations, the Wire Mill Pond was used as a treatment basin, holding wastewater to allow oil and greases to be removed prior to discharge to the St. Louis River. Heavy materials in the influent waste streams settled in the pond and lighter materials were captured with an active skimming process prior to discharge to Spirit Lake and the St. Louis River. The photo below was taken sometime after 1967 when the Wire Mill Pond was constructed, The floating skimmers can be seen on the pond.

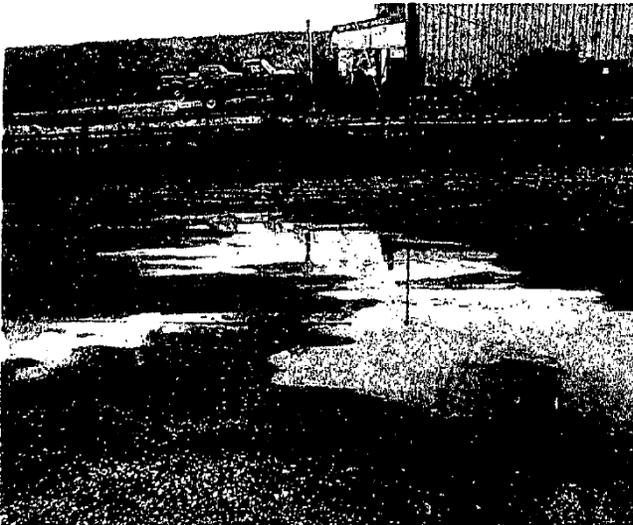
This former location of two tanks removed during the Soil OU remedial action is the location originally identified as the Area D Tar Seep. The location was marked by GPS and is shown on Figure 7 as Area D-2.

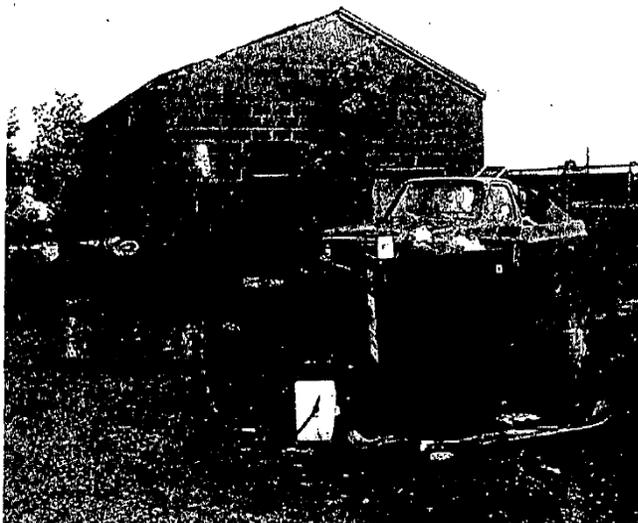
Area D, located midway down the 59th Avenue peninsula, was inspected to verify that no visible tar remained at the site and to assess the protectiveness of the soil remedy. No evidence of tar or contamination was observed. Residual soil contamination above the clean-up levels is present under the old pump house and another building on the east side of the area. Excavation could not be completed without damage to the structures. The area is currently used for industrial purposes.

Residual Contamination is present under this pump house in Area D.

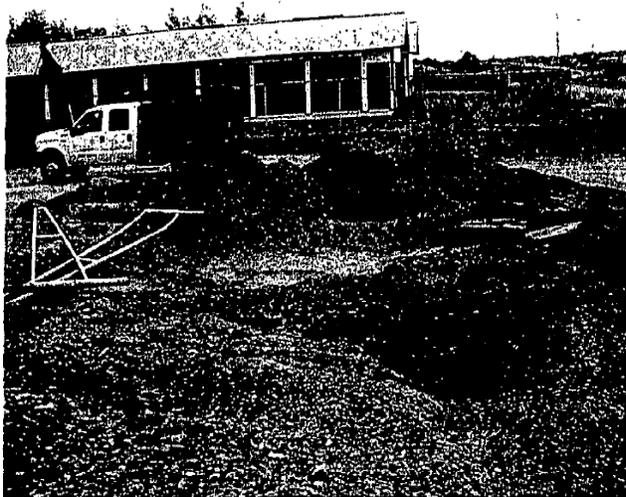
To the left is the backside of Maurices' Parking lot, looking east.

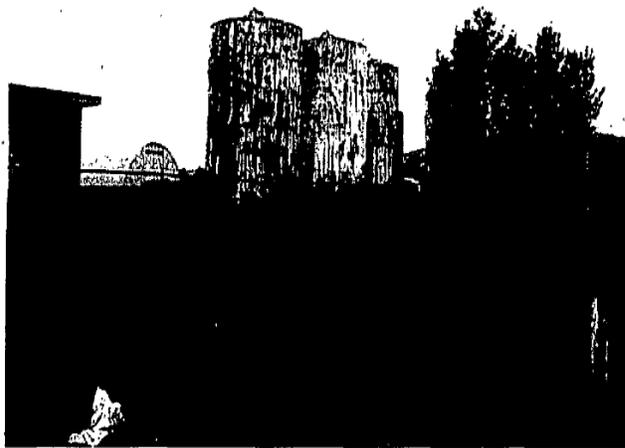
Shown to the left is the north side of Area E looking to the southwest.

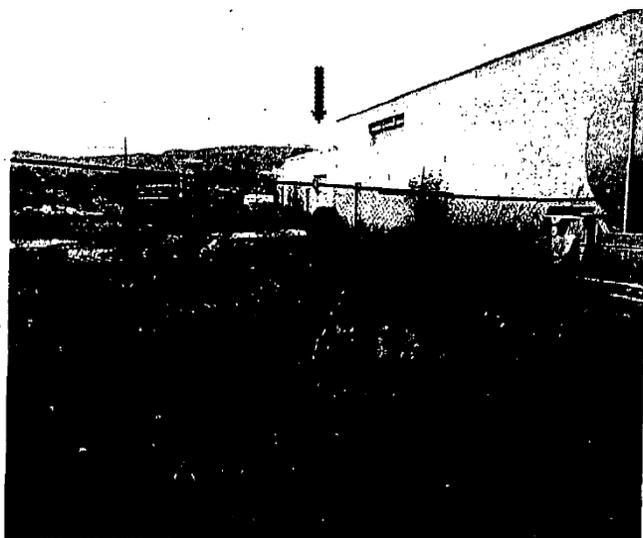
During the investigations and remedial actions, no testing or excavation was performed under existing buildings. It is known that residual contamination remains under the foundation of one of the former Duluth Auto wrecking buildings because concentrations above clean-up levels were detected. However, excavation could not be completed with damage to the structure.

Represented by the arrow is the south side of former Duluth Auto Wrecking Inc. where residual contamination remains.

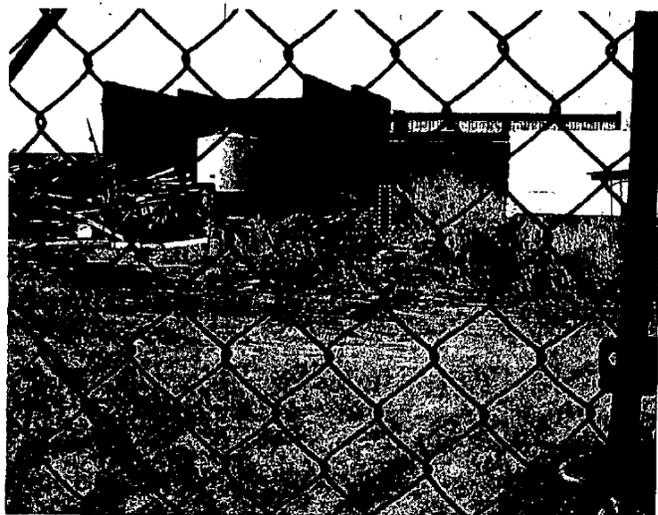
Looking west from the east side of Area E, this pile, excavated during gas line installation, reportedly contains coal tar.
