Fracturing Under Buildings and other delicate work

FRx, Inc.
P.O. Box 498292
Cincinnati, OH
45249-8292

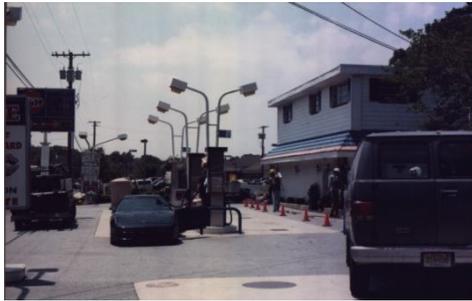
treatments. Some of the work was performed by cutting through the concrete floor of the building. Uplift was monitored by surveying techniques. This building, which was of light construction, was elevated by the fractures. No damage was realized in the structure or large plate-glass windows. Operation of the facility was not disrupted by the work, although pedestrian
