Formosa Mine Groundwater Flow in Fractured Rock

Formosa Mine Superfund Site

The 76-acre Formosa Mine site is located on Silver Butte in Douglas County, Oregon.

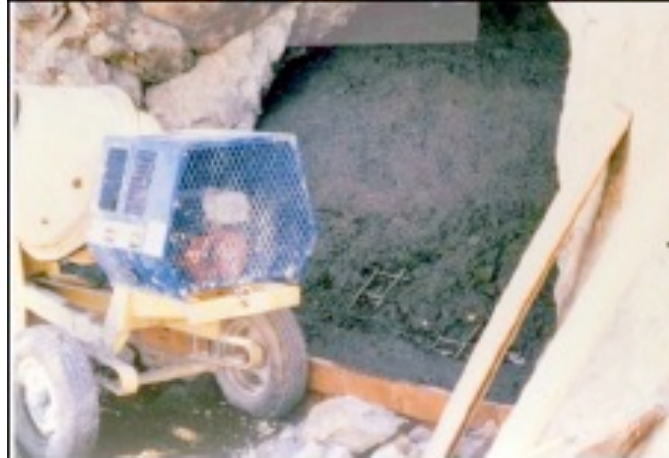
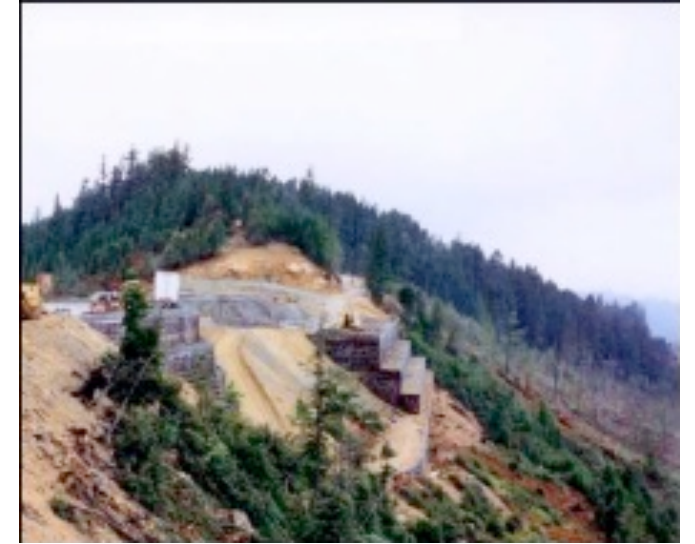
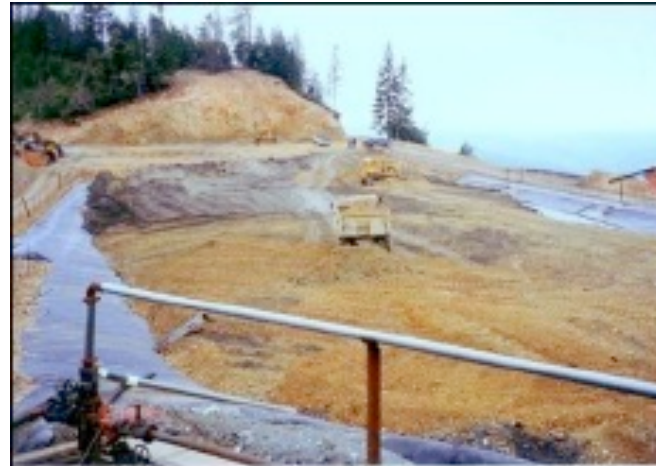
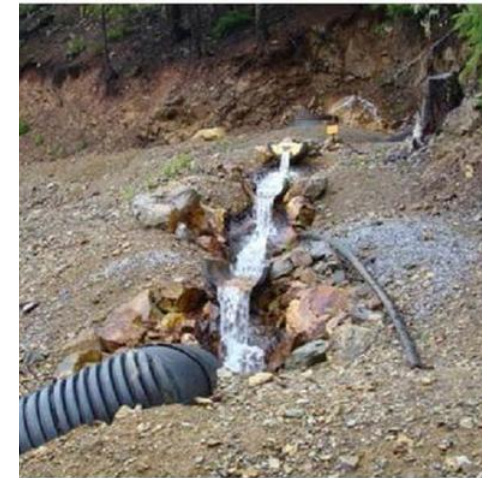
Adit portals were sealed with a wooden and burlap bulkhead, crushed limestone backfill, an 8-inch concrete cap, and an outer rock cover.

Adit drainpipes were then installed.

In February 1995 drainpipes were plugged by iron precipitate scale and flow eventually ceased.

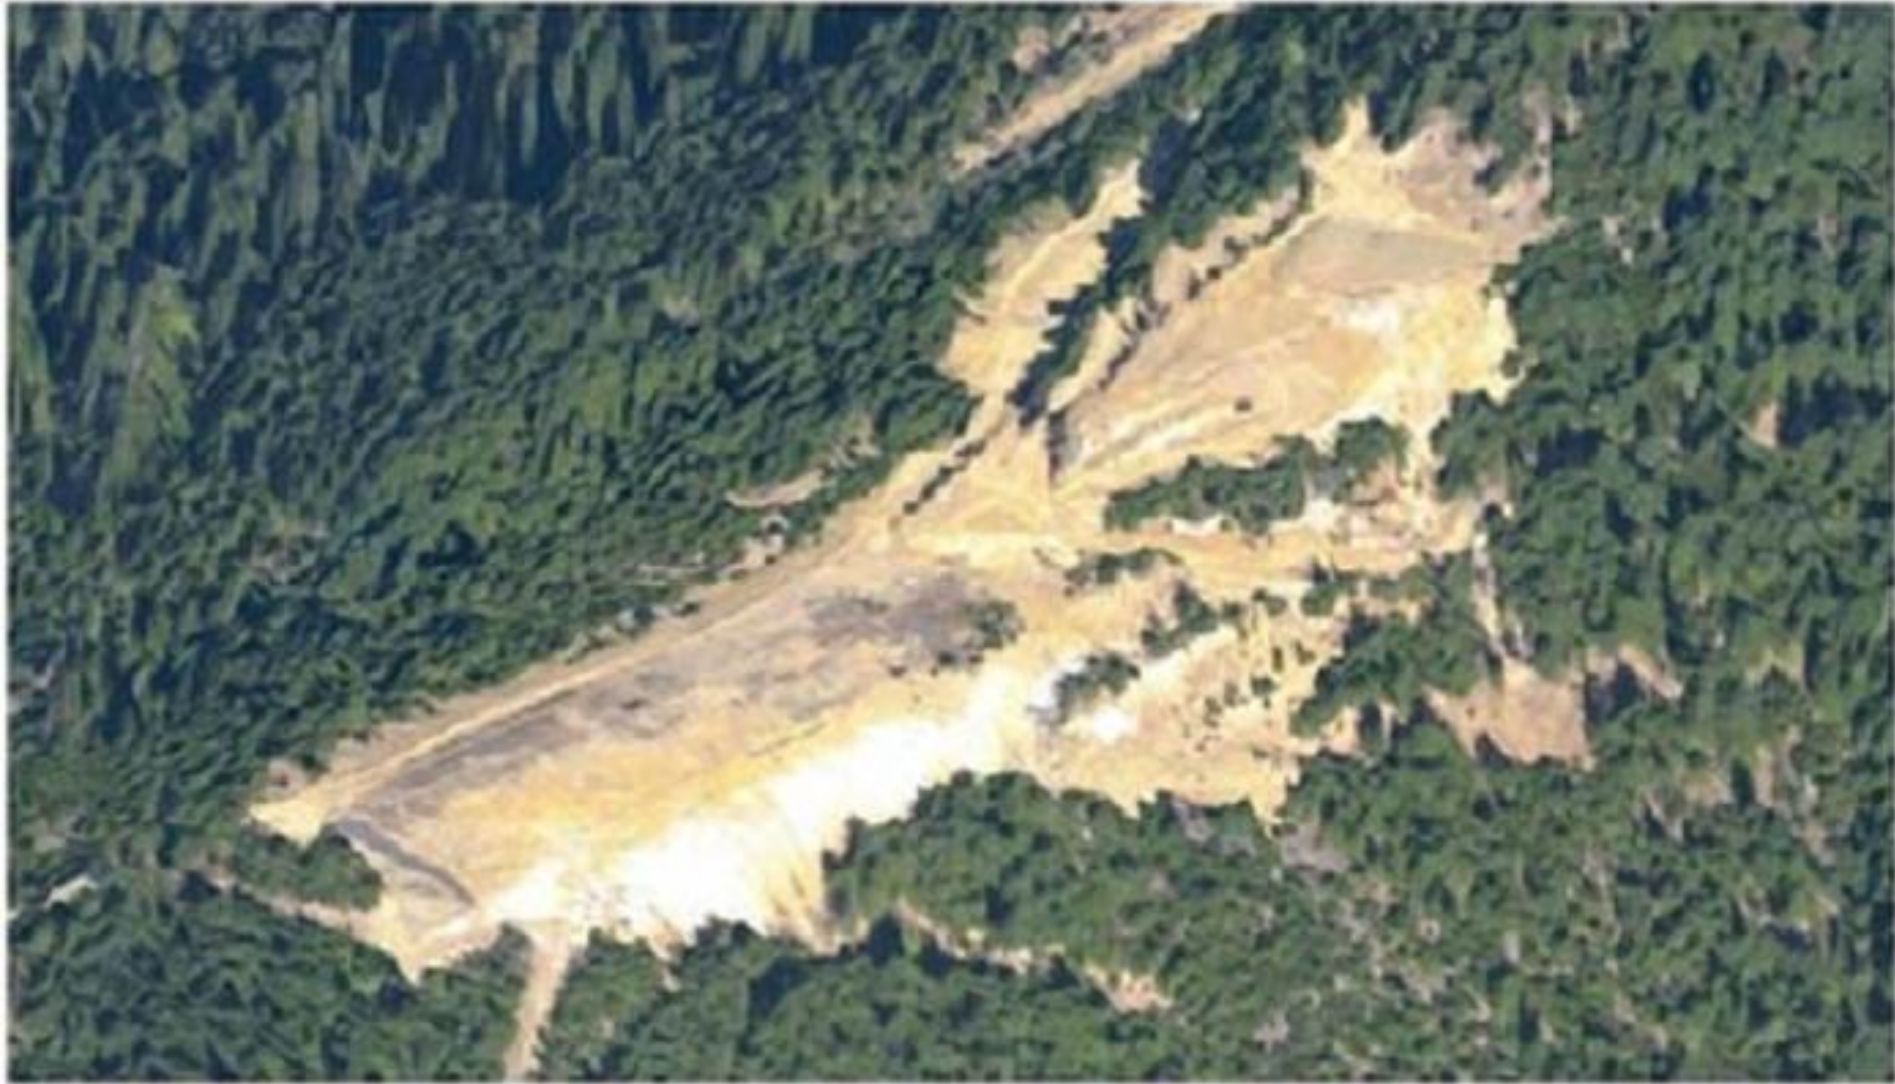
Adit Bulkhead Installation

2018 bulkhead installation at
Formosa 1 adit

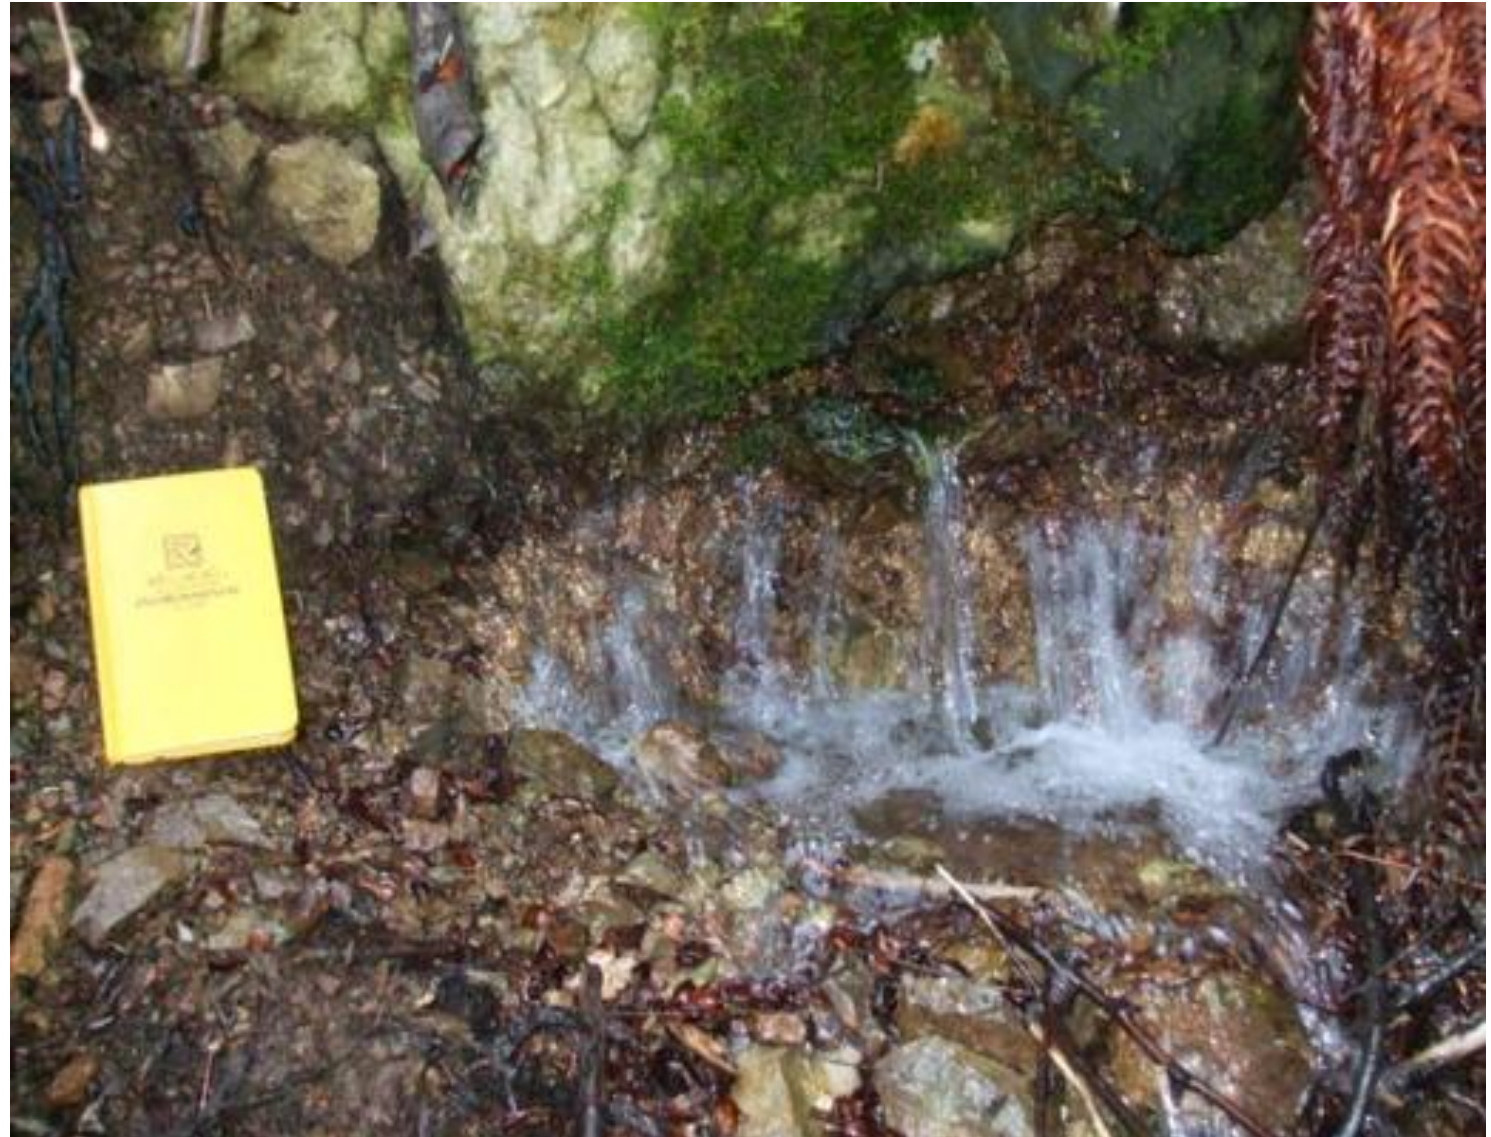
Bedrock Groundwater System

The bedrock aquifer is a source of water flowing into the underground workings where the water (mine pool water) interacts with backfilled mine materials, generates MIW, and discharges at mine adits.

The mine pool gradient, causing MIW to flow towards the Formosa 1 Adit and Upper Middle Creek, may be influenced by the orientation of a major fracture set trending west-northwest.

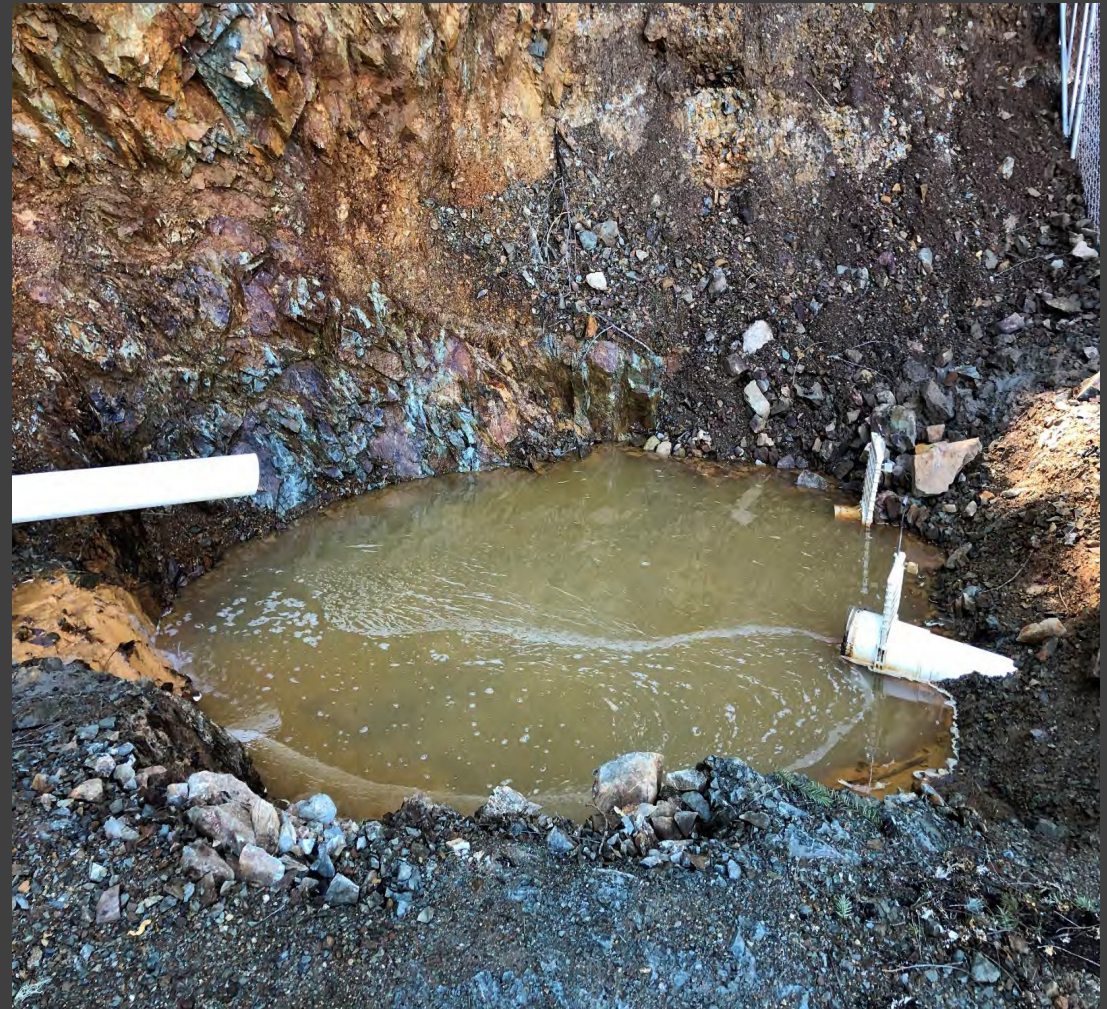
Mine Tunnels and Adits

The portal of the Formosa 1 Adit is the lowest point of ingress/egress for the mine. The underground workings extend downwards approximately 420 feet and upwards approximately 290 feet from the portal of the Formosa 1 Adit. Much of the underground mine is backfilled with various mine materials placed during mine restoration.

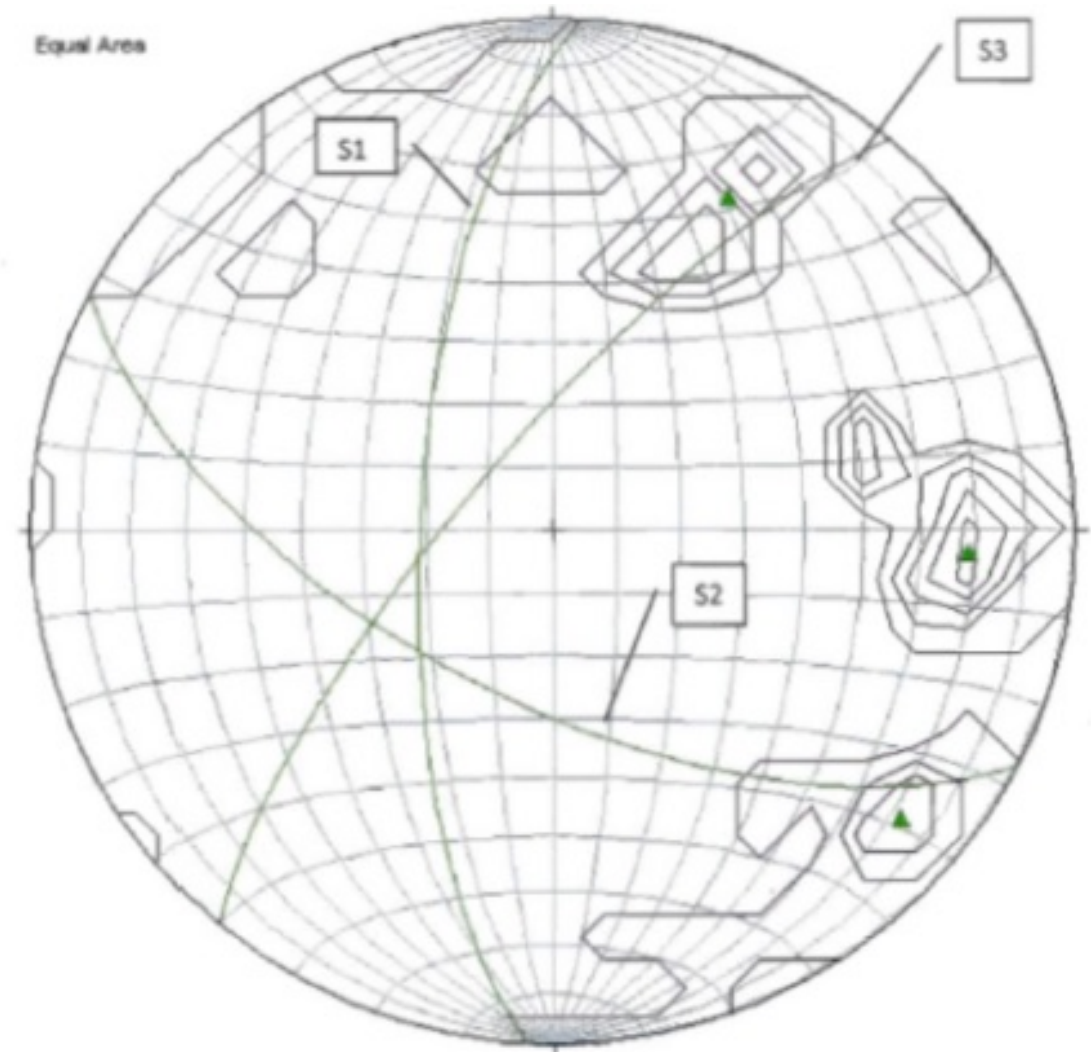
Figure 3-17
Statistical Analysis of Fracture Orientations in Formosa 1 Adit Area

- Three dominant fracture trends denoted S1, S2, and S3:
- S1 strikes north-south and dips 69 degrees towards the east.
- S2 strikes towards the west-northwest and dips 63 degrees towards the northeast.
- S3 strikes north-northeast and dips 76 degrees towards the southeast.

- The S2 fracture trend is of particular interest because contaminant transport along the west northwest trend could convey MIW from mine pool towards Upper Middle Creek.

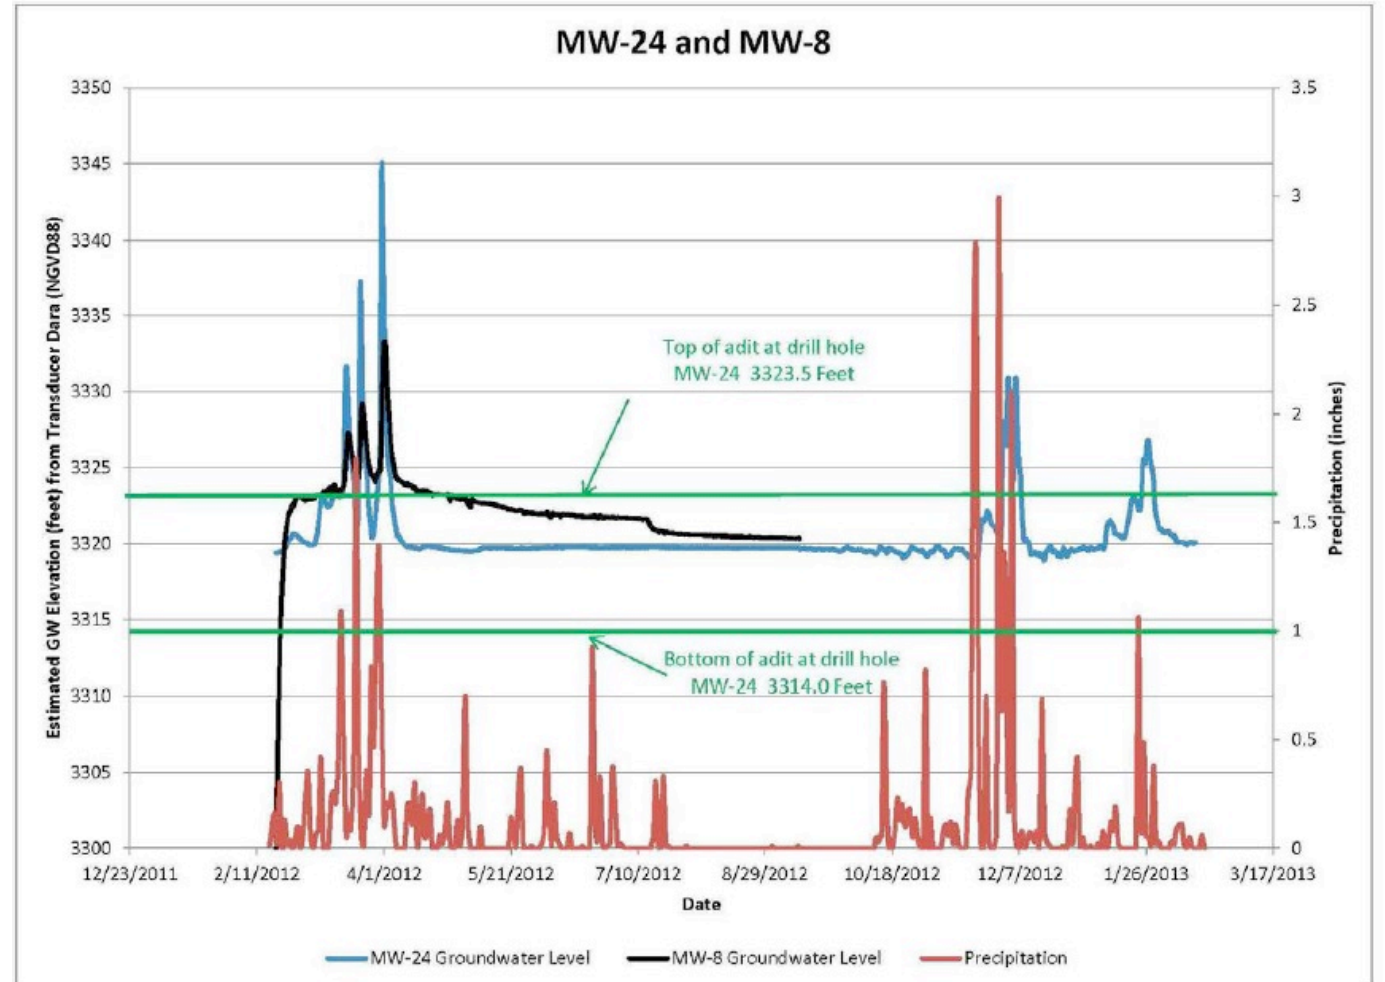
Figure 25. Graph of Monitor Well Transducer and Precipitation Data

MW-8 screened in fractured bedrock.
