Case Study: Fort Ord

Fort Ord

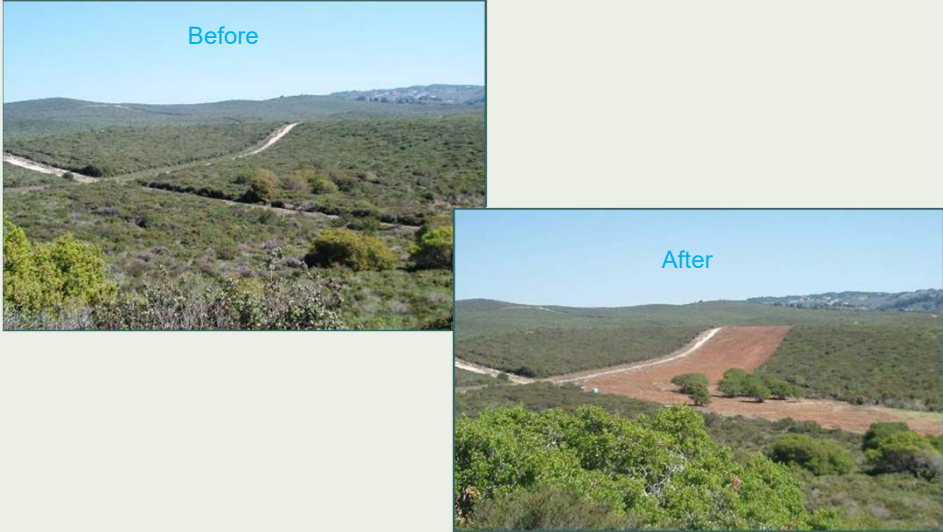
Fuel Break Cutting

The image shows two side-by-side photographs of a landscape. The left photograph, labeled 'Before', shows a dirt road winding through a dense, green brushland. The right photograph, labeled 'After', shows the same area after a fuel break cutting, with a large section of the brushland cleared, revealing brown soil. The EPA logo is in the bottom left corner, and the text '3a-7' is in the bottom right corner.

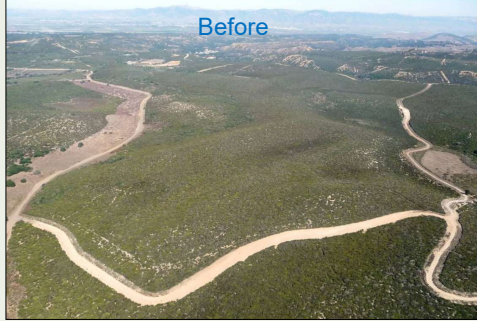
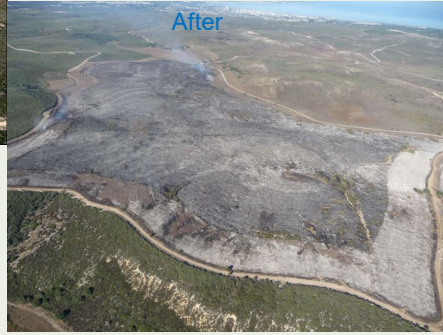
Prescribed Burn Before and After

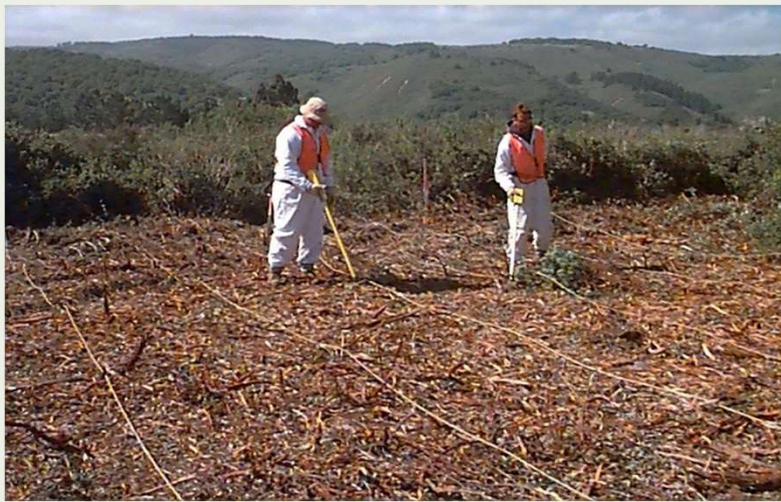
Analog Detection and MEC Removal

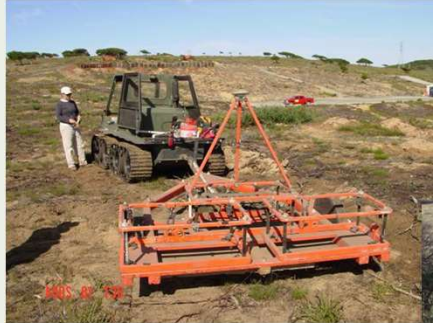
Towed Digital Geophysical Mapping

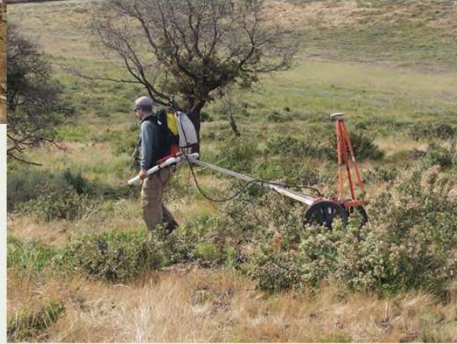
Manual Digital Geophysical Mapping

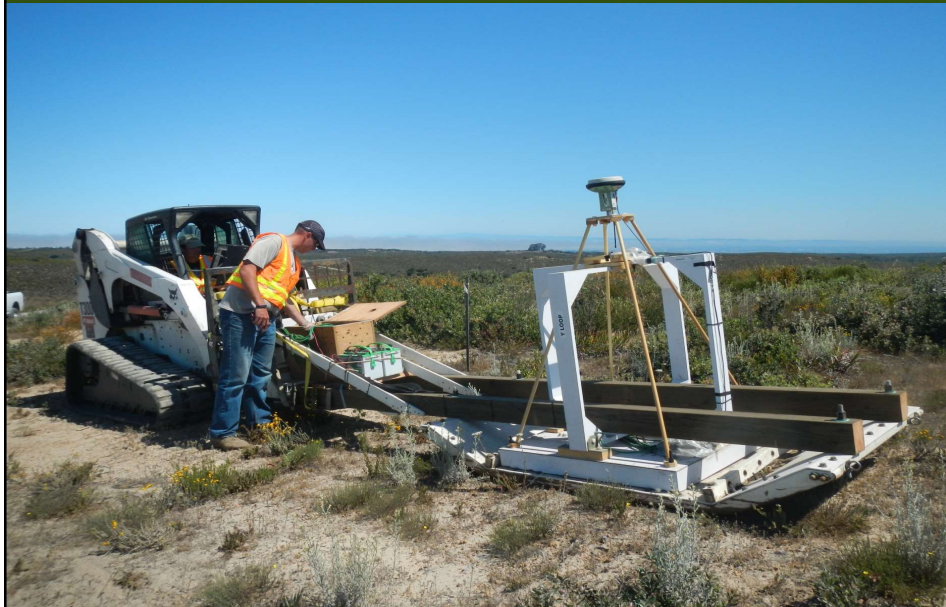
Metal Mapper (DGM)

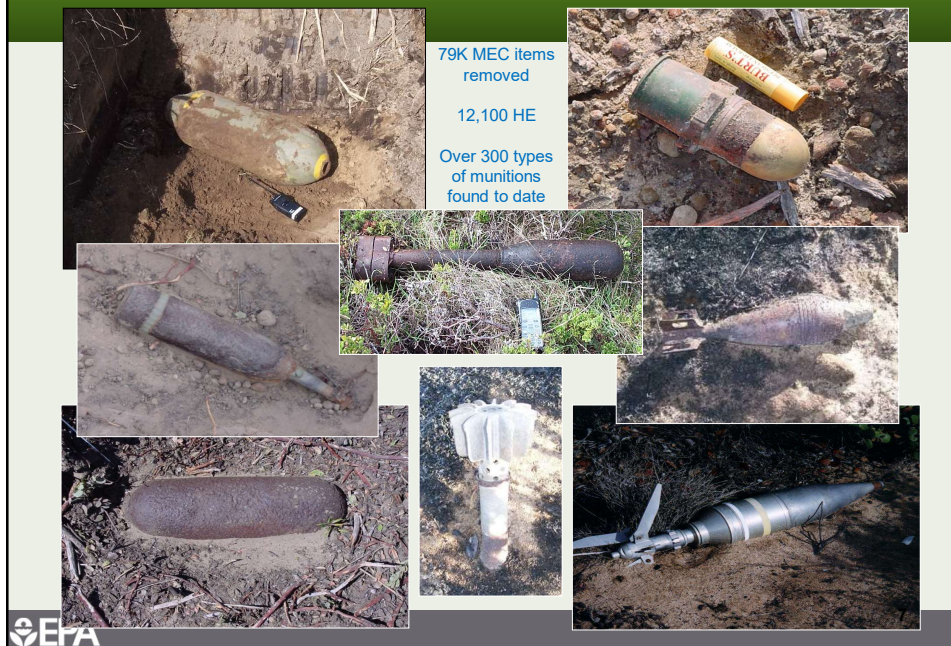
Types of UXO Found
