***Green Pond Oil Spill Site Revegetation/ Restoration  
Project***

***Royal J. Nadeau, The Eco-Strategies Group  
Allamuchy, New Jersey  
and  
Michael F. Solecki, OSC  
USEPA Region II Removal Program  
Edison, New Jersey***

***EPA WebCast March 30<sup>th</sup> 2006***

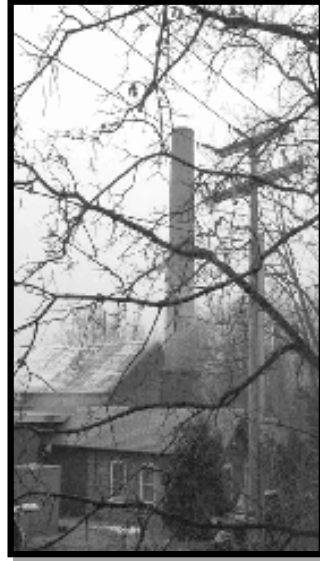
*Relict Pumping Station at Unionville, New York similar to Newfoundland Pumping Station*

*+ Eleven stations, 28 miles apart, over a 315 mile distance with 4 six inch diameter pipelines*

*+ Maximum capacity of 50K barrels a day (2.1 million gallons)*

*+ Operation period: 1881-1920*

One of the few if not only remaining pumping stations in existence. The buildings are intact but the pumps and boilers have been removed to make room for the present day utilization.

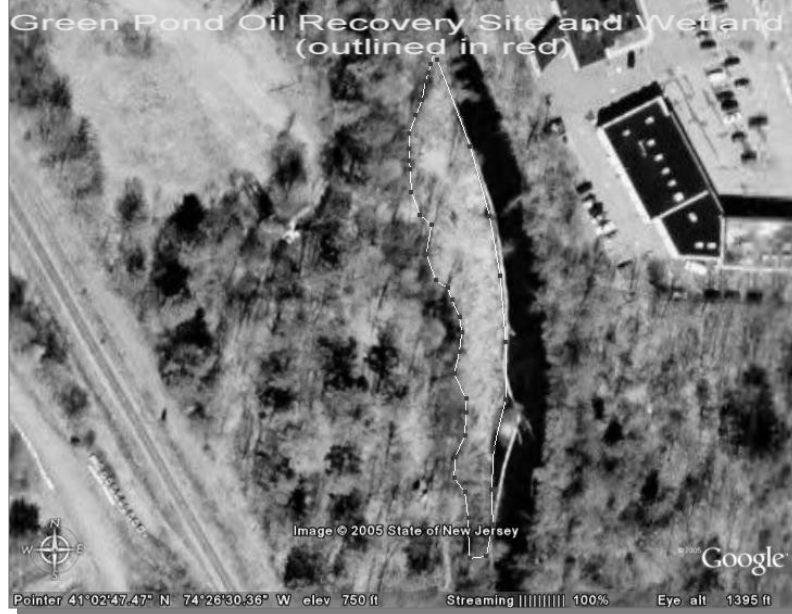
An aerial view of the Green Pond Oil Removal Site and Wetland. The wetland is 1.3 acre (.53 hectare) in size and borders the Pequannock River which serves as the connecting stream for the reservoir system of the City of Newark's water supply. The stream volume and current is regulated, especially during the summer months by the City of Newark water supply managers when the demand is greatest.

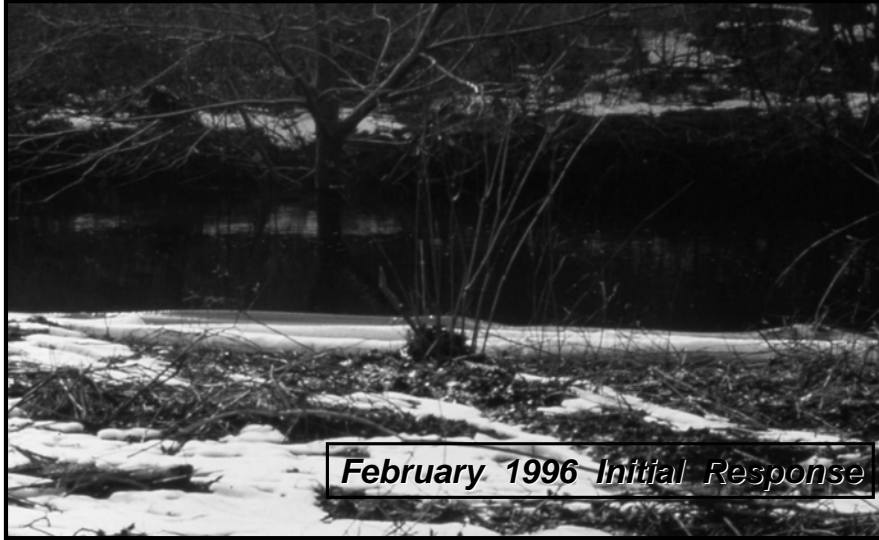
Background: In the winter of 1996, the water table was higher than usual from all the previous rain events and melting snow. The water table and oil surfaced on to the adjacent wetland located between pump station site and the Pequannock River ultimately discharging into the river. It is uncertain how often this phenomenon had occurred previously but apparently this time the severity was such as to initiate reporting to the National Response Center and ultimately a response by state and federal officials.

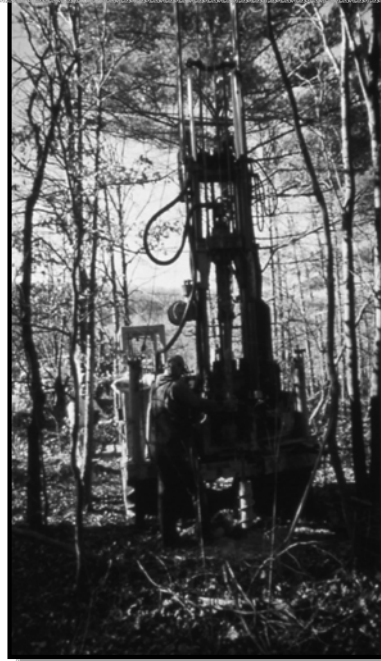
Later that Spring, twenty small diameter monitoring wells (piezometers) were drilled and sampled to locate the boundary of the subsurface oil deposit. Eventually, additional wells were installed to better locate the area of greatest concentration of subsurface oil. An upland recovery well was installed at this point using a bi-phase pumping system that skimmed and pumped the surface oil into a storage tank while the bottom pump created a zone of depression by pumping water to an injection pit 46 meters west of the recovery well location.

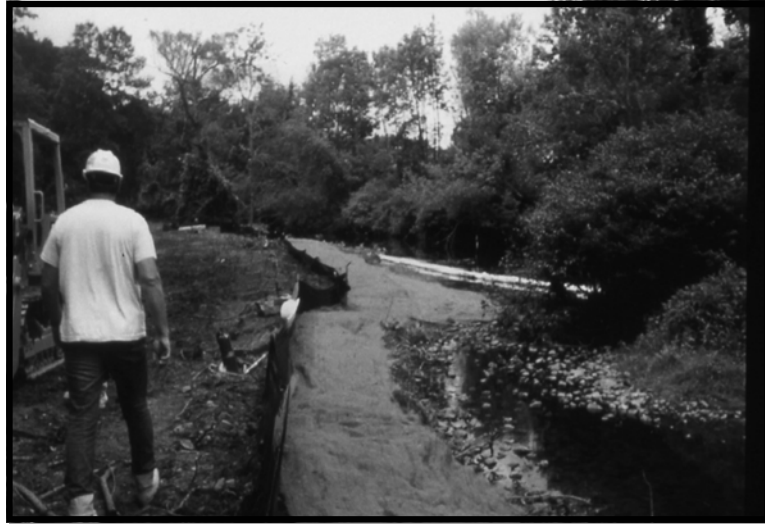
11

In mid-summer 1998, marsh soil cleanup operations commenced with the removal of oiled woody debris (deadfalls, etc). Once these materials were removed, then a minimum amount of oily marsh soil was removed, sufficient only to remove the upper most oiled portion (10-15 cm). Most of the released oil had been trapped and sorbed on to the vegetative mat.

*July 1998*

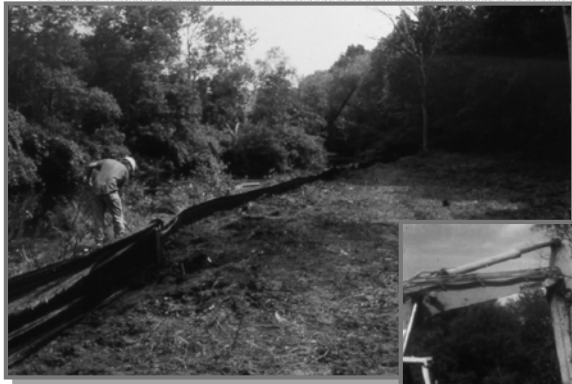
12

Although revegetation of the marsh was always considered, the main emphasis at this phase was on restoring and stabilizing the stream bank. Coconut fiber matting was installed adjacent to the stream to stabilize the soils and prevent erosion and possible further contamination of the Pequannock River. Erosion Control Fencing had been installed prior to the surface removal procedure but was removed to install the matting. This fencing was re-installed as an extra measure of protection of the stream.

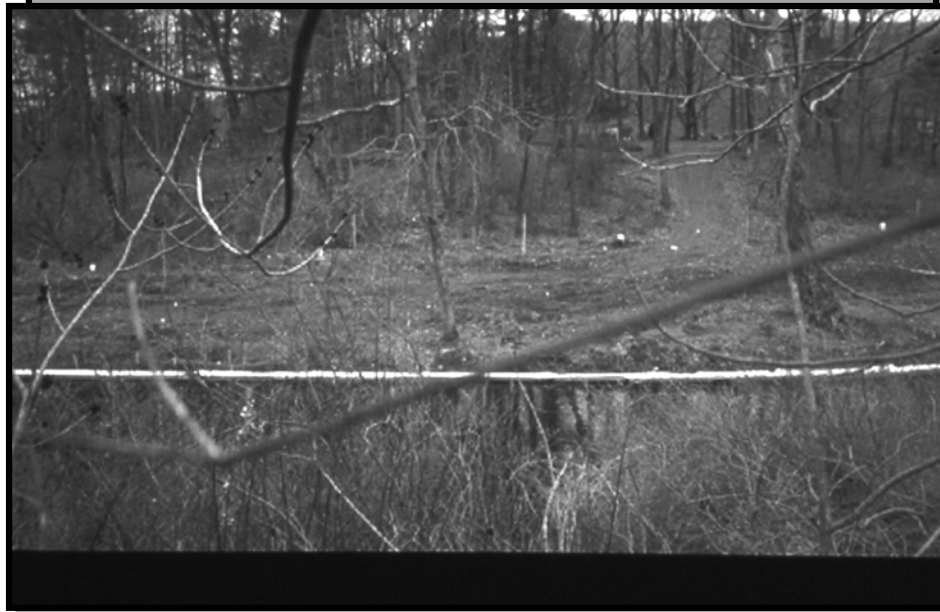
Here is a view of the wetland from across the Pequannock River in the Autumn of 1998 following the removal of the oil contaminated soils. The white absorbent and containment boom can be seen along the streambank to collect oil that might still be leaching out of the marsh surface and subsurface deposits.

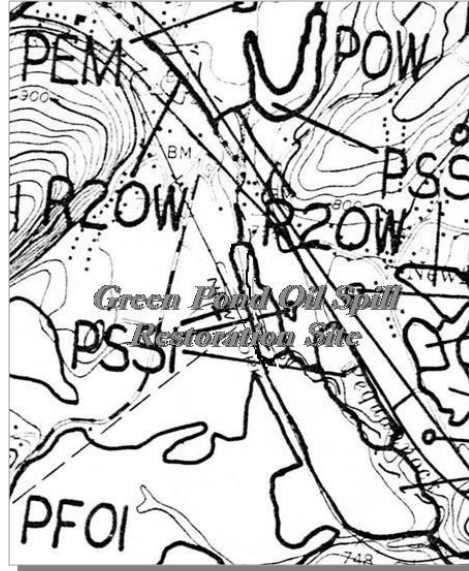
18

*PSS1 = Palustrine  
Scrub Shrub Broad  
leaved Deciduous  
e.g. Red Maple swamp*

The Restoration Team using the National Wetland Inventory Map was able to determine that the Green Pond site was considered a Palustrine Scrub Shrub Broad-leaved Deciduous wetland (PSS1). Before removal of the contaminated soil, some shrubs had been observed but had not been identified to species. Using the Inventory Map list and visiting the undisturbed floodplain wetland across the stream from the site, the Restoration Team generated a list of candidate species for restoration.

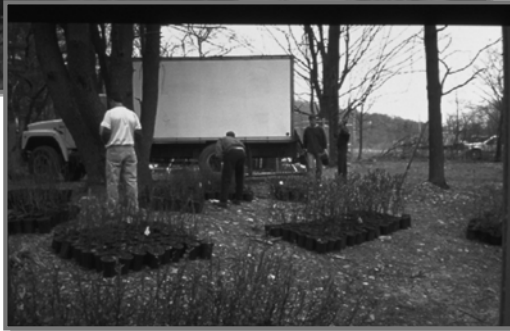
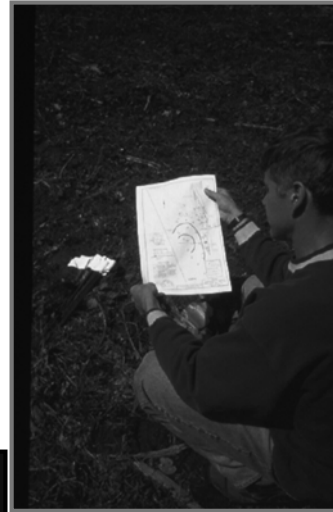
22

*April 1999 Earth Day at Green Pond  
Oil Spill Site*

On Earth Day 1999, the plant materials and installers arrived on site. A Bid Package with Specifications had been prepared by the Restoration Team and submitted to the EPA OSC. A landscape firm who specialized in native plant installation was selected from three firms who had submitted bids.

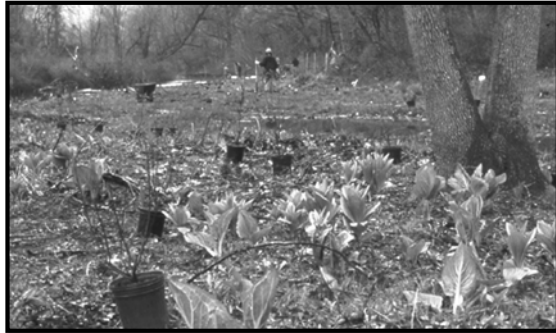
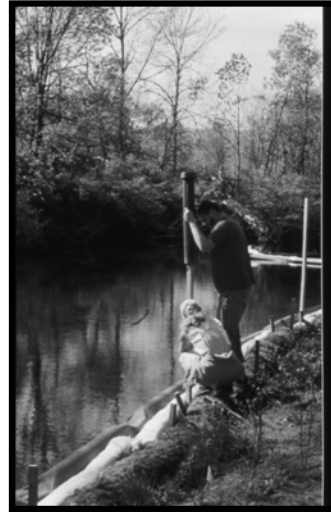
23

Originally the Statement of Work in the Bid Package called for live stakes for the shrubs but due to the lateness in the season, potted materials were substituted instead to insure greater survivability of the plants. Here you see the placement of the individual plants on the marsh surface. All the plant materials were installed within a two day time frame in mid April 1999 followed by deer fencing surrounding the entire site. A suggestion was made by the installation crew chief, Bill Young to the Restoration Committee as to the exact location and number of plants needed. Instead of grouping the plantings in clusters as originally proposed in the NRCS Plan, Mr. Young suggested that the plantings be distributed in smaller but more numerous clusters throughout the entire site. Two major advantages of this scheme would be that the deer fencing required to protect the new plantings (seen here being installed) could then encompass the entire site rather than the clusters as previously proposed. The other advantage was that only two-thirds of the plant materials would be required to fulfill the objectives of the project.

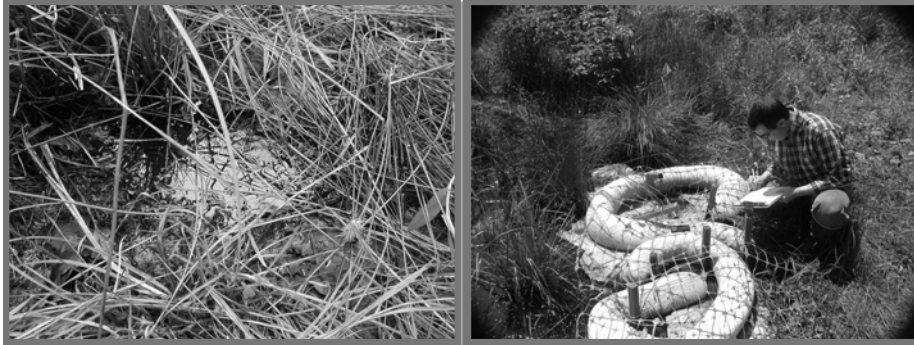
Over the winter, the recovery system was not in operation and “spooges” occurred at the same locations due to the Spring high water table. The contamination levels in the soils reflected the influence of these various “spooage” events. When the oil recovery systems had been shut down during the winter and during high ground water conditions, oil had surfaced in specific locations in the marsh. Much of this oil was trapped in the vegetation mat and the rest was trapped by the absorbent booms stretched along the shoreline.

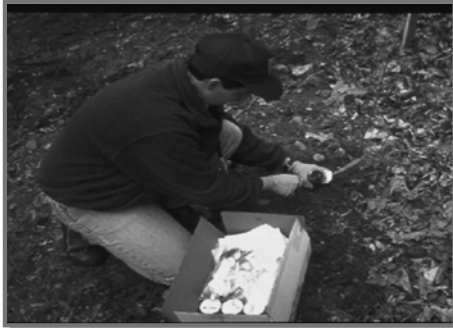
28

### Monitoring Oil Levels in the Soils

At the outset of the study in order to determine the impact of the cleanup operations at the Green Pond Oil Spill Site, it was determined that soil samples should be collected and analyzed for residual petroleum hydrocarbons. Following the installation of plant materials in April 1999, soils were collected from selected sites within the restored wetland and a control site across river. The residual TPH levels in the soils were important to document any potential toxic effects to the newly installed plants in terms of mortality and/or growth patterns.

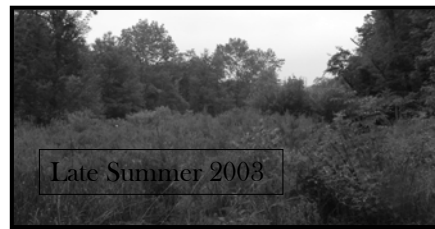
31

Prior to the Transects being established, photodocumentation was initiated as a regular activity to document the growth of the herbaceous plant community. A single reference location, called the Photo Rock located in the northwest corner of the wetland, was used consistently to photograph growth and successional changes.

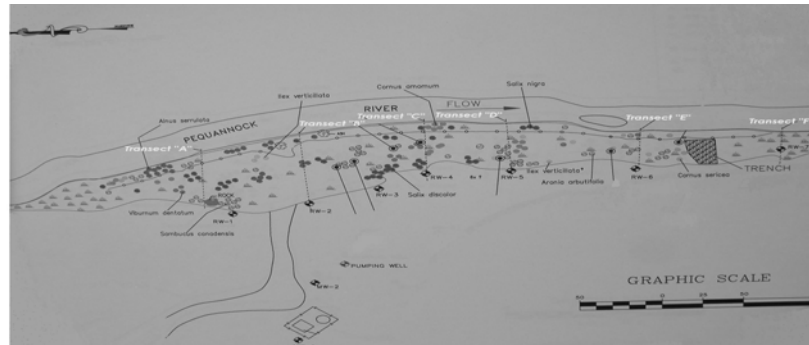
### Monitoring the Wetland Plant Community

Six transect lines were established running east to west from the initial Recovery Wells. Plant species were identified at four foot intervals within six inch radius of each location and identified to the lowest taxonomic level possible. Any plants discovered within this radius were included in the survey. This type of survey is called **Point Intercept Sampling** and is one of the methods recommended in the 1989 manual for delineating wetlands (Tiner, R.W. 1999). It is a plot based method with a point on the transect representing the smallest plot which was used primarily for characterizing grassland plant communities. At the Green Pond site, we use the six inch radius as the plot size. A Spring survey was performed to document the spring ephemeral plants which likely would not be present in the Fall. The Fall survey was performed to document those plants which develop later in the growing season. Each location along each transect was marked and delineated with a red flag. Transect F is considered a control as it is located in an area that was not cleared during the site work and is considered representative of an undisturbed area.

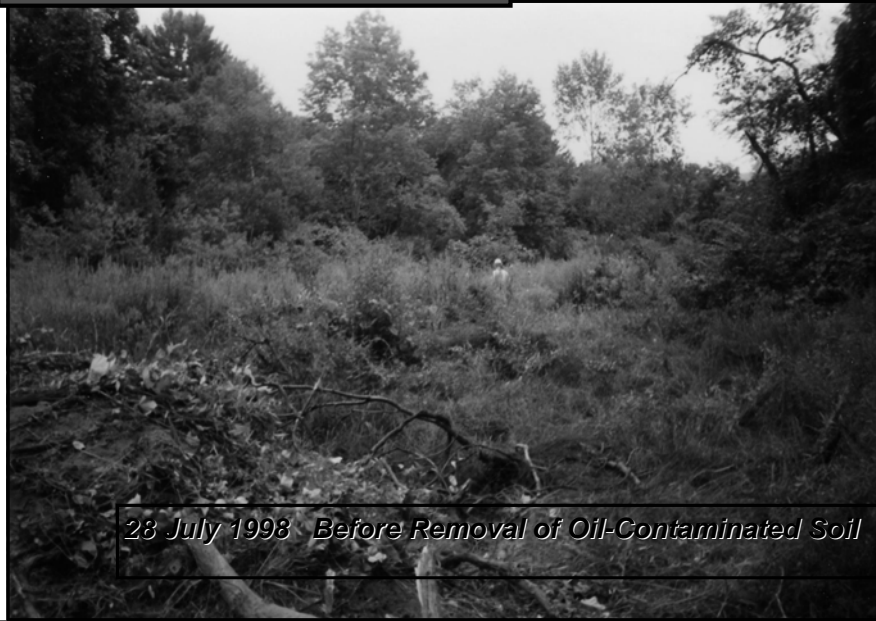
*23 July 1998 - Before Removal of Oil-Contaminated Soil*

We know from this photo taken before the removal of contaminated soil in July 1998 that Purple Loosestrife (***Lythrum salicaria***) was present at the Green Pond site.

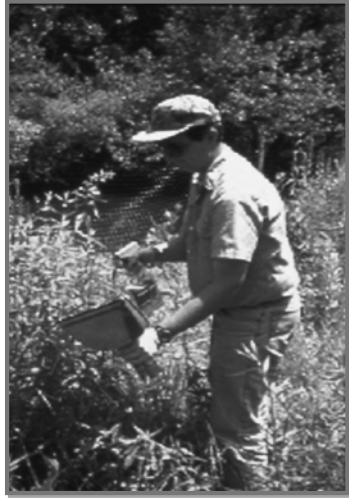
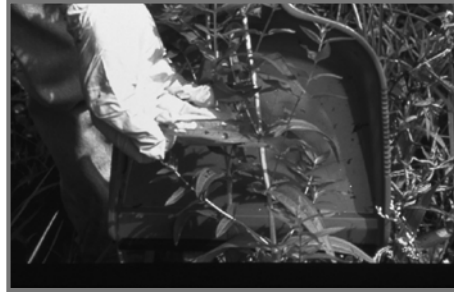
*Invasive Species  
Management for Purple  
Loosestrife 2000*

Invasive species control was instigated early in 2000 in the project during the growing season following the installation of the shrubs. A limited spraying program used a glyphosate herbicide (Roundup) on a small stand of Loosestrife that had survived the previous year's soil removal operations. This test was abandoned after it was realized that the amount of Roundup needed to control the Loosestrife might possibly impact the water quality of the nearby Pequannock River.

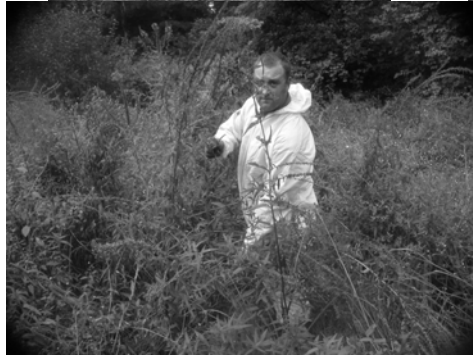
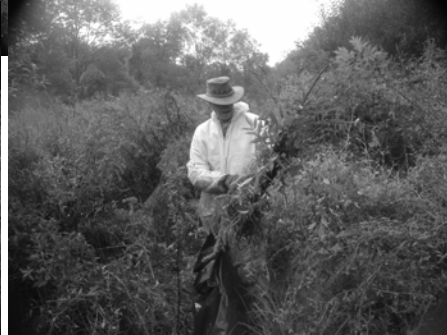
### Pulling Purple Loosestrife as a Control Technique

A hand extraction effort was tried in a small area. This involved physically removing individual plants by hand which is considered an effective control technique (Malecki, et al. 1993). However, at Green Pond, this technique was also abandoned as being too labor intensive.

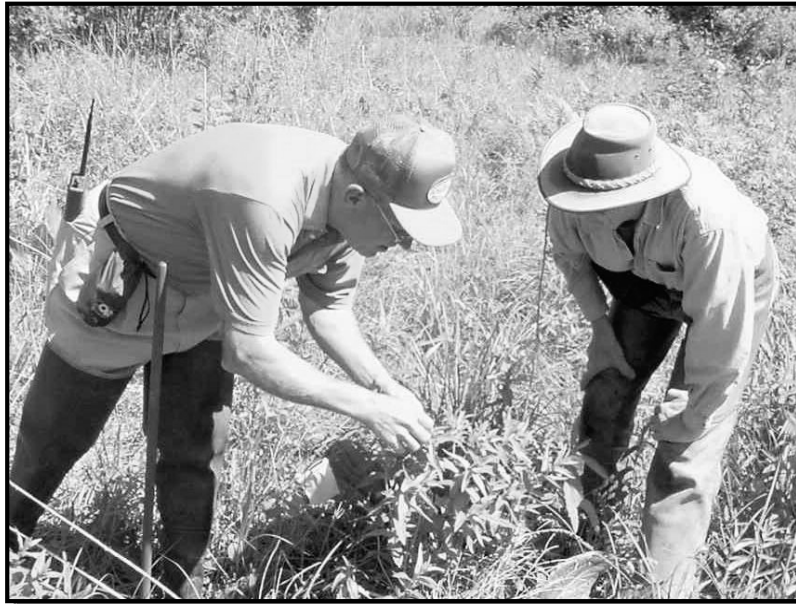
45

By 2001, we had learned of the Biological Control Program that the State of New Jersey's Department of Agriculture had in place for Purple Loosestrife and contacted the appropriate officials about the Green Pond site as a possible candidate for biological control. In June 2001, Tom Scudder, State Entomologist, visited the site to evaluate the potential for biological control and later in the summer released 3000 *Galerucella californiensis* and *pusilla* at the Green Pond site in the densest stands of Purple Loosestrife. Mr. Scudder marked these locations with blue and white tape to be visited in subsequent years to monitor the *Galerucella* populations.

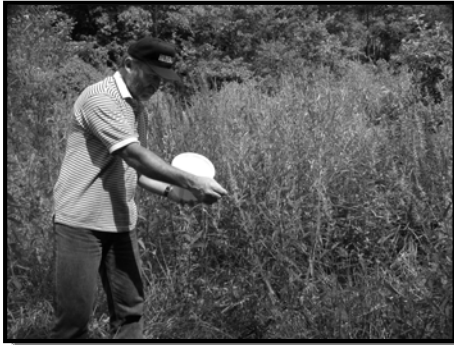
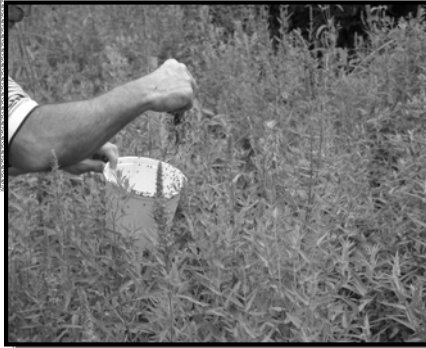
46

Adding more *Galerucella* beetles

On July 24th, 2002, 3000 *Galerucella* adults were added to the existing Green Pond population by Craig Bitler, The Eco-Strategies Group's Biological Control expert. Mr. Bitler, shown here, distributed the beetles to areas of loosestrife growth that had not been assaulted by the beetles introduced in June 2001. Although the "2001 class" has performed admirably in the biological control program, the loosestrife was extremely prolific in seed production with new plants becoming established in other areas of the wetland, thus the need for introducing additional beetles. The new recruits were supplied by the State of New Jersey Department of Agriculture's Bureau of Biological Control Laboratory. According to Craig Bitler, these recruits will eat their fill, drop to the ground, hibernate just below the soil surface and will emerge next spring (2003).

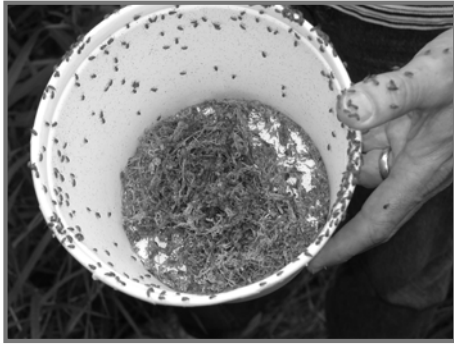
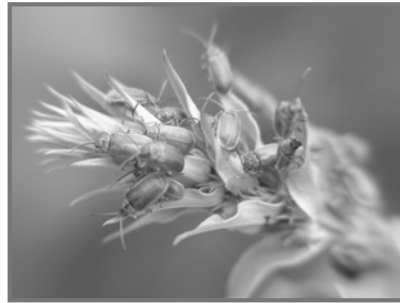
47

*Biological Control with Galerucella beetles 2002 & 2003*

A minimum of 2,000 to 3,000 beetles per site are recommended. Releases in successive years will improve the chance for establishment. As the population increases, beetles may move larger distances (up to a few miles). Beetles may be released at any time after purple loosestrife emerges in the spring until late August. Beetles released prior to the summer solstice (June 21) may reproduce and show significant increase in the year of release. Beetles released after the summer solstice are likely to feed and over-winter without reproducing. These same beetles will reappear the following spring to restart the cycle. A measure of success of introducing a bio-control agent is when the agent is able to reproduce, over-winter and emerge the following season in numbers sufficient to be effective against the target plant species.

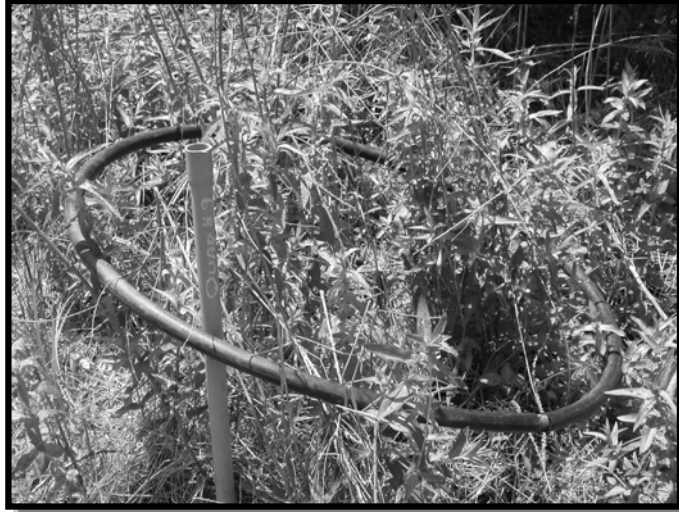
49

### Monitoring Purple Loosestrife Biological Program at the Green Pond Site

A monitoring program was initiated in June 2002 and carried out in 2002 and 2003 using the Protocol developed by Dr. Bernd Blossey of Cornell University. This entails ten randomly placed one-square meter plots being established within the site. Survey data was gathered in the spring and then in late summer. The purpose is to determine to what extent the beetles are having an impact on the Loosestrife populations, if any. The results, shown below, are compiled and voluntarily submitted to Cornell University for their database on overall Biological Control Program.

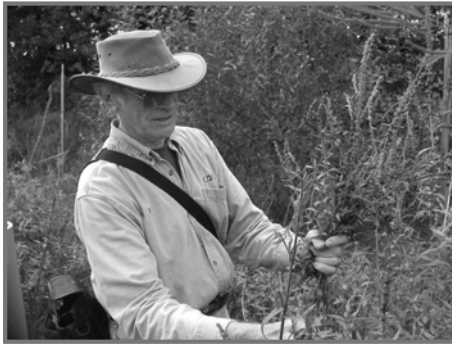
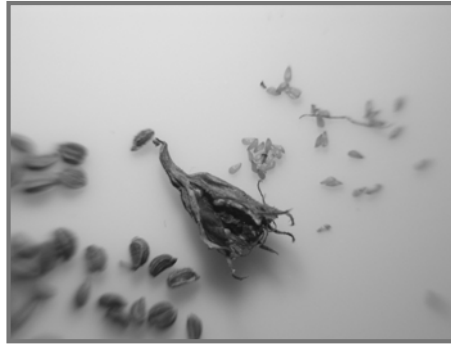
59

- Seed head clipping in Spring.*
- Clipping Flowering structures in late summer before seed maturation*

Clipping the seed bearing structures prior to the release of seeds helps deter the spread of Purple Loosestrife to new locations. At the Green Pond site, the most likely seed spreading vector would be the Pequannock River during spring flood conditions. A single plant may produce as many as two million seeds, a very prolific species indeed.

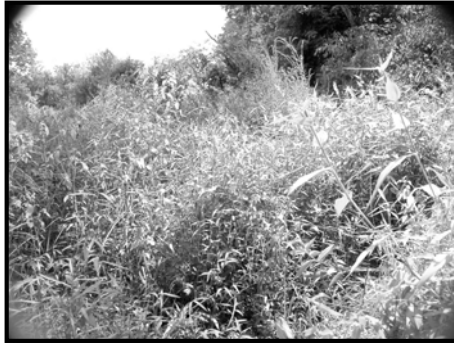
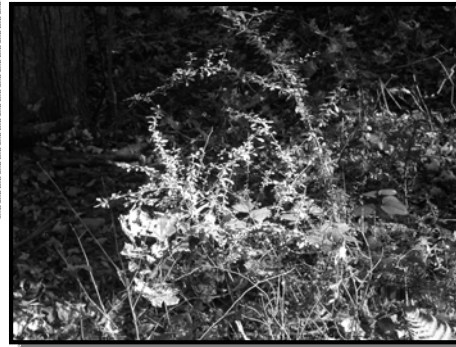
60

Nepal Microstegium (Japanese Stiltgrass)

Japanese barberry

A number of alien invasives have been documented at the Green Pond site. Japanese Stilt grass, once confined to a small clump in the southern end of the wetland has now spread to other locations. It has a sprawling habit and grows slowly through the summer months, ultimately reaching heights of 2 to 3-1/2 ft. Japanese stilt grass is especially well adapted to low light conditions. It threatens native plants and natural habitats in open to shady, and moist to dry locations. Stilt grass spreads to form extensive patches, displacing native species that are not able to compete with it. Japanese stilt grass is a colonial species that spreads by rooting at stem nodes that touch the ground. Stilt grass reproduces exclusively by seed. Individual plants may produce 100 to 1,000 seeds that fall close to the parent plant. Seed may be carried further by water currents during heavy rains or moved in contaminated hay, soil, or potted plants, and on footwear. Stilt grass seed remains viable in the soil for five or more years and germinates readily.

Japanese barberry is a dense, deciduous, spiny shrub that grows 2 to 8 ft. high. The branches are brown, deeply grooved, somewhat zig-zag in form and bear a single, very sharp spine at each node. At Green Pond, only few individual plants were observed in the wetland close to the Pequannock River although it is abundant in the upland portion of the site. Japanese barberry forms dense stands in natural habitats including canopy forests, open woodlands, wetlands, pastures, and meadows and alters soil pH, nitrogen levels, and biological activity in the soil. Once established, barberry displaces native plants and reduces wildlife habitat and forage. White-tailed deer apparently avoid browsing barberry, preferring to feed on native plants, giving barberry a competitive advantage. In New Jersey, Japanese barberry has been found to raise soil pH (i.e., makes it more basic) and reduce the depth of the litter layer in forests. Japanese barberry spreads by seed and by vegetative expansion. It produces large numbers of seeds which have a high germination rate, estimated as high as 90%. Barberry seed is transported to new locations with the help of birds (e.g., turkey and ruffed grouse) and small mammals which eat it.

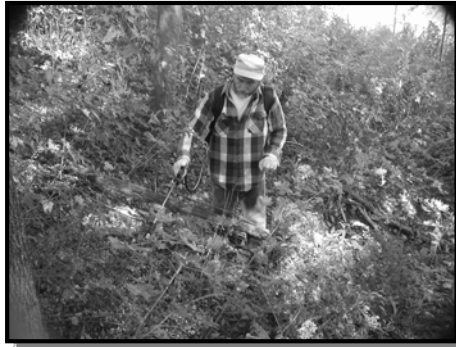
Japanese Barberry Control measures at Green Pond

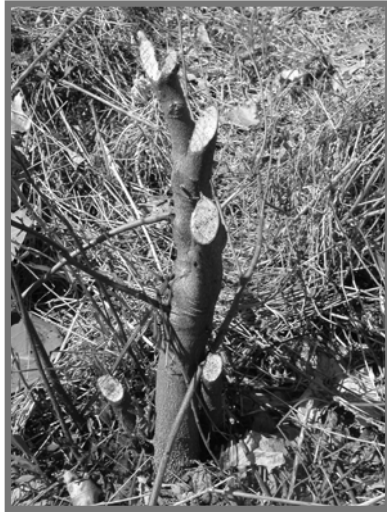
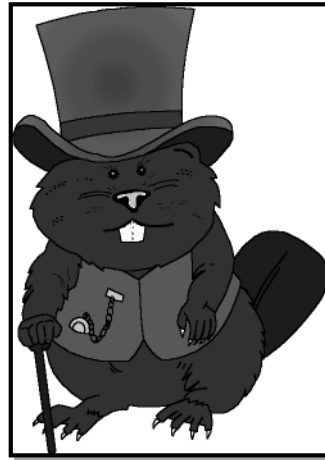
67

In late winter of 2002, unwelcomed beavers clipped many of the willows and alders that had been planted in 1999. They removed the branches off site such that originally, we thought that the shrubs had been vandalized by humans but a closer look revealed who the vandals really were. These beavers were probably young adults who live in the streambank closeby. The Pequannock River is too large to dam and create beaver ponds but offers miles of streambank with abundant shrubbery for food.

However, by the end of the growing season of 2002, the shrubs had regained their original stature and density by base sprouting and growth. Beaver harvesting in 2003 was observed but was marginal compared to the harvesting that occurred in 2002 and none was observed in 2004 and 2005.

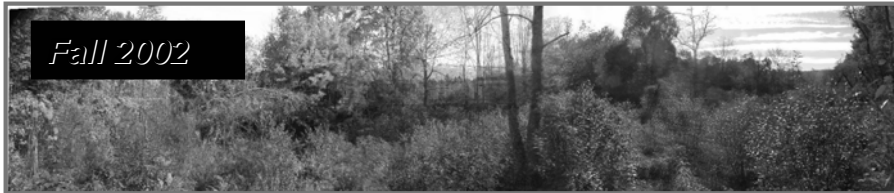
Shrub Recovery after Beaver Herbivory

This is not uncommon and has been observed at other locations and may have some beneficial aspects as the number of stems per plant after harvesting is greater than without harvesting.

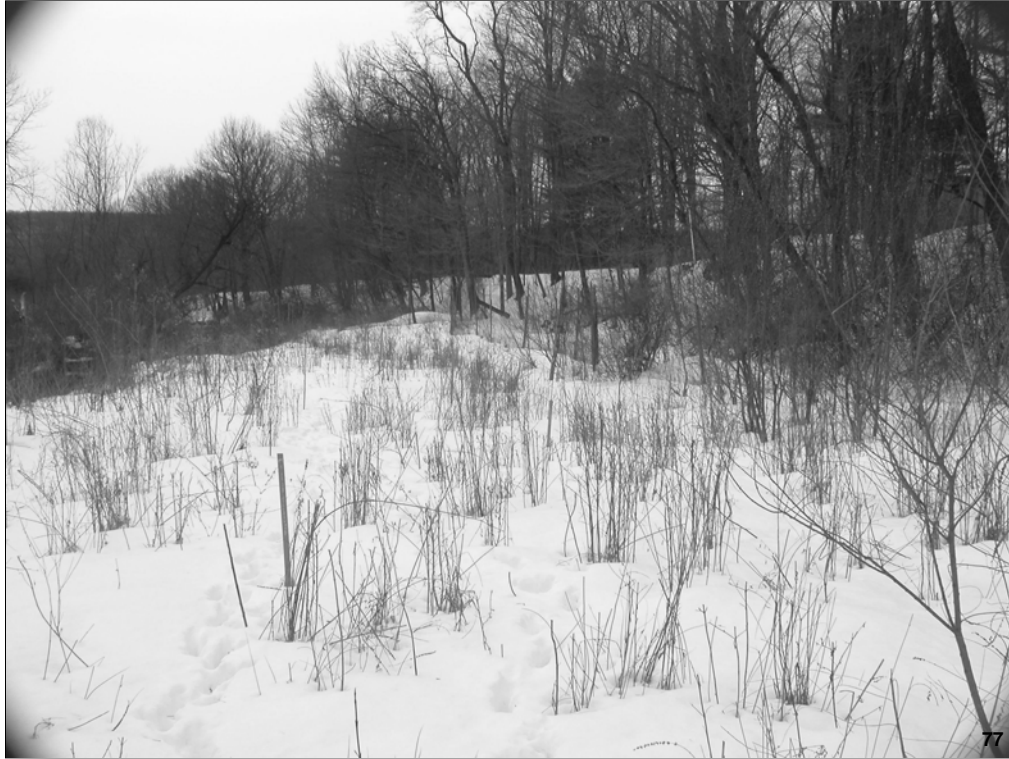
The Green Pond Restoration site as it appears today looking south from mid-site. Note the gray PVC stakes that mark the location of the Bio-Control Protocol Sampling Quadrats.
