***Green Pond Oil Spill Site Revegetation/ Restoration  
Project***

***Royal J. Nadeau, The Eco-Strategies Group  
Allamuchy, New Jersey  
and  
Michael F. Solecki, OSC  
USEPA Region II Removal Program  
Edison, New Jersey***

***EPA WebCast March 30<sup>th</sup> 2006***

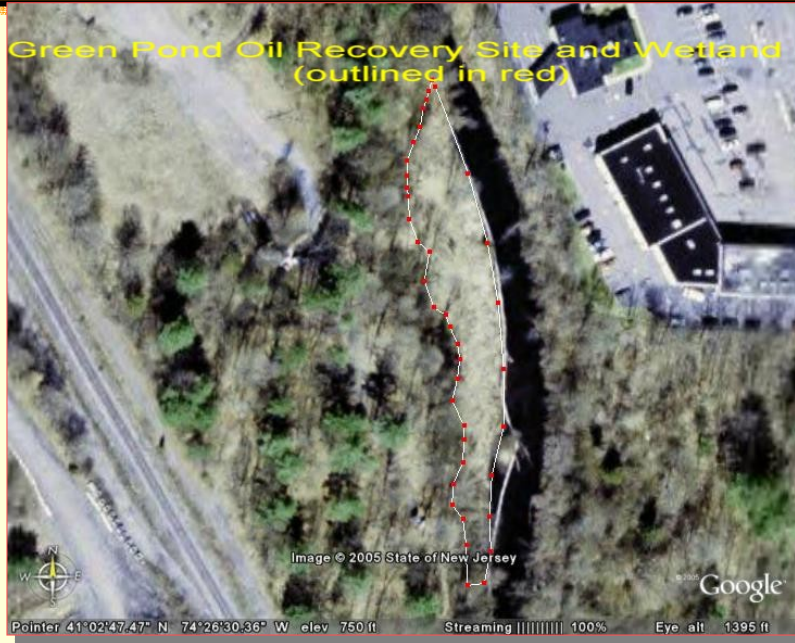
Green Pond Oil Recovery Site and Wetland  
(outlined in red)

An aerial view of the Green Pond Oil Removal Site and Wetland. The wetland is 1.3 acre (.53 hectare) in size and borders the Pequannock River which serves as the connecting stream for the reservoir system of the City of Newark's water supply. The stream volume and current is regulated, especially during the summer months by the City of Newark water supply managers when the demand is greatest.

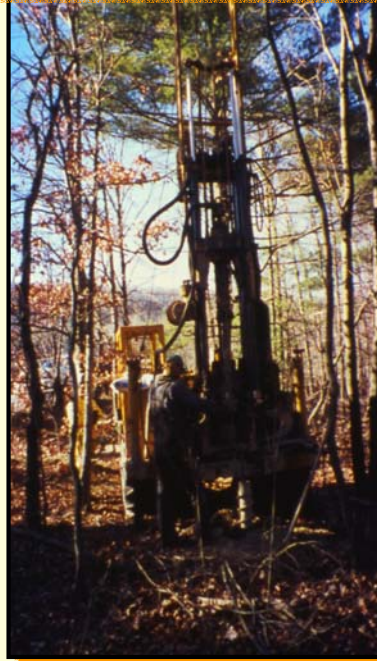
Later that Spring, twenty small diameter monitoring wells (piezometers) were drilled and sampled to locate the boundary of the subsurface oil deposit. Eventually, additional wells were installed to better locate the area of greatest concentration of subsurface oil. An upland recovery well was installed at this point using a bi-phase pumping system that skimmed and pumped the surface oil into a storage tank while the bottom pump created a zone of depression by pumping water to an injection pit 46 meters west of the recovery well location.

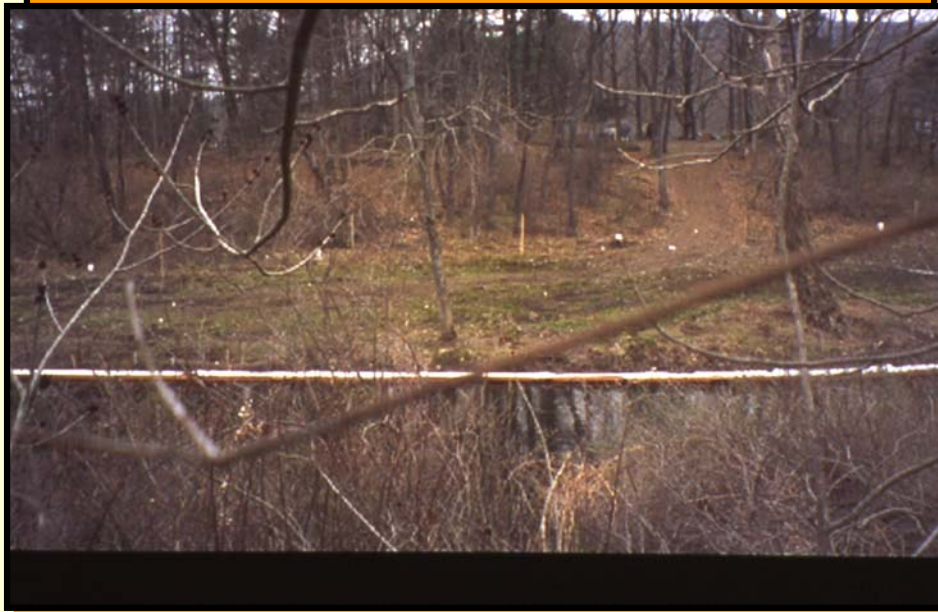
Here is a view of the wetland from across the Pequannock River in the Autumn of 1998 following the removal of the oil contaminated soils. The white absorbent and containment boom can be seen along the streambank to collect oil that might still be leaching out of the marsh surface and subsurface deposits.

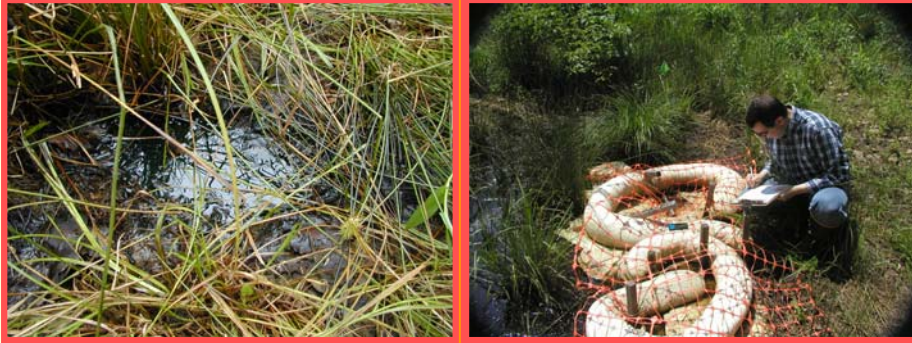
Over the winter, the recovery system was not in operation and “spooges” occurred at the same locations due to the Spring high water table. The contamination levels in the soils reflected the influence of these various “spooage” events. When the oil recovery systems had been shut down during the winter and during high ground water conditions, oil had surfaced in specific locations in the marsh. Much of this oil was trapped in the vegetation mat and the rest was trapped by the absorbent booms stretched along the shoreline.

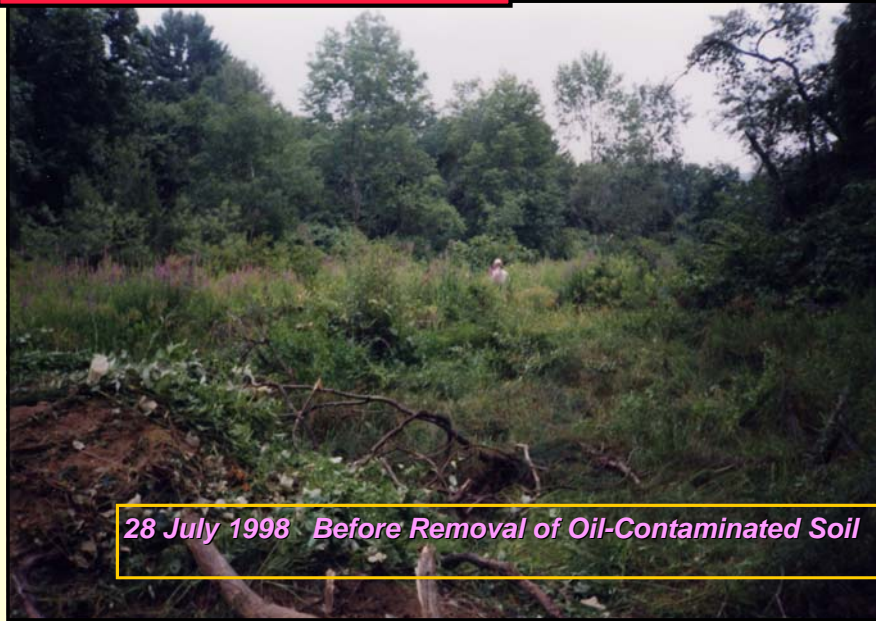
*28 July 1998 Before Removal of Oil-Contaminated Soil*

We know from this photo taken before the removal of contaminated soil in July 1998 that Purple Loosestrife (***Lythrum salicaria***) was present at the Green Pond site.

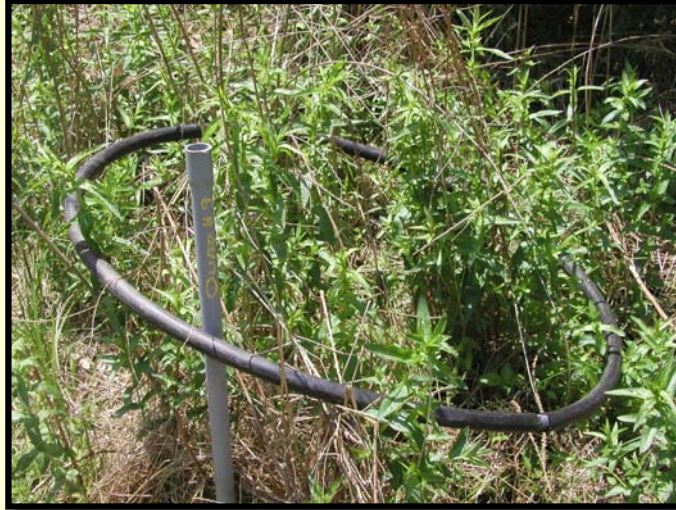
### Monitoring Purple Loosestrife Biological Program at the Green Pond Site

A monitoring program was initiated in June 2002 and carried out in 2002 and 2003 using the Protocol developed by Dr. Bernd Blossey of Cornell University. This entails ten randomly placed one-square meter plots being established within the site. Survey data was gathered in the spring and then in late summer. The purpose is to determine to what extent the beetles are having an impact on the Loosestrife populations, if any. The results, shown below, are compiled and voluntarily submitted to Cornell University for their database on overall Biological Control Program.

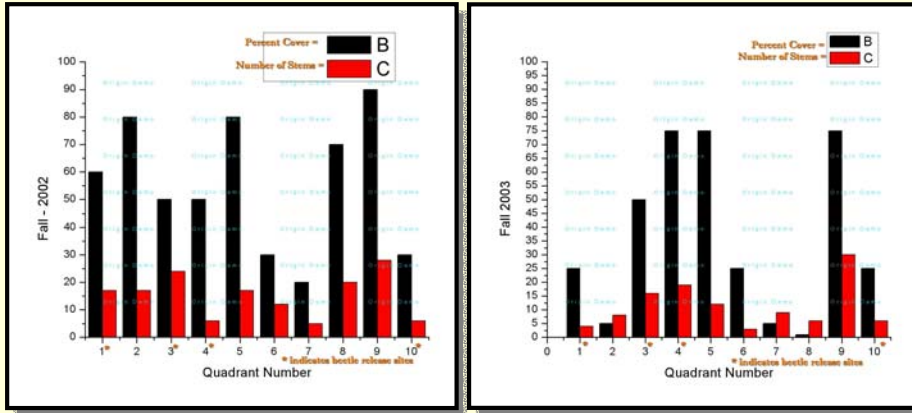
At many locations noticeable decrease in percent cover and stem numbers

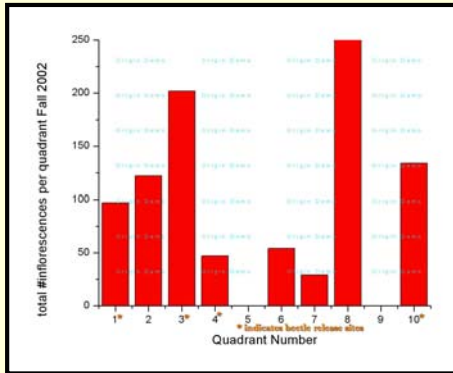
At many locations noticeable decrease in total number of flower heads

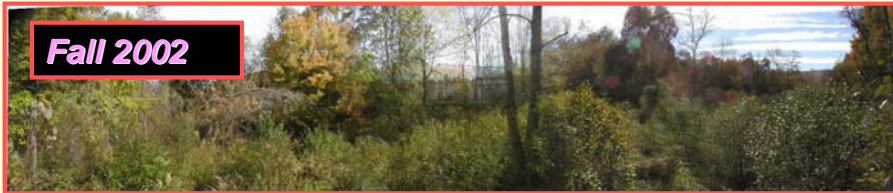
**Shrub Recovery after Beaver Herbivory**

However, by the end of the growing season of 2002, the shrubs had regained their original stature and density by base sprouting and growth. Beaver harvesting in 2003 was observed but was marginal compared to the harvesting that occurred in 2002 and none was observed in 2004 and 2005.

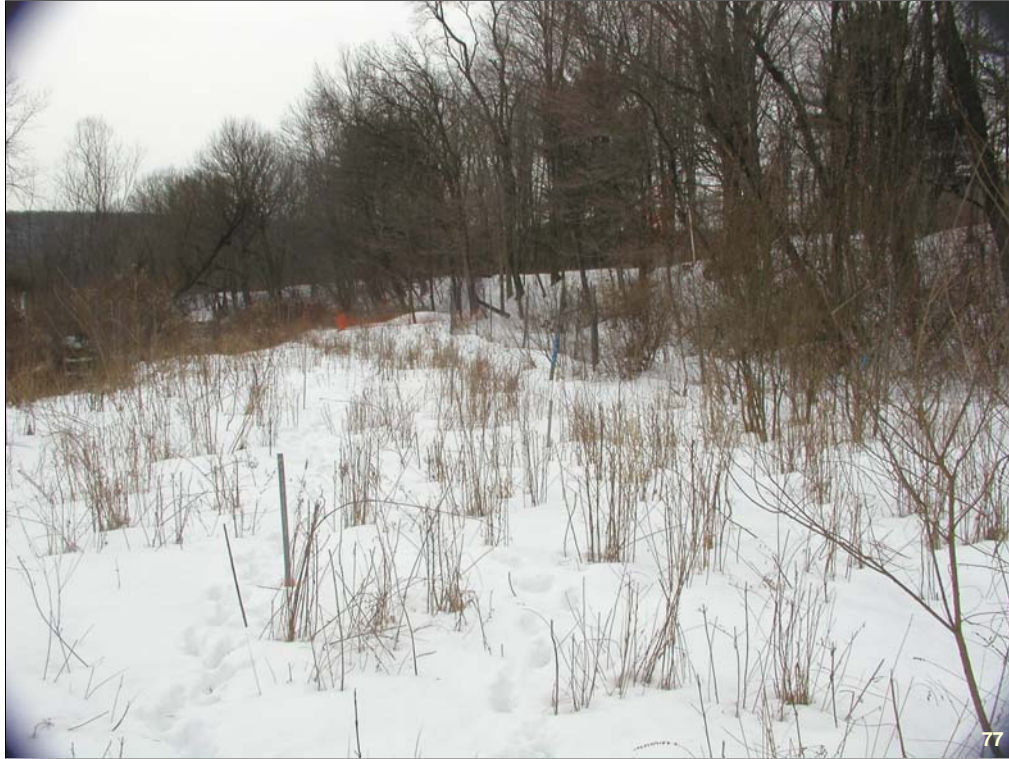
The Green Pond Restoration site as it appears today looking south from mid-site. Note the gray PVC stakes that mark the location of the Bio-Control Protocol Sampling Quadrats.
