2018 Long-Term Stewardship Conference

Long-Term Stewardship of Three Evapotranspirative Covers, 15 years

Sue Collins, Long-Term Stewardship Program Lead Sandia National Laboratories

> Track 2.2: Understanding the Post-Closure Changes of Engineered Disposal Cell Covers, Part 1

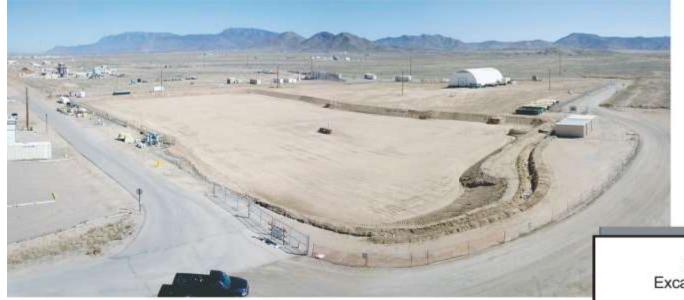
Pre-cover installation Excavation backfilled to 4 ft bgs

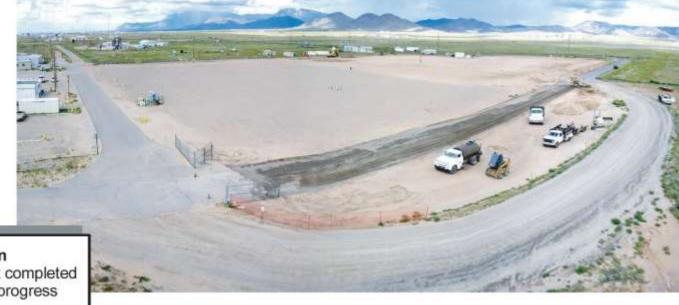
ET Cover Construction at Chemical Waste Landfill

Post-cover installation

Drainage swales/revegetation not completed Restoration of asphalt road in progress

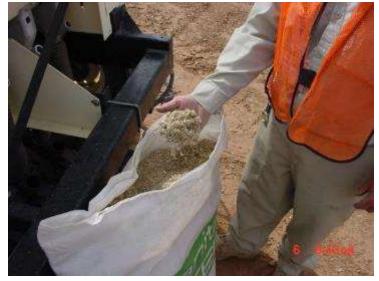
Seed mix

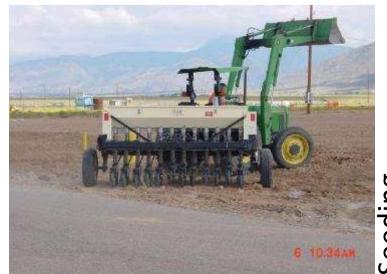
Seeding

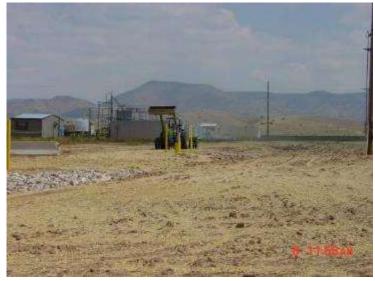
Mulching, Crimping

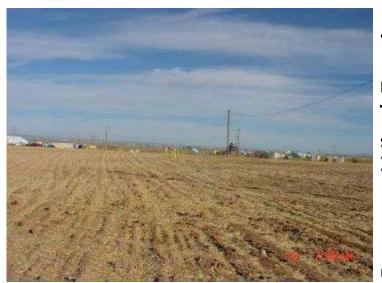
Prevent Wind Erosion
